Coastal Embankment Improvement Project, Phase-I (CEIP-I)

**Long Term Monitoring, Research and Analysis of  
Bangladesh Coastal Zone (Sustainable Polders Adapted to  
Coastal Dynamics)**

**Report  
on  
Selection of Polders for Conceptual Design as Pilot  
Program (Revised)**

March 2021

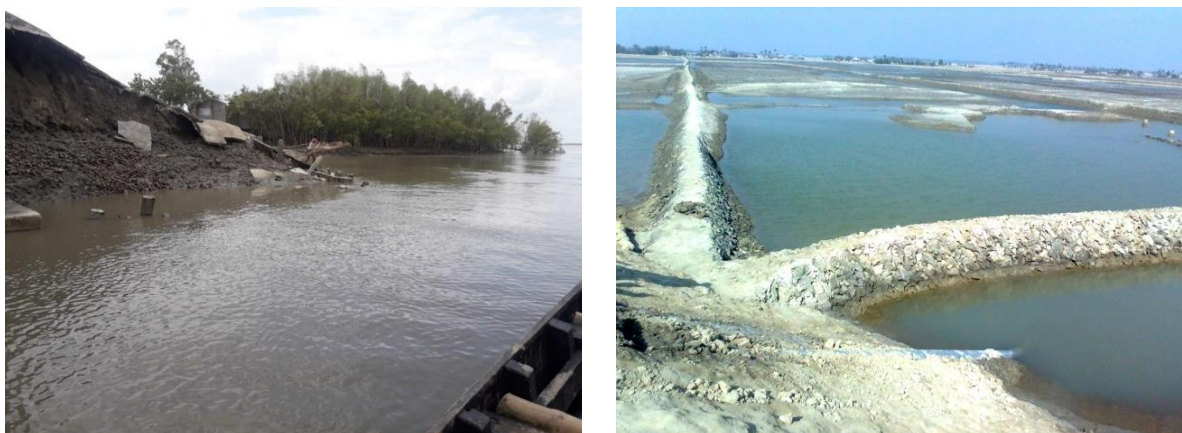
The existing embankment of Polder 15 ( from km 8.60 to 8.80 ) has been protected by Slope Protection works by CC blocks about 50 m length has already been damaged due to wave action. The embankment is prone to river erosion as well as wave action. Bank protection work is essential to protect the embankment, crops and local community. Recent bathymetric survey suggests that the existing Bank of the river is about 70-80 meters away from the toe of the existing embankment. On the other hand, the cross-section indicates that the slope of the bed of the river is not very stiff and the location of the same is far away from the existing embankment. Mangrove afforestation is required.

Figure 4: River bank erosion and Fish ghers in the Polder 14/1 and Polder 15

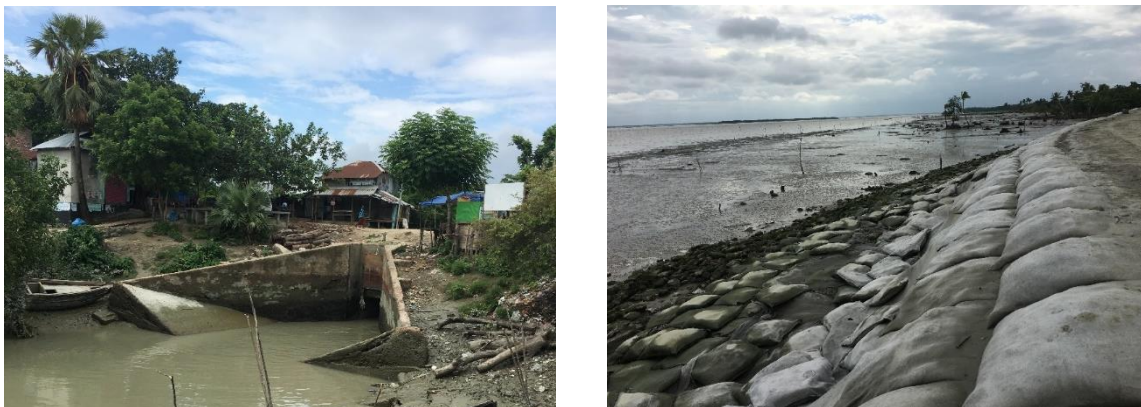
The polder was severely damaged during the Cyclone SIDR in 2007. The team visited the most vulnerable part of this polder at Padma Hat and Rohita area along the left bank of Baleswar river. Local people informed the team about the damage in the polder during Cyclone SIDR and recent condition around these areas. The retired embankment was built at Rohita area after the cyclone which was totally damaged during SIDR and this embankment is now again vulnerable to erosion. So, the BWDB official informed that the structure has repaired recently, and the team also observed the recent repair work (Figure 5). In Padma Hat area, a long stretch of the existing embankment is vulnerable to erosion and emergency protective works by geo-bag was made by BWDB (Figure 6). Planned protective measures considering, river flow, cyclonic storm surge, climate change and mangrove afforestation is required

Figure 6: Repaired damaged regulator and erosion protective work in Polder 40/1

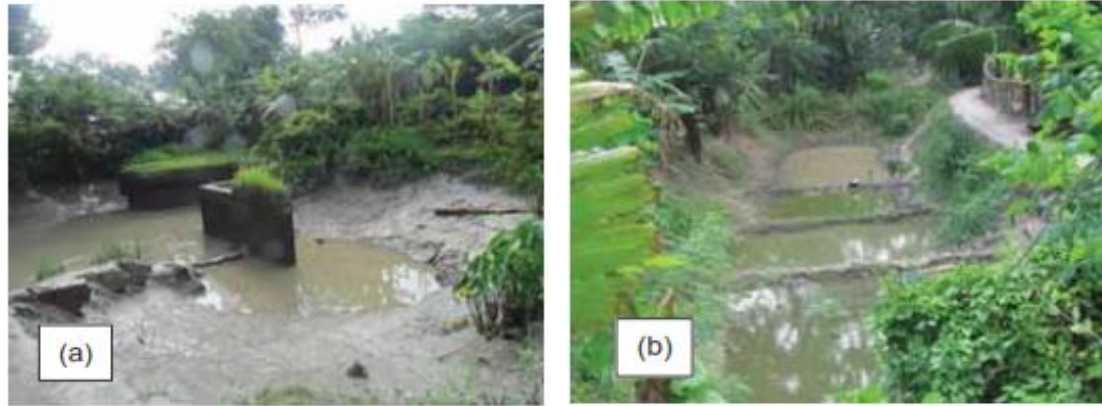
Few years back, IWM carried out a research project in this polder and collected topography data, khal and structure information. IWM found that this polder is experiencing some severe problems. Therefore, there is an opportunity to introduce some engineering innovations in this polder for the better water management. There are huge potentials to increase the cropping intensity and economic activities of local communities since river water salinity remain below 1ppt all over the year and road communication is very good. The existing problems inside the polder are presented in the Figure 8.

Figure 8: Present condition of existing regulators (a) Keukhali sluice and Cross dam in Sutanalir Khal (b)

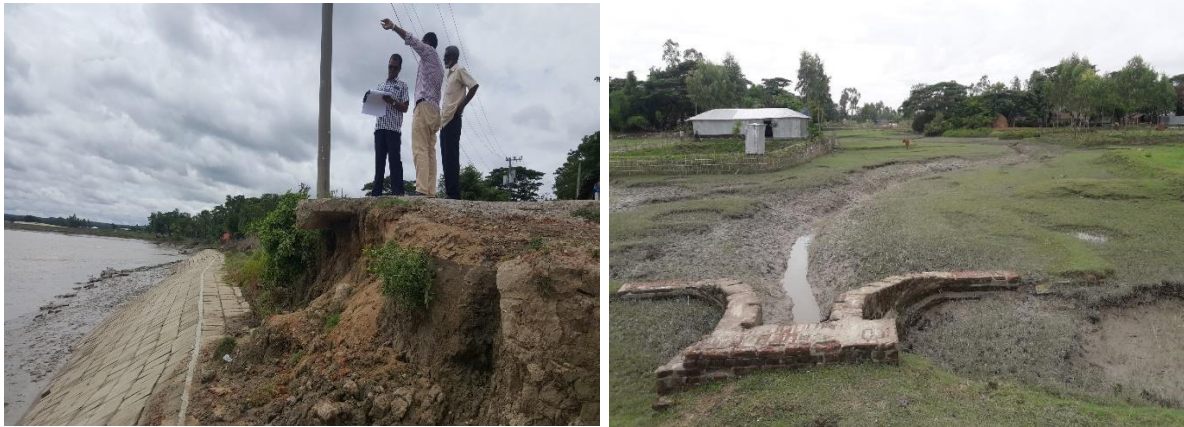
- At first, visit was made at Jalkadar Khal and the breach of embankment and eroded area by the Sangu River (Photograph-10, Photograph-11 & Photograph-12). The team visited bank protection at Eshorbabur Hat (390m). The erosion threat area is already protected by the construction of revetment from Sangu Bridge to outfall of the River. The total length of the revetment work (Photograph-12) is 3300 m. The overall condition of the revetment is good. The bank protection work has been constructed in two phases of 2100 m (near Polder 64/1b) and 1200m (near 64/1a).

- The team discussed with local community. Water logging problems was not observed during the visit. However, it was reported that the polder facing water logging problems for 2–3 days during Flash Flood According to local people. Jalkadar khal needs to re-excavate from Sangu confluence to outfall. The team observed that Jalkadar Khal is wider and deeper in the South (Photograph-21). Only the upper part of the Khal is narrow and silted up which needs to re-excavate (Photograph-16). The polder is exposed to Bay of Bengal and vulnerable to cyclonic storm surge There is need of excavation internal khal system.

Figure 9: Eroded river bank with bank protection work and sedimented khal with broken structure in the Polder 64/1b

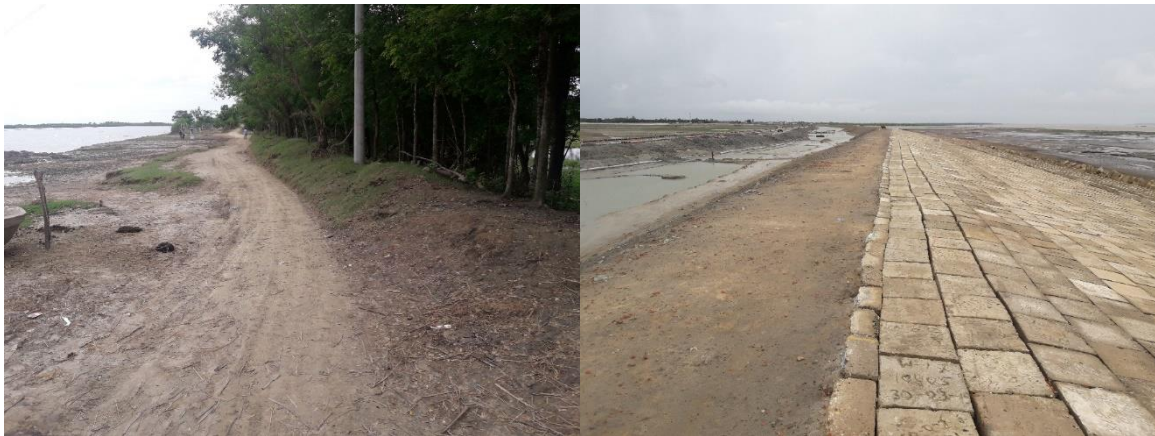
- The embankment at the sea side of the polder is kancha and damaged in the salt farming areas. The team observed the damaged embankment at sea side near Haliapara in Polder 64/1a. The embankment is damaged due to movement of Salt carrying tractors (Photograph-18). The part of the embankment of Polder 64/1a needs to be repaired and maintenance.

Figure 10: Broken embankment and sea-dyke protection work in the Polder 64/1a

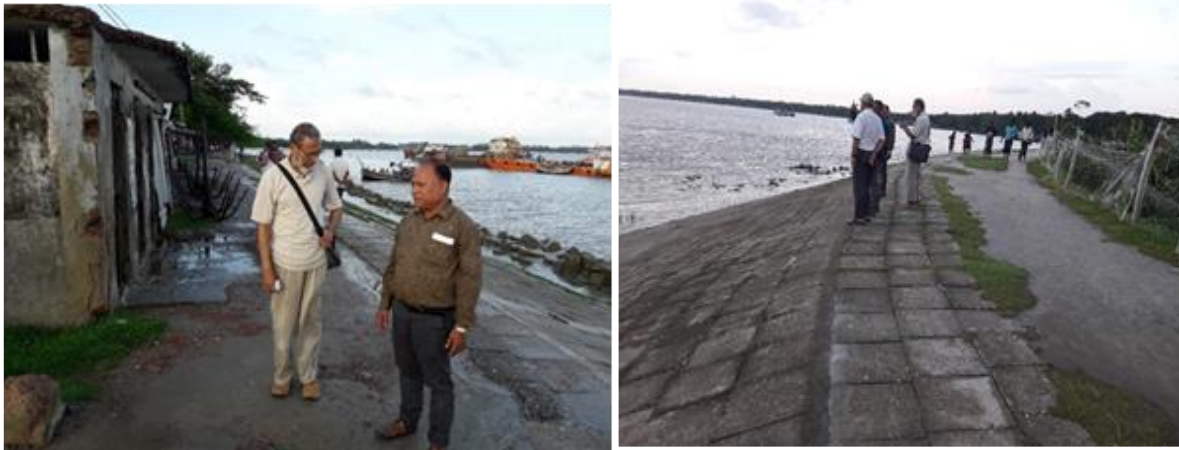
A protection work has been carried during (2016 –17) and (2017 – 18) in the severe eroded areas. Part of the protection works of 600m at the tail end of Ramgati and 3000m at Kamal Nagar has been implemented and the performance is satisfactory except areas at terminal points. A detail reconnaissance survey will provide the status of present revetment and the need of bank protection at all areas of Ramgati. Figure 12 shows the historical bank erosion and Figure 13 shows the existing bank protection work at Lower Meghna.

Figure 13: Bank protection at Kamalgonj area and upstream termination

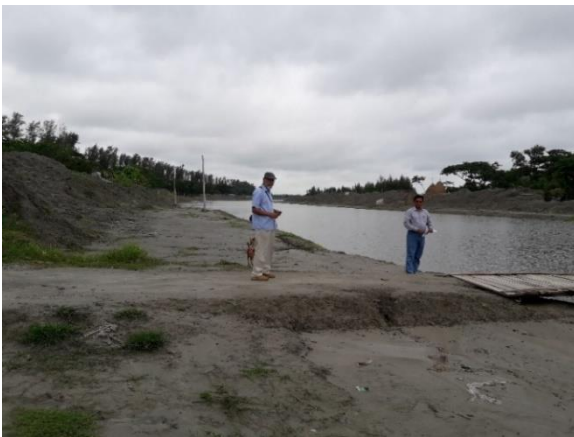
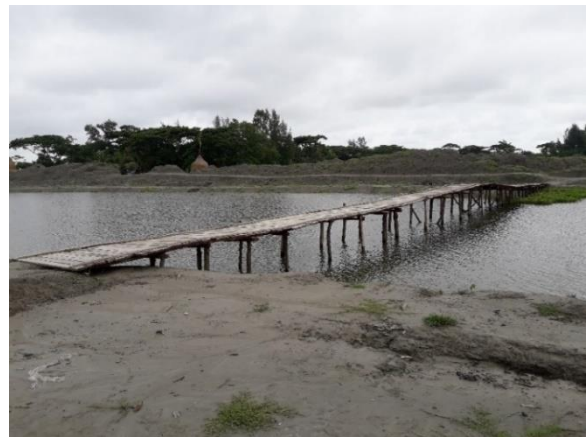
It has been silted up often from sediment laden water from downstream. Thus, any re-excavation was not successful. This year re-excavation has started with close monitoring keeping then downstream closed.

- Excavation completed up to 12 Km length (3 m depth & 40 m bed width). Benefit from such excavation is not available as the downstream end is kept closed to arrest entry of any sediment.
- Remaining reach of Noakhali khal is planned for re-excavation next year when entire area will benefit from drainage through Algir Khal.

Excavated area of Noakhali Khal and nearby embankment

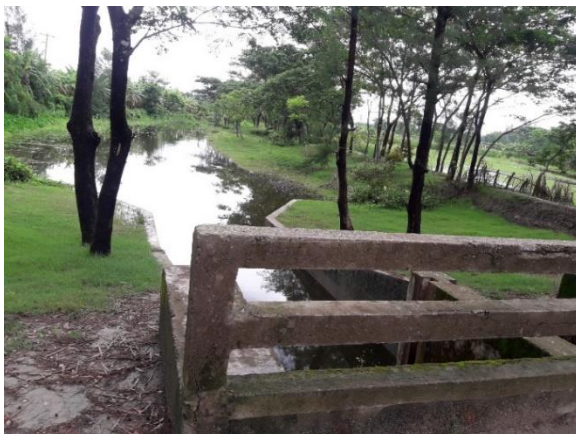
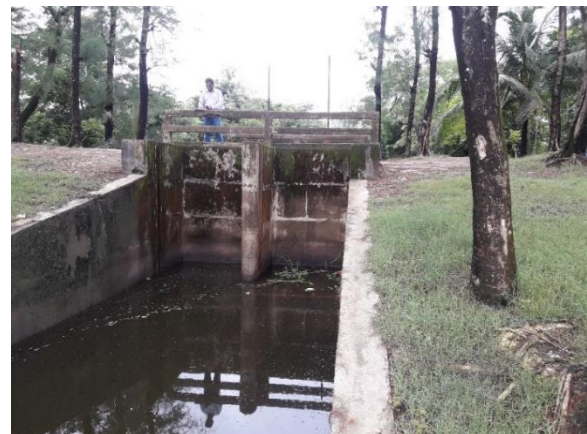
Nabagram Regulator ( up and downstream )

No drainage has been observed through the regulator during the visit. The downstream canal linked to Noakhali khal is water logged and will have to wait so long full length of re-excavation is over for drainage. Water logging is expected during the rainy season in absence of drainage from the area.

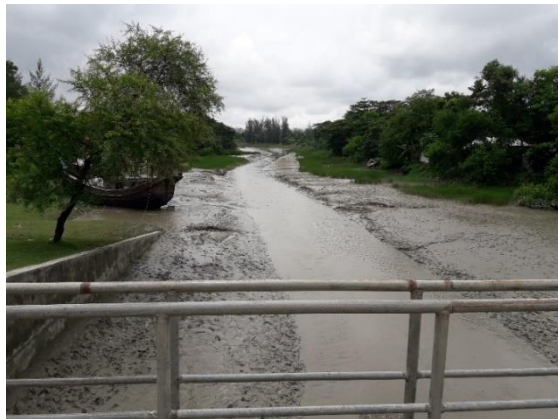
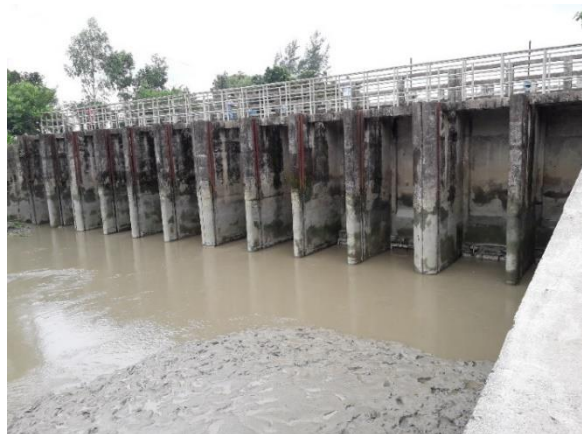
Gangchil regulator is functioning properly. However, approach channel got significantly silted up inside the polder due to allowing of sediment laden water during high tide. Improvement of channel and appropriate operation of regulator can help improved and sustainable drainage. Any positive response from nearby people on the flushing of water was not available.

Drainage Regulator at Gangchil ( up and downstream )

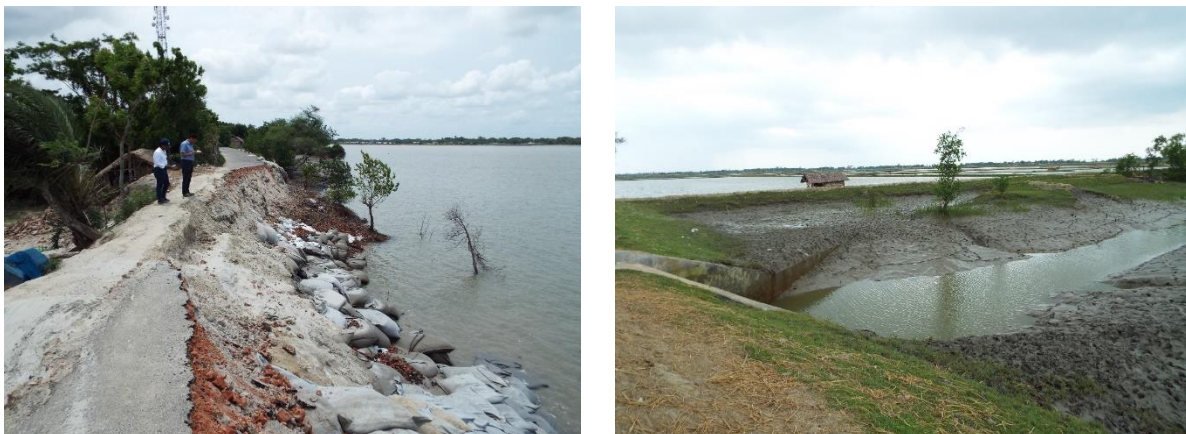
The major problem at present in the Polder as observed was erosion at the Bhadra River along right bank at Chandghar and Baroaria. According to Rashedul Islam of BWDB, 3 km (ch. 25.3 km to ch. 28.3 km) along right bank of Bhadra river at Baroaria is under threat of erosion and a portion of it has suddenly been eroded on the night of April 19, 2019. The reason behind it as reported is the development of a bar at the middle of Bhadra river which made the flow area constricted on the side channels. As a result, the near bank velocity along the right bank of Bhadra river at Baroaria is increased and caused bank erosion. However, BWDB has taken it up on an emergency basis through protective work by Geobag placement. Precautionary protective work by Geobag is also been done under Blue Gold program at Chandghor and other places, but they are not enough. A permanent solution to the problems is the demand of the local inhabitants.

Figure 16: River bank erosion and siltation problem in the Polder 29

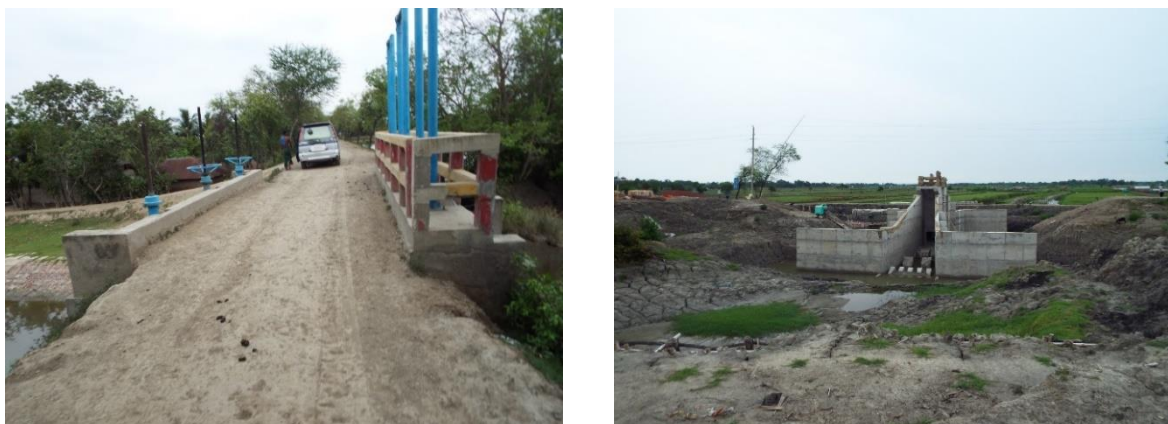
Figure 18: Polder improvement activities in Polder 26

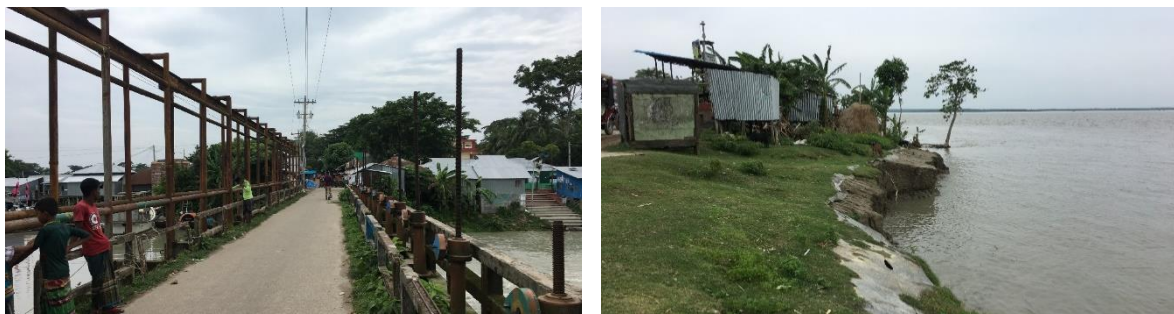
The team visited the most vulnerable part of this polder at Panpatty Bazar and Panpatty launch Ghat area along the bank of the confluence of Lohalia and Tetulia river. Local people informed that this area was mostly affected during the Cyclone SIDR, 2007 and still it is vulnerable to erosion. Some emergency protection work by sand geo-bag was observed and some new erosion area also found in this area ( see the Photographs ). Local people were also informed the team that there is some more erosion vulnerable area along the right bank of Tetulia river. Prior to visit Panpatty Bazar, the team also visited Boalia Sluice and the structure looks good in condition ( Figure 20 ).

Figure 20: Existing sluice gate condition (Boalia) and erosion prone location at Panpatty Bazar in Polder 55/1.
