November, 2023

POLDER 32

FIELD VISIT REPORT

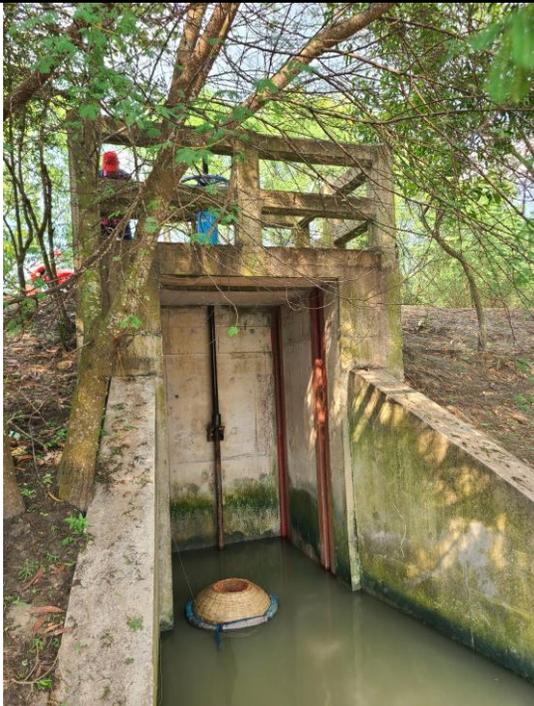
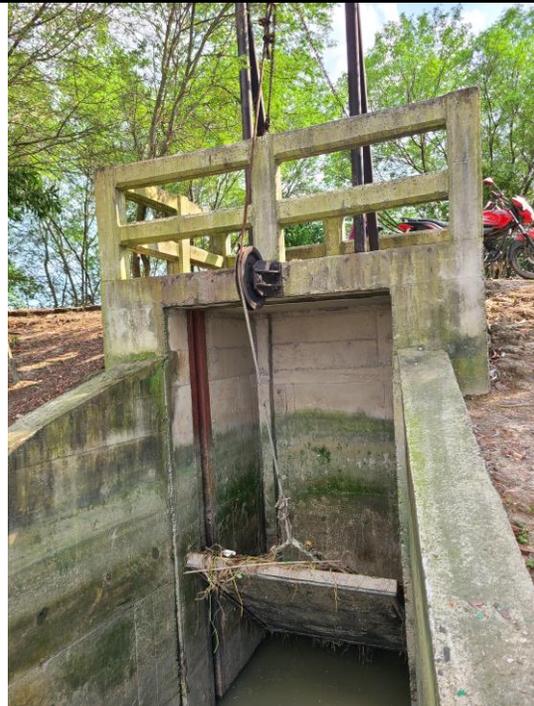
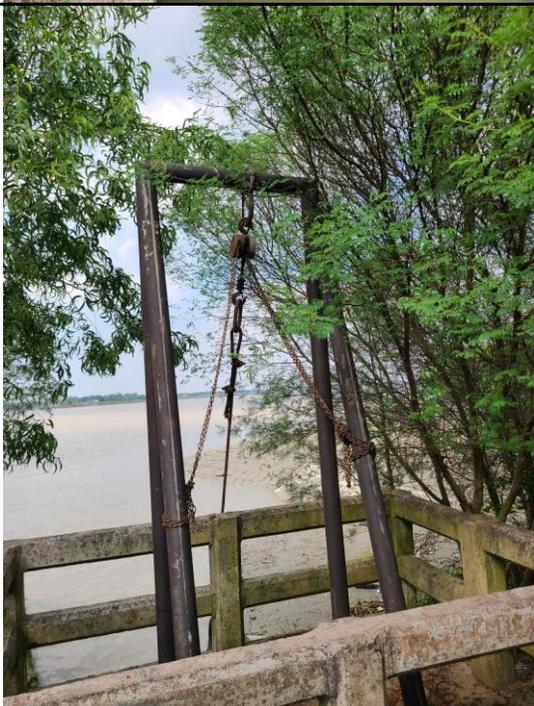
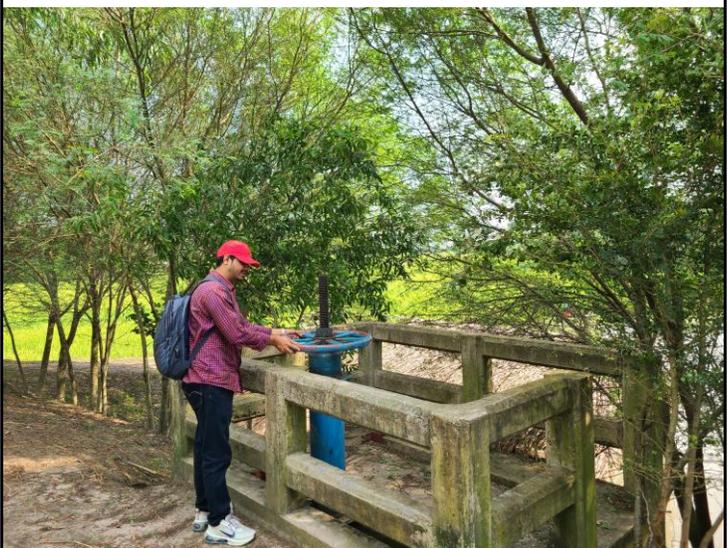
Date	Polder Name	Chainage (Km)	ID of Structure
19.11.2023	Polder 32	18.81	DS-1

Observation: The structure is in good condition. Flap gate is open and Lift gate is closed and both gates are Operable. Chain Pulley block and Hoist is installed. We didn't found any leakage in C/S. There is minor rust on nuts, bolts, flap gate and lift gate.

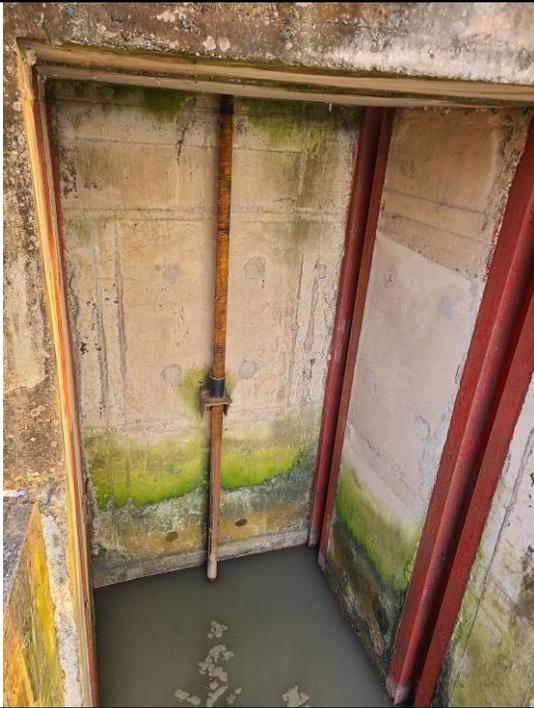
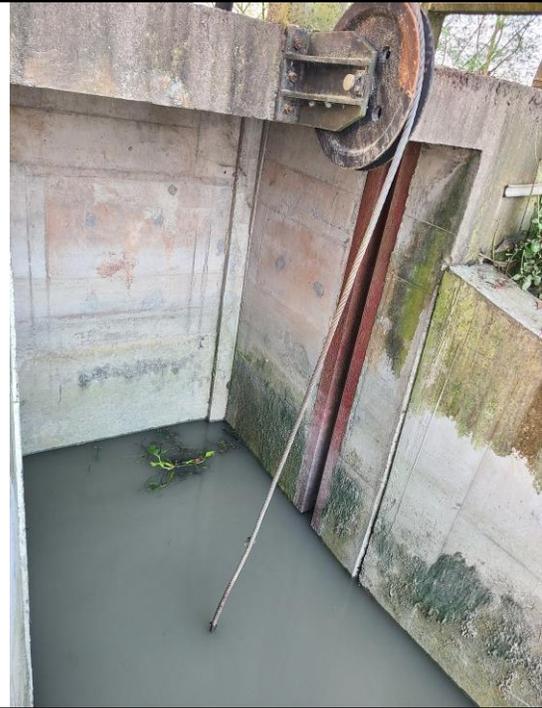
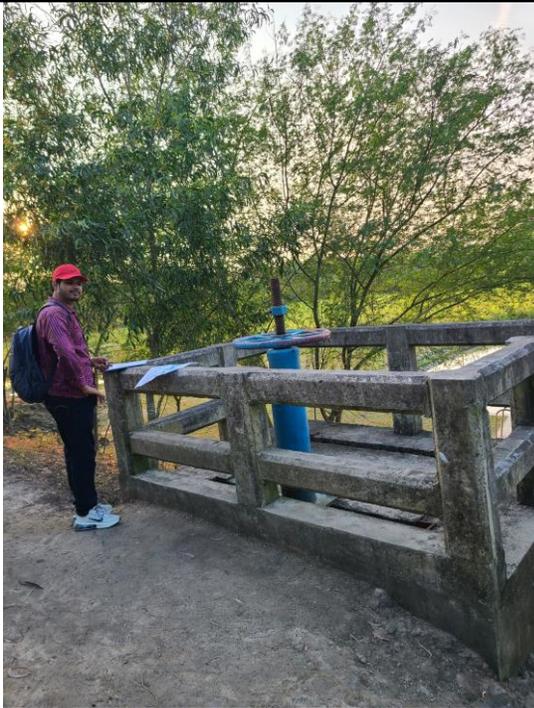
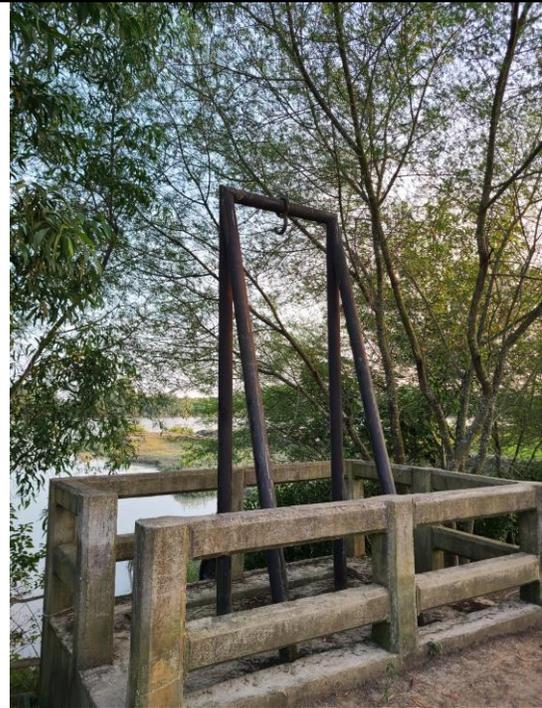
Date	Polder Name	Chainage (Km)	ID of Structure
19.11.2023	Polder 32	24.133	DS-2

Observation: The structure is in good condition. Lift gate and Flap Gate is closed. Pulley and steel rope is available but flap gate is not opreable because chain pulley block is not available. Vertical lift gate is operable. We didn't determine any leakage due to gates are under water. There is medium rust on nuts, blots, flap gate and lift gate.

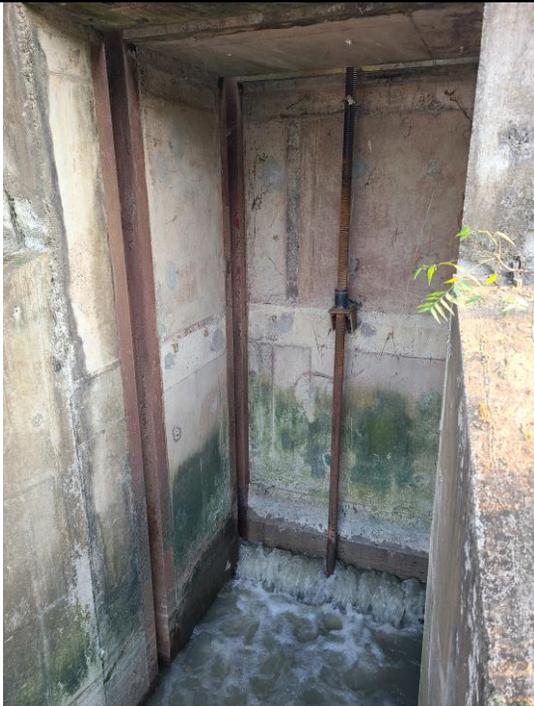
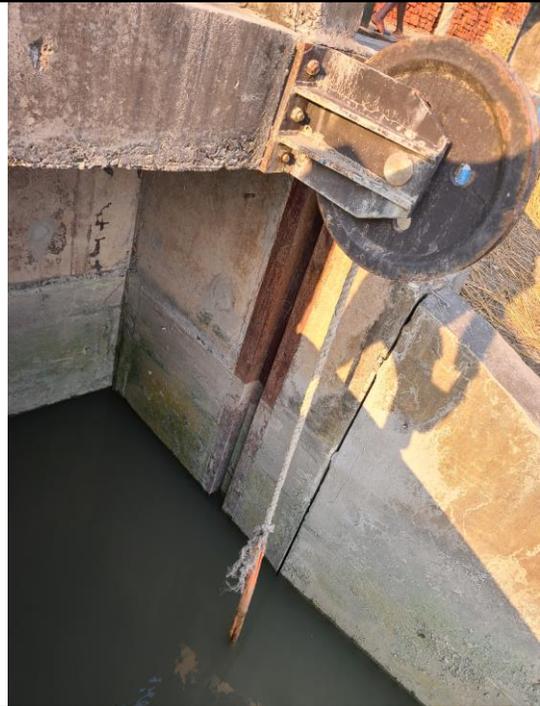
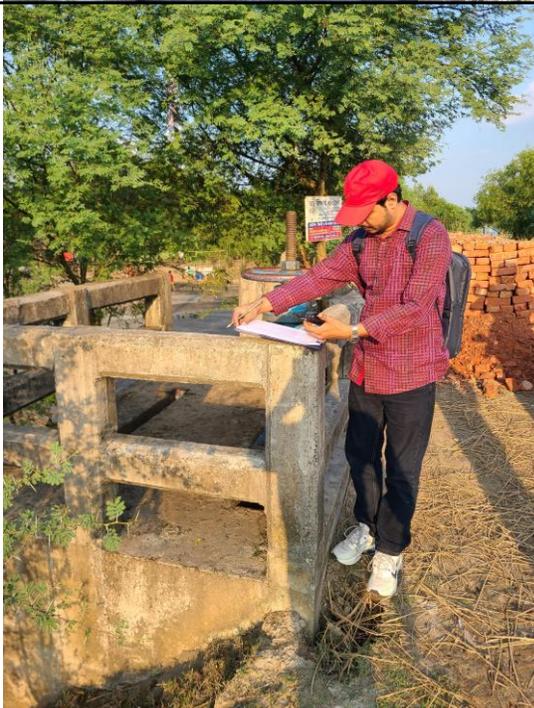
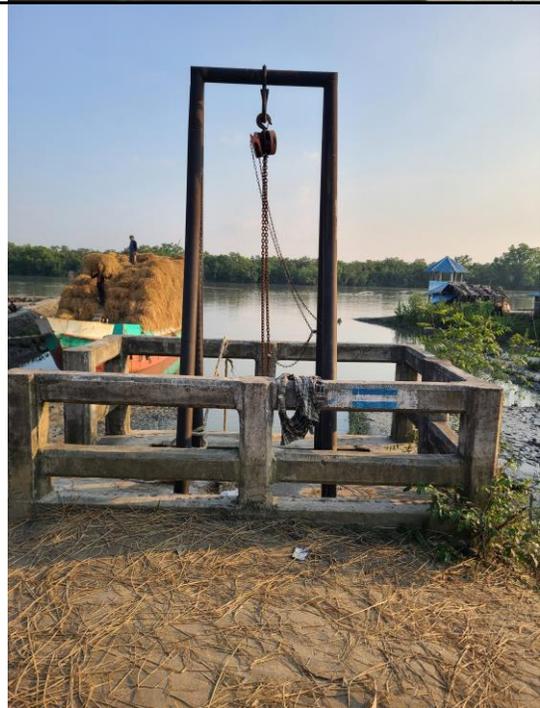
Date	Polder Name	Chainage (Km)	ID of Structure
19.11.2023	Polder 32	35.83	DS-7

Observation: Lift gate is closed and Flap Gate is open. Both Gates are operable. There is Leakage in Country side lift Gate. There is minor rust on nuts, bolts, flap gate and lift gate.

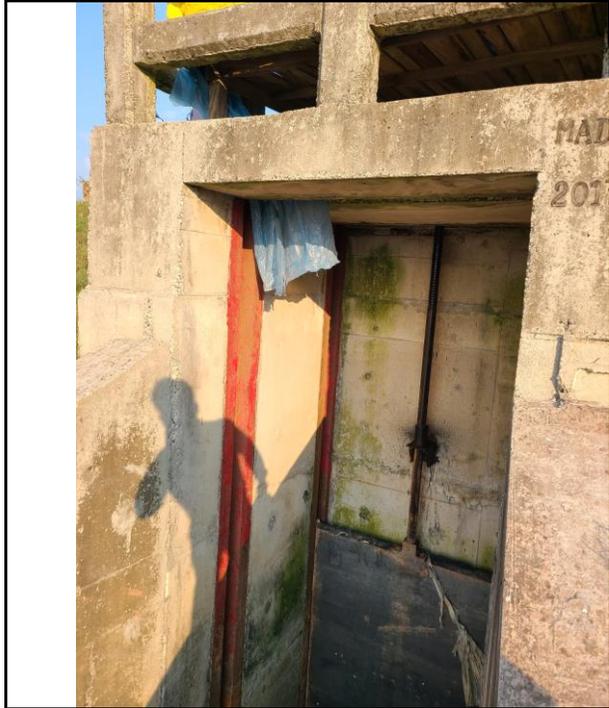
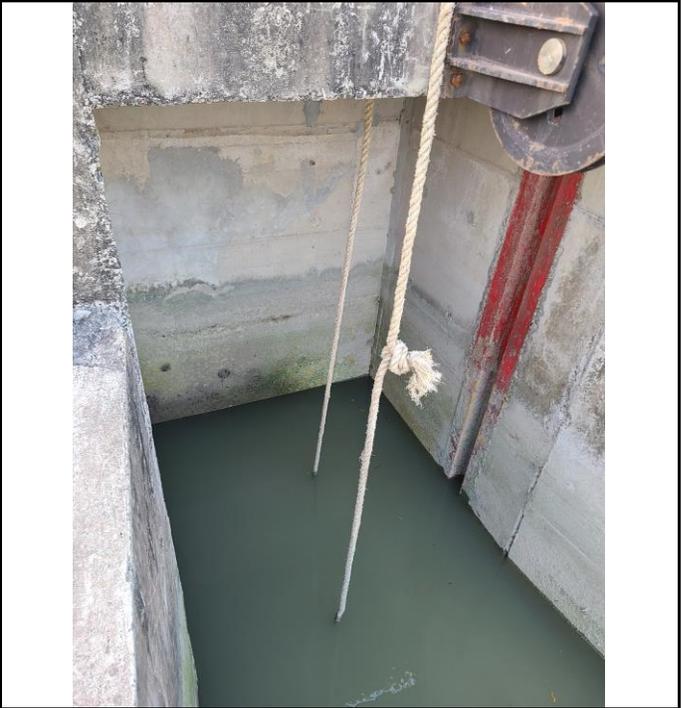
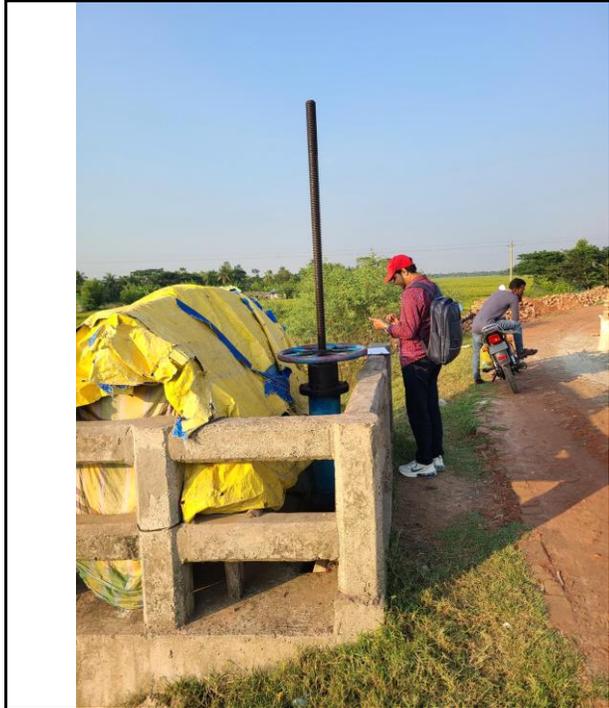
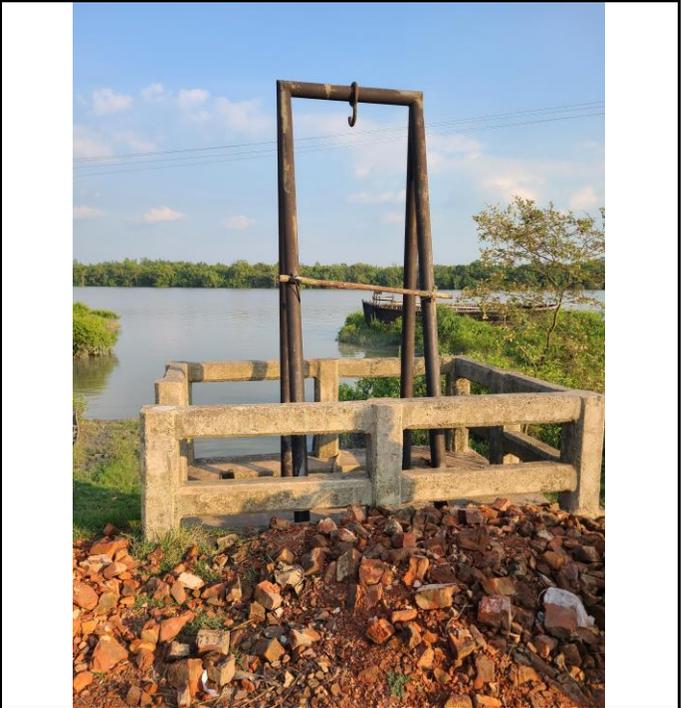
Date	Polder Name	Chainage (Km)	ID of Structure
19.11.2023	Polder 32	40.072	DS-8

Observation: Structure is in good condition. The lift gate is opened and operable. Flap gate is closed and it is not operable because steel rope and chain pulley block is not available. Local people tie a rope with flap gate for opening when needed. There is medium rust on gates and nuts bolt.

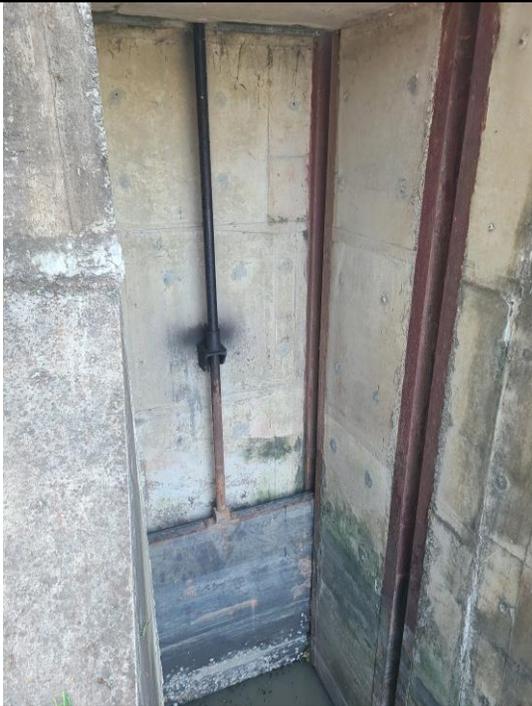
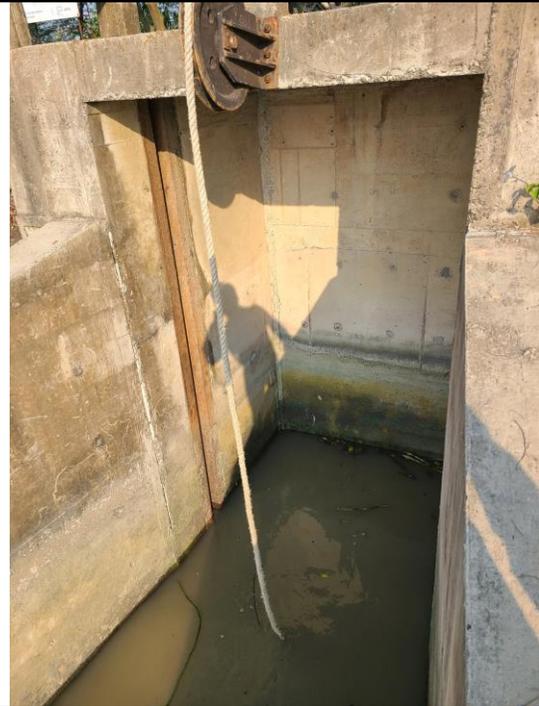
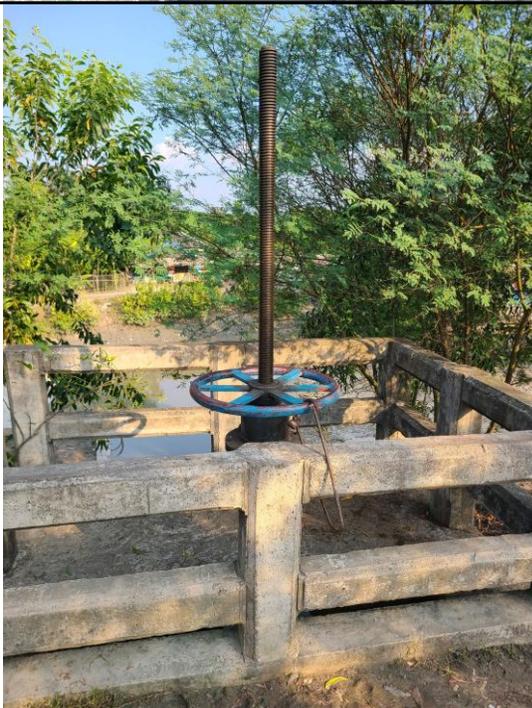
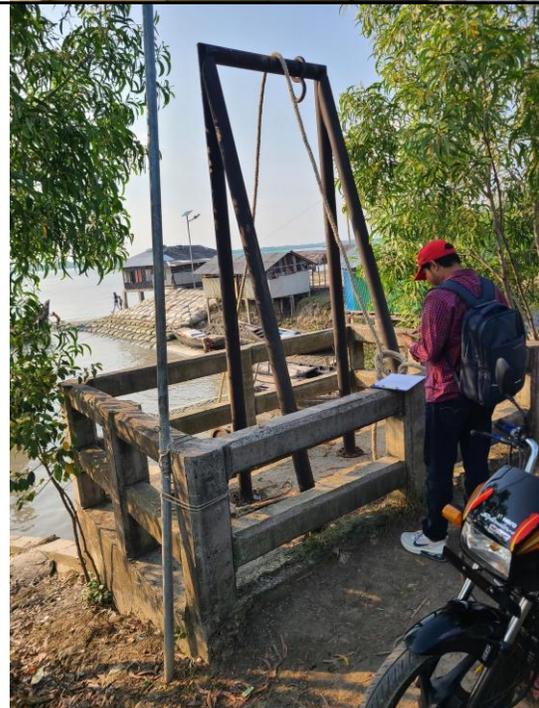
Date	Polder Name	Chainage (Km)	ID of Structure
19.11.2023	Polder 32	45.506	DS-9

Observation: Structure is in good condition. The lift gate is opened and operable. Flap gate is closed and it is not operable because steel rope and chain pulley block is not available. Local people tie a rope with flap gate for opening when needs. There is medium rust on gates and nuts bolt.

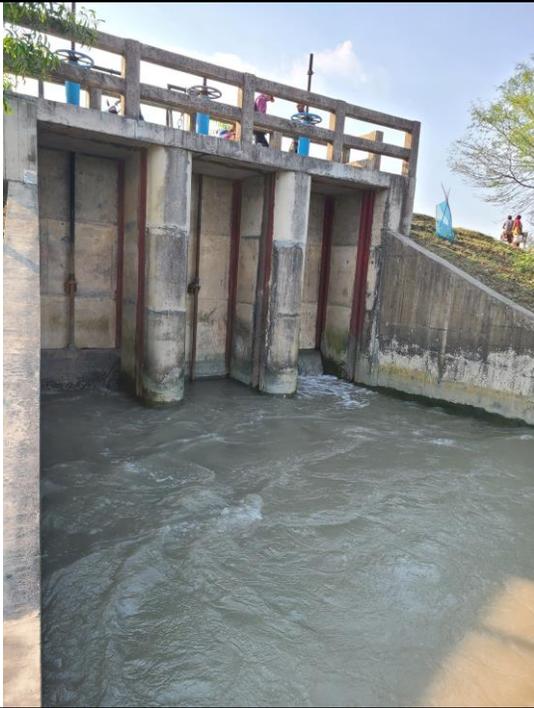
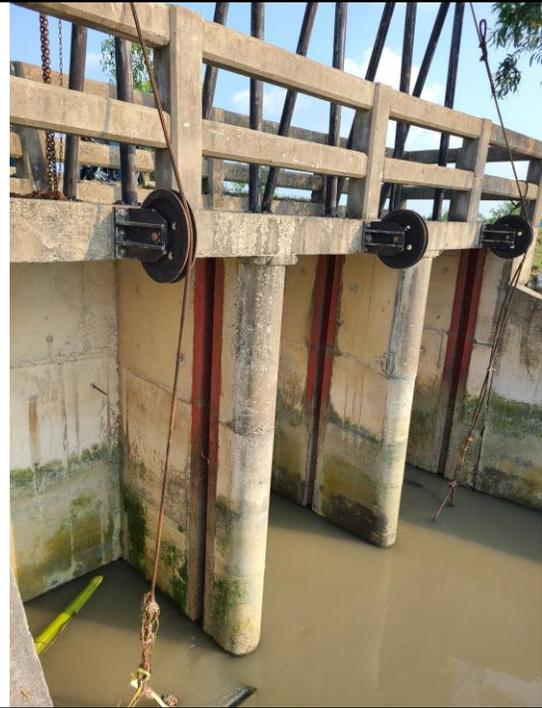
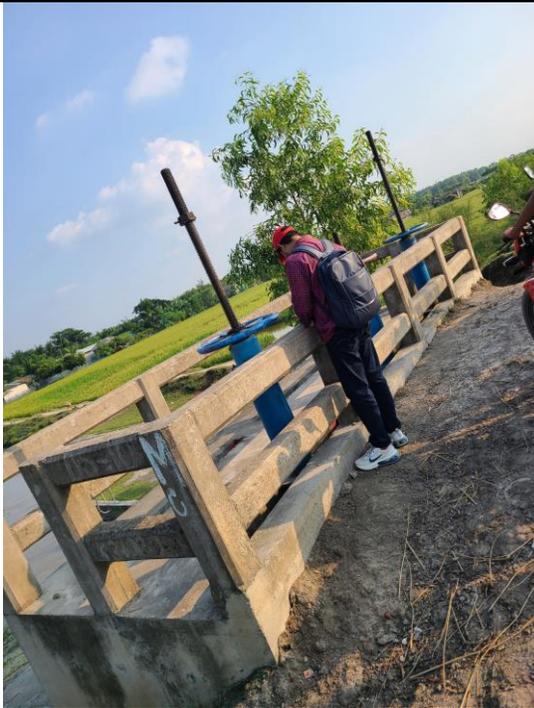
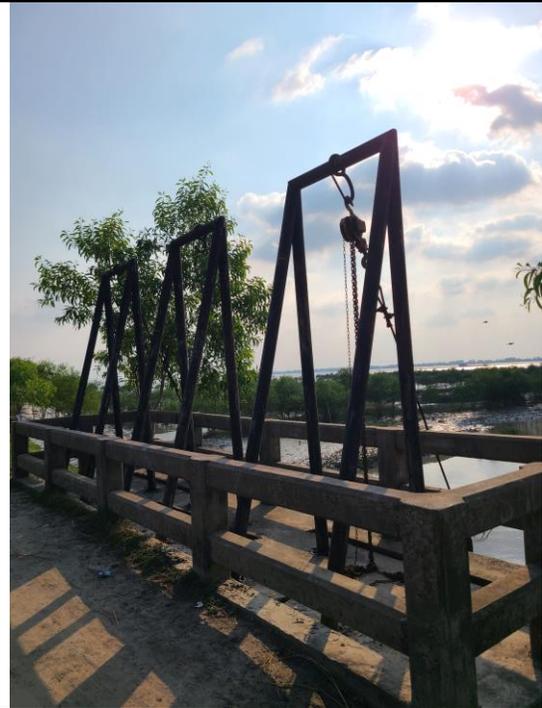
Date	Polder Name	Chainage (Km)	ID of Structure
19.11.2023	Polder 32	2.96	DS-10

Observation: It is a 3 vent structure. Two lift gates are opened and one gate is closed. All Vertical lift gates are operable. For Flap gate two flap gate is opened and operable and another flap gate is closed and not operable because there is no steel rope and chain pulley block. There is only one chain pulley block. People use one chain pulley block for operate two flap gates. There is medium rust on gates.

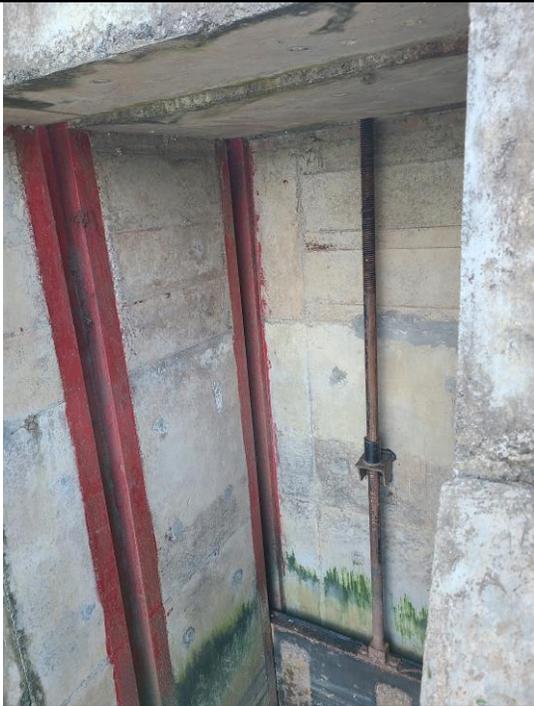
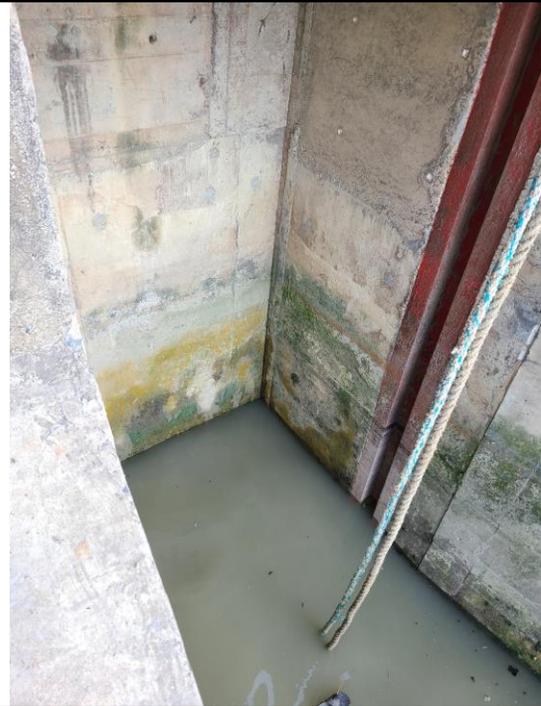
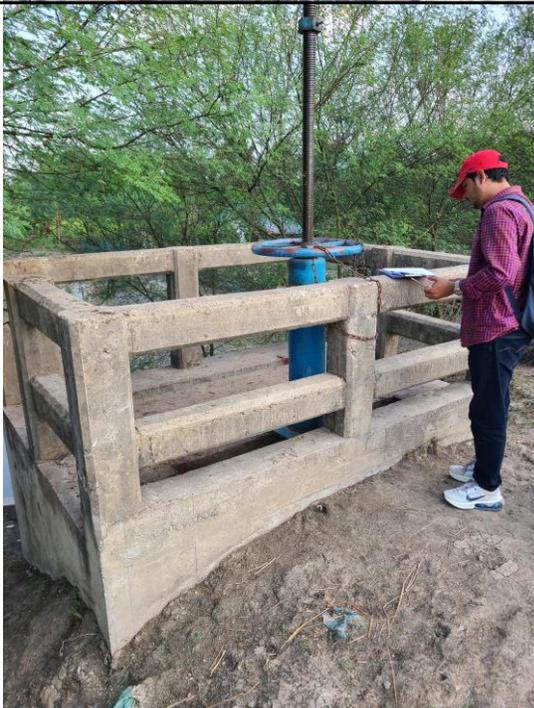
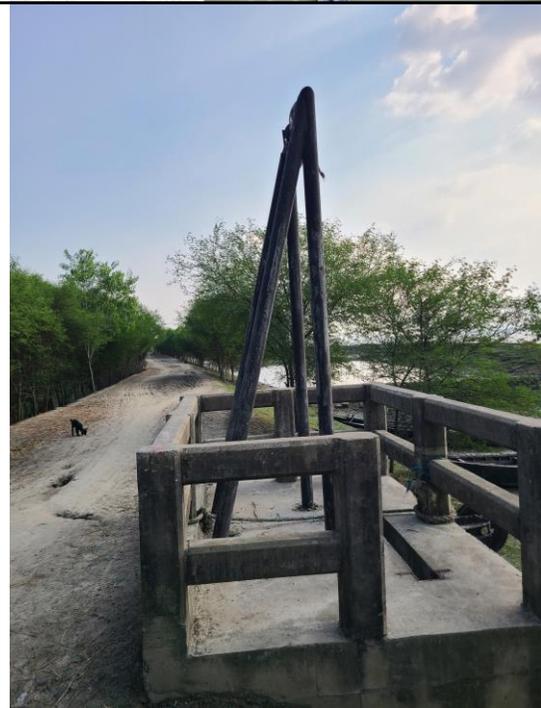
Date	Polder Name	Chainage (Km)	ID of Structure
19.11.2023	Polder 32	4.948	DS-11

Observation: The lift gate is opened and operable and minor rust on gates and nuts and bolts. Flap gate is under water and it is not operable. Because chain pulley block is not available. People tie a rope with flap gate. Steel hook is missing from the operating support. There is also medium rust on flap gate, nuts, and bolts.

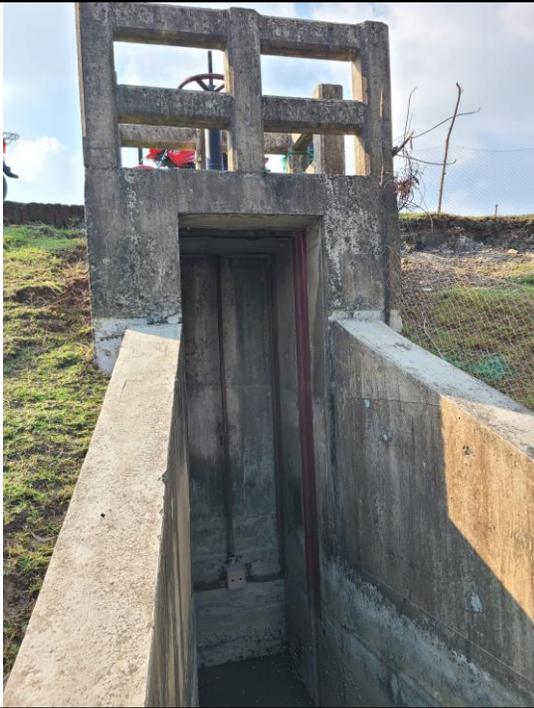
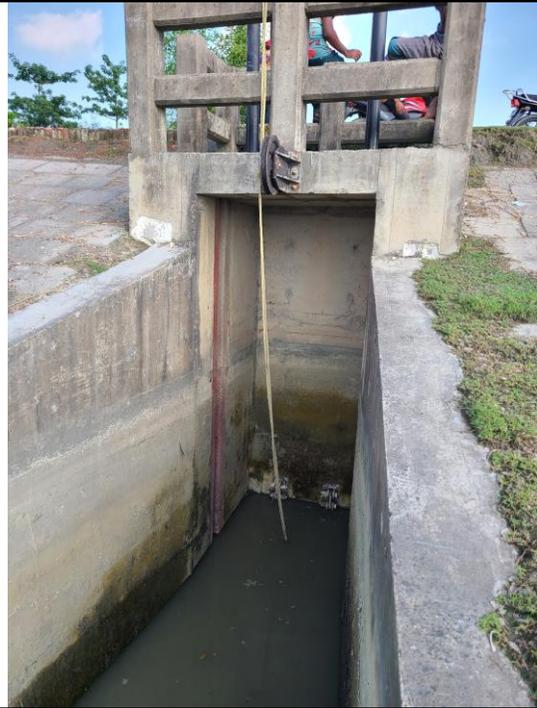
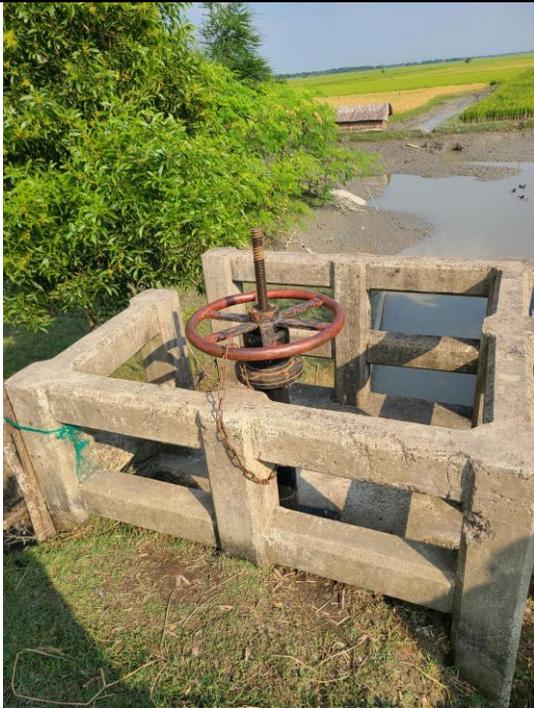
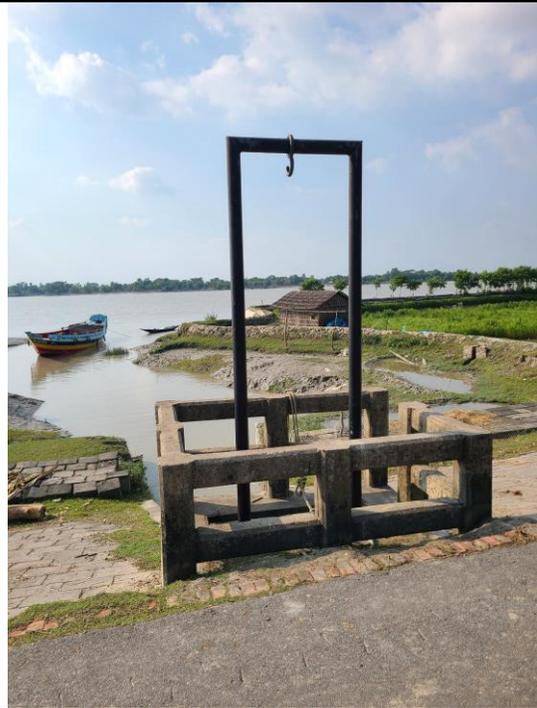
Date	Polder Name	Chainage (Km)	ID of Structure
19.11.2023	Polder 32	10.875	D-10

Observation: The lift gate is opened and operable and minor rust on gates and nuts and bolts. Flap gate is under water and it is not operable. Because chain pulley block is not available. People tie a rope with flap gate. There is also medium rust on flap gate, nuts, and bolts.

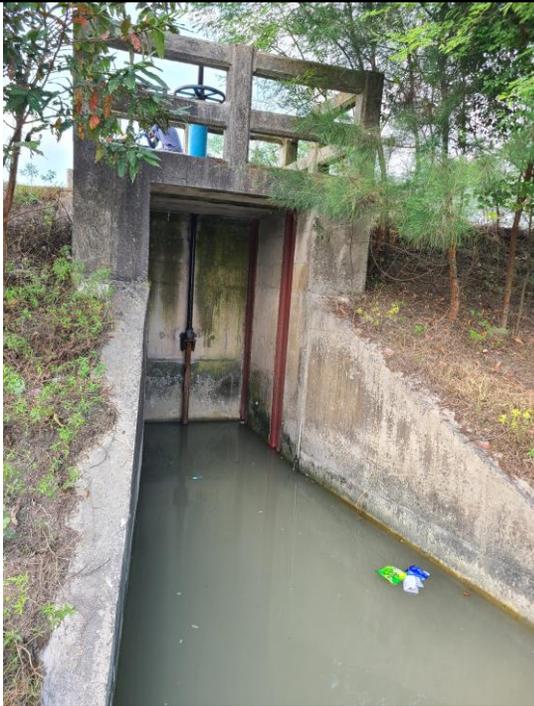
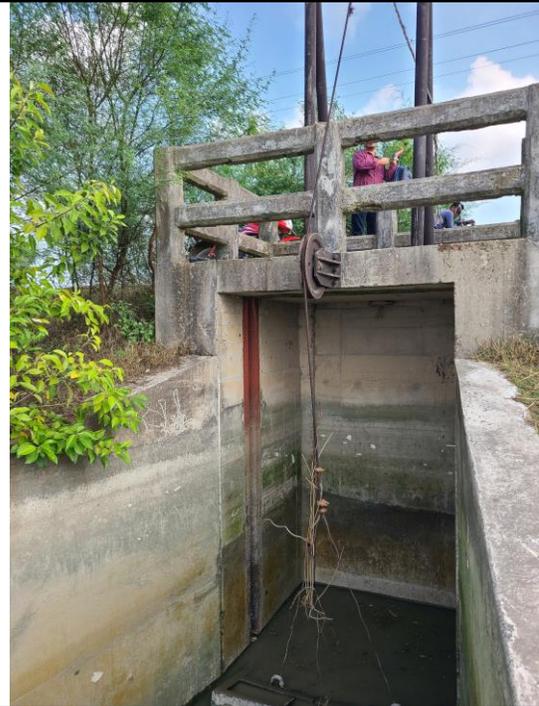
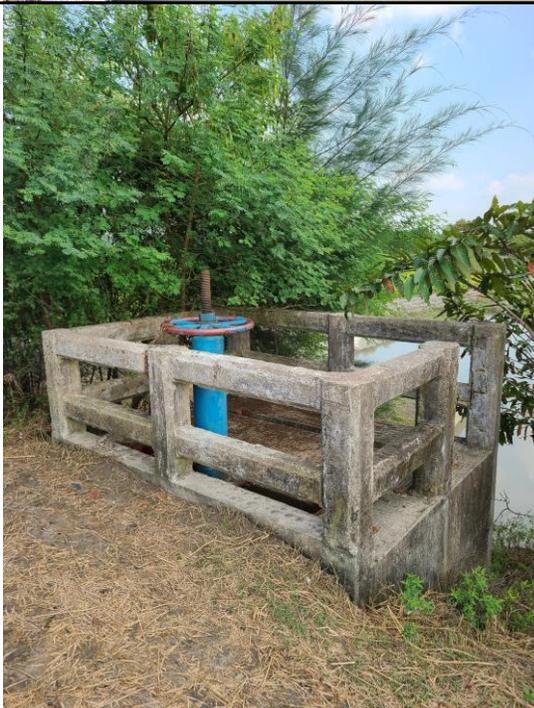
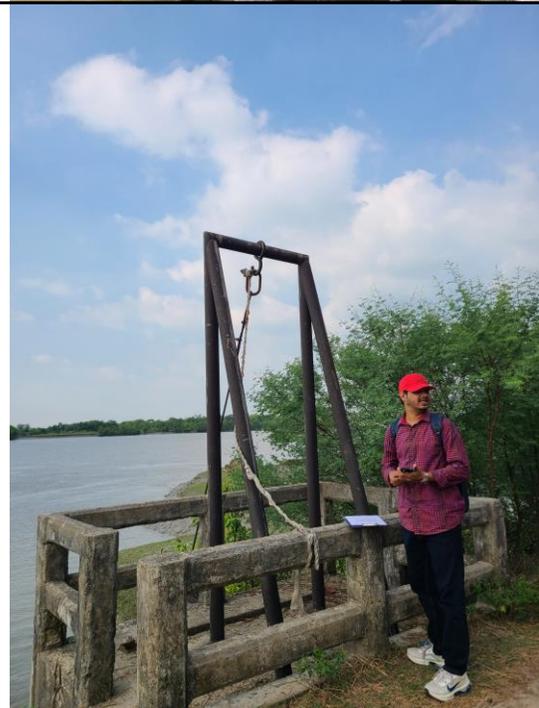
Date	Polder Name	Chainage (Km)	ID of Structure
19.11.2023	Polder 32	14.305	DS-16

Observation: Structure is in good condition. The lift gate is closed and operable. Flap gate is opened and it is not operable because chain pulley block is not available. Local people tie a steel rope with flap gate for keeping it open. There is medium rust on gates and nuts bolt and steel rope.
