November, 2023

# POLDER 33

FIELD VISIT REPORT

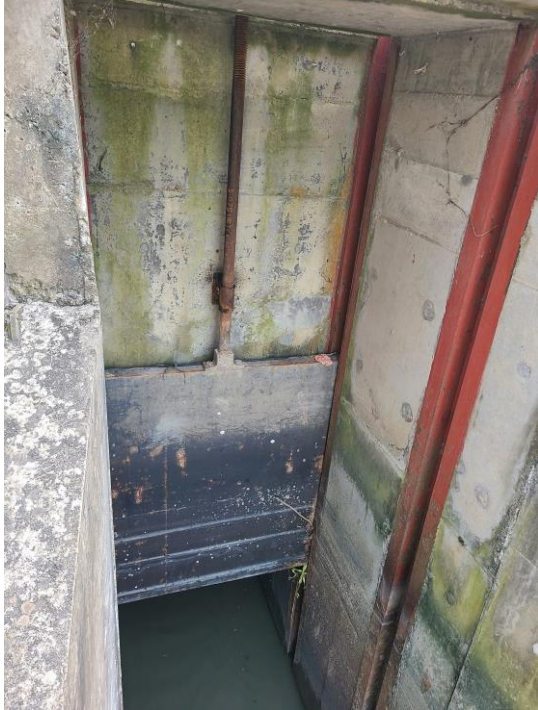
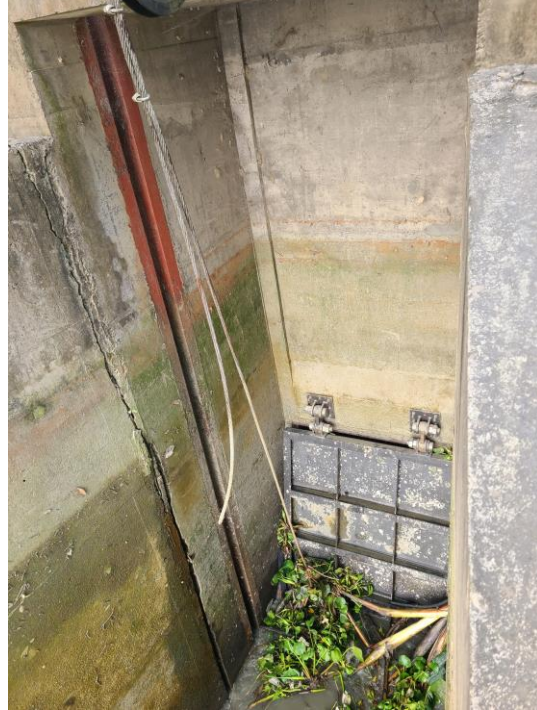
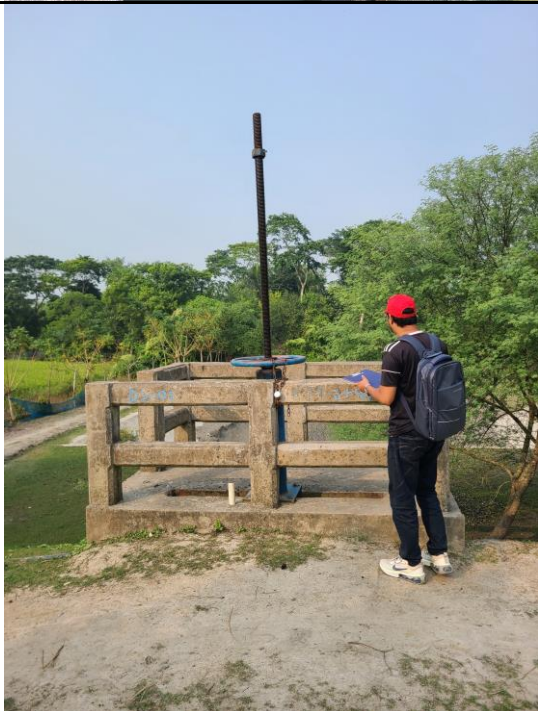
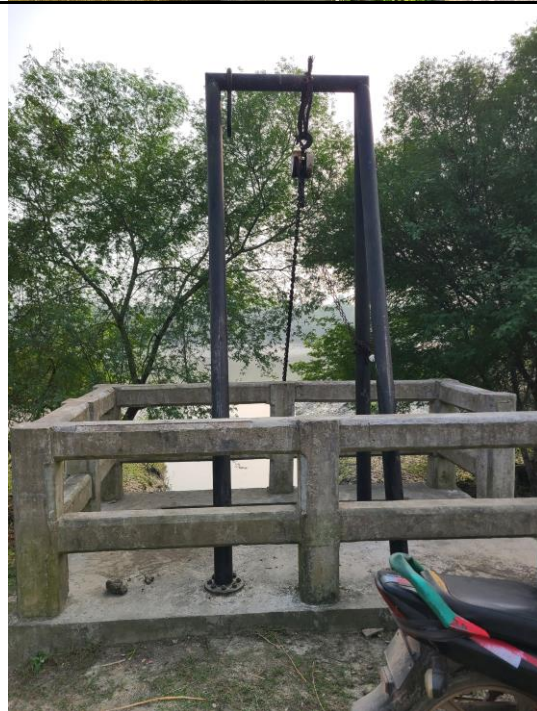
Date	Polder Name	Chainage (Km)	ID of Structure
22.11.2023	Polder 33	3.4	DS-1

**Observation:** Flap gate is closed and Lift gate is open and both gates are Operable. Chain Pulley block and Hoist is installed. We didn't found any leakage in C/S. There is minor rust on nuts, bolts, flap gate and lift gate.

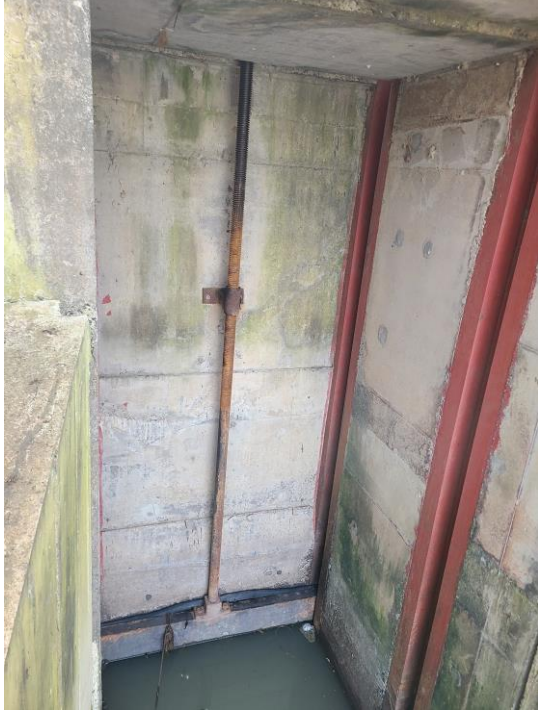
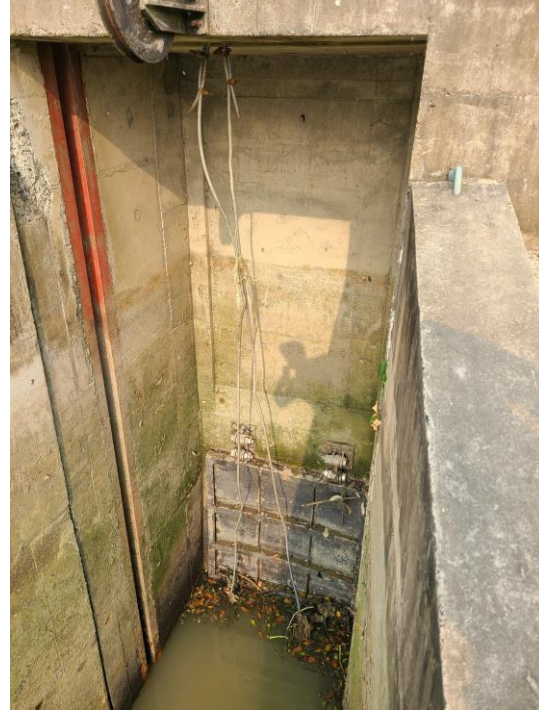
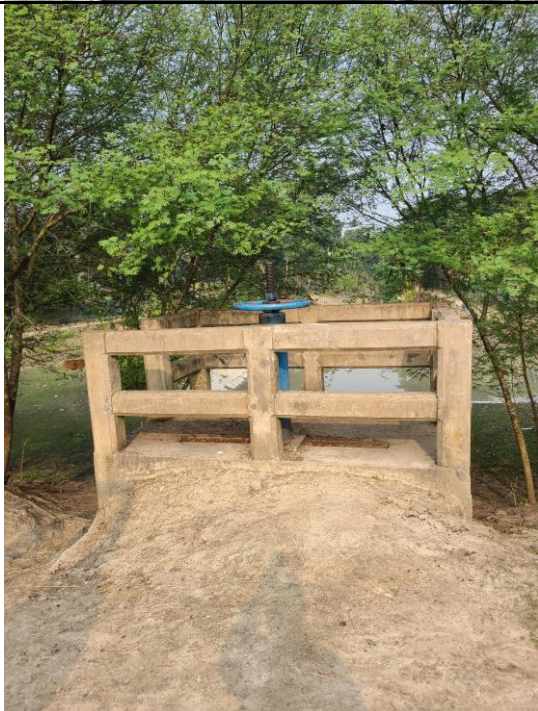
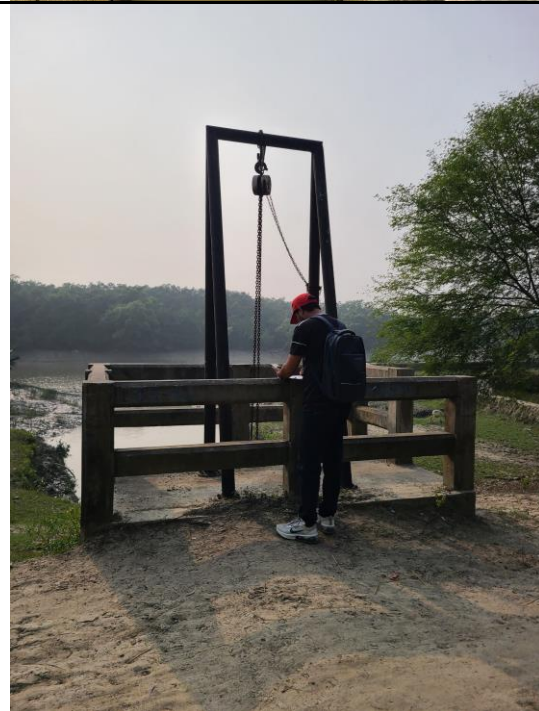
Date	Polder Name	Chainage (Km)	ID of Structure
22.11.2023	Polder 33	5.81	DS-2

**Observation:** Flap gate and vertical lift gate are closed and both gates are Operable. Chain Pulley block and Hoist is installed. We find minor leakage in lift gate. There is minor rust on nuts, bolts, flap gate and lift gate.

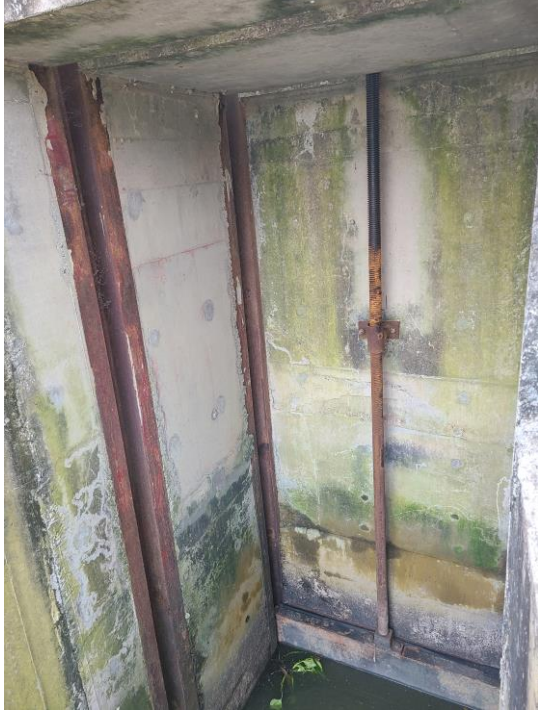
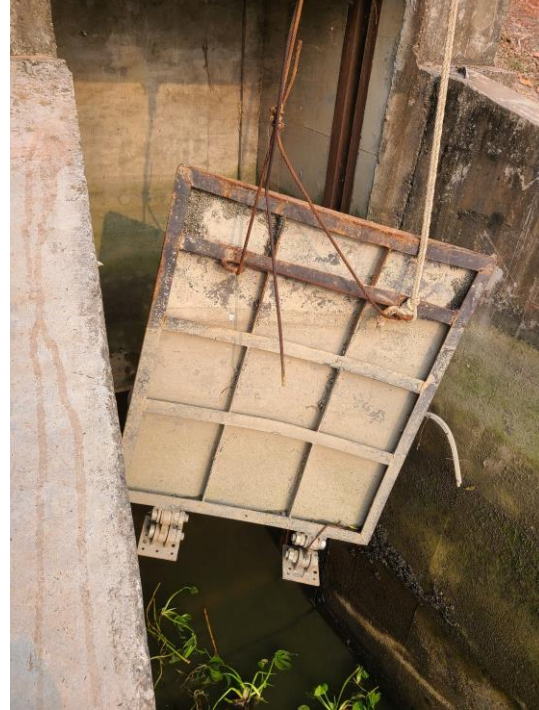
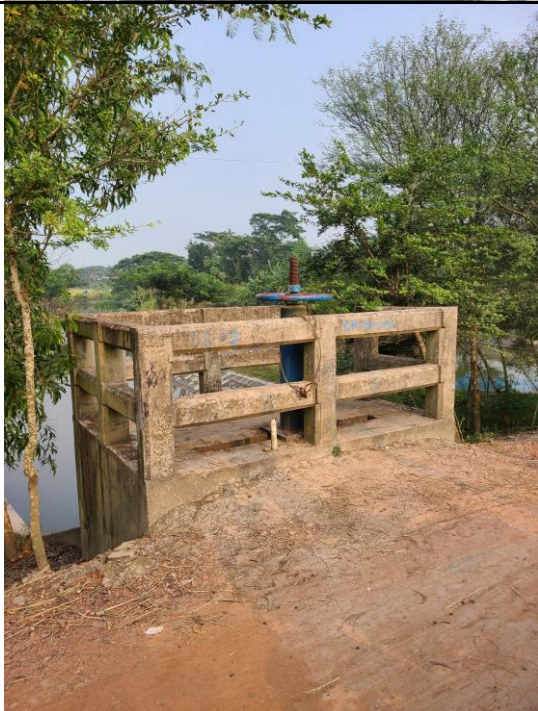
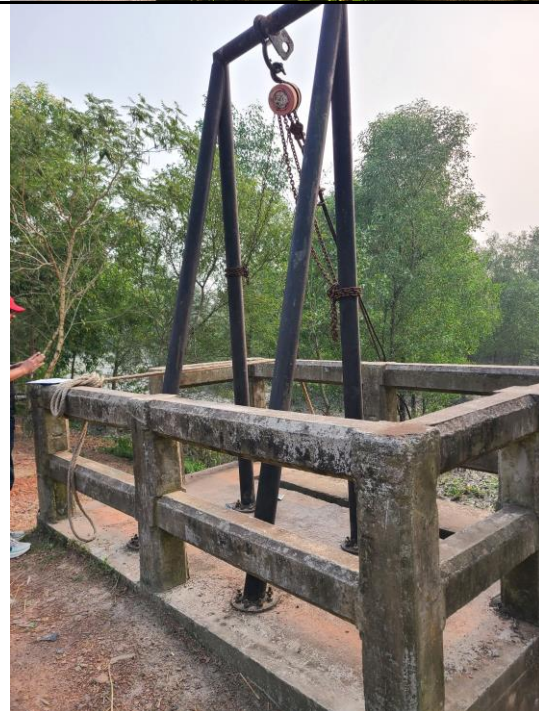
Date	Polder Name	Chainage (Km)	ID of Structure
22.11.2023	Polder 33	11.04	DS-3

**Observation:** Lift gate is okay and operable but flap gate is displaced and it is hanging with steel rope. There is medium rust on both gate.

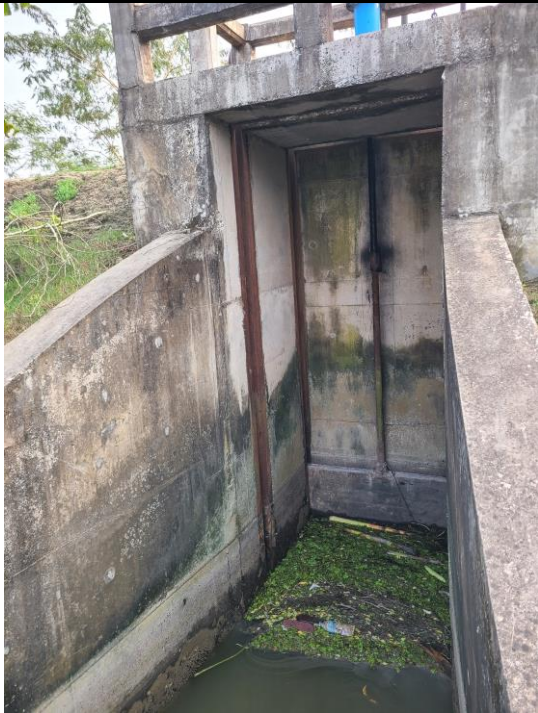
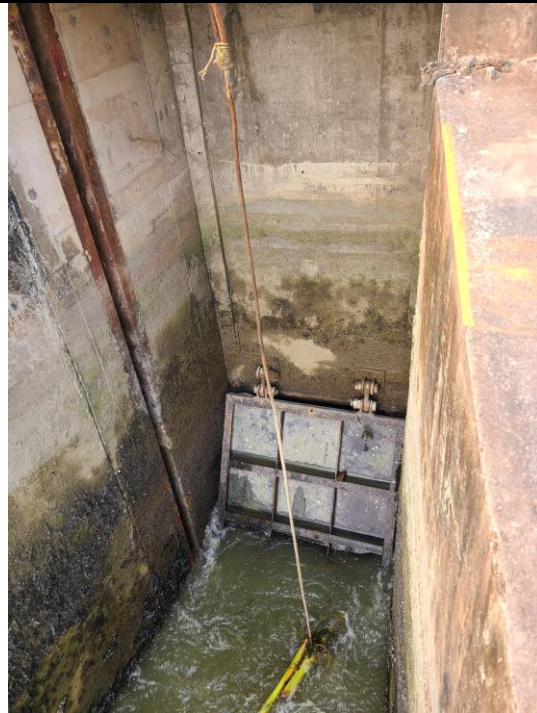
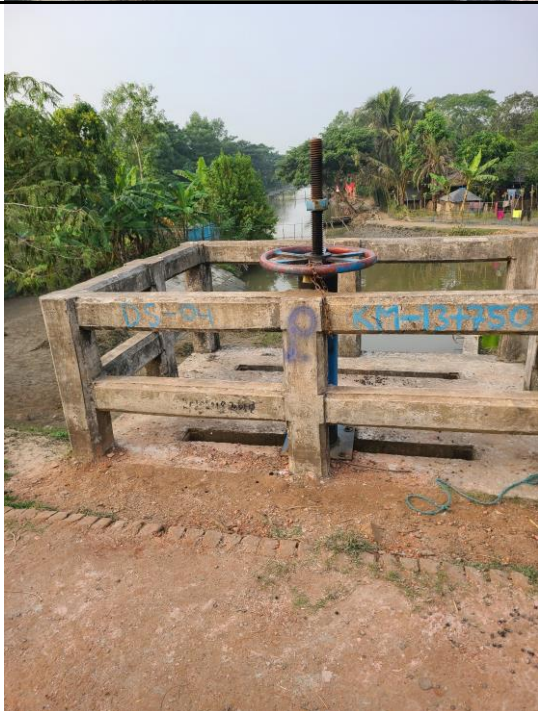
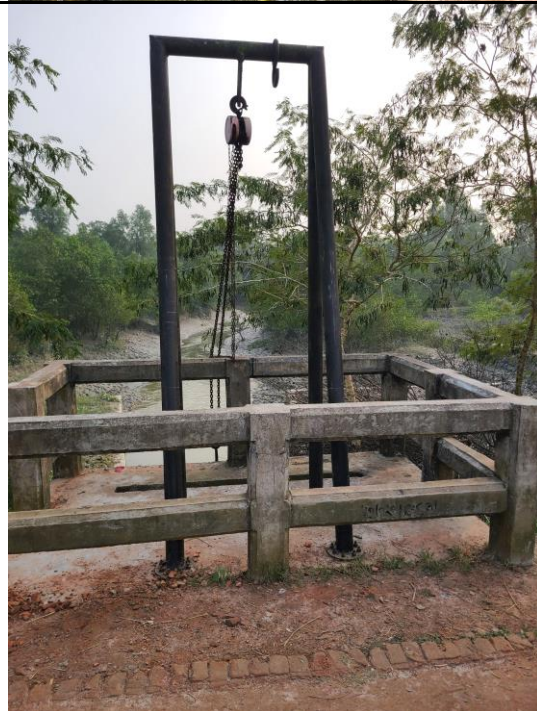
Date	Polder Name	Chainage (Km)	ID of Structure
22.11.2023	Polder 33	13.75	DS-4

**Observation:** Both gates are operable and closed. There is leakage in the bottom of the flap gate. Flap gate is not closed properly due to debris in the bottom of the structure. The steel rope is rusted.

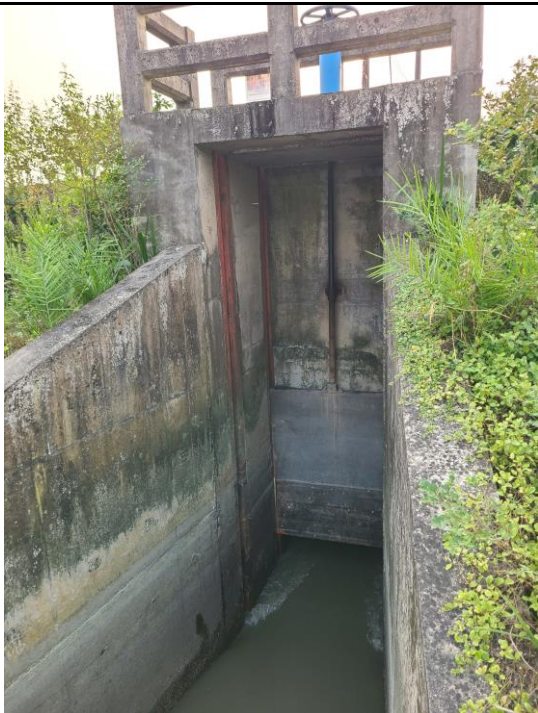
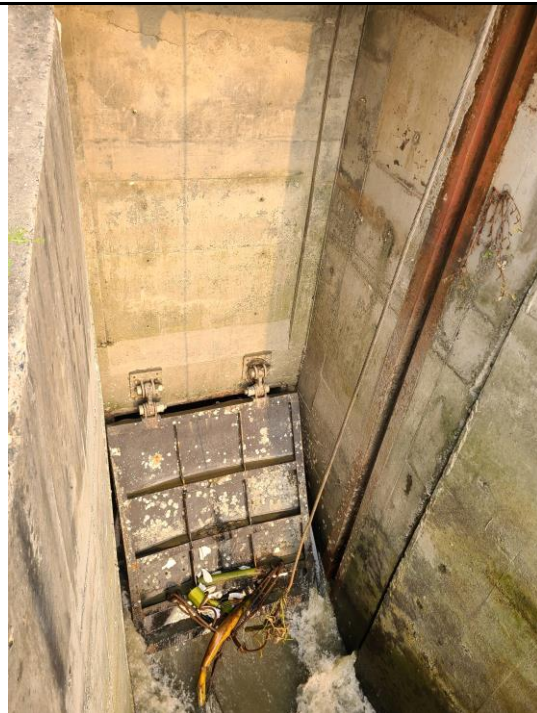
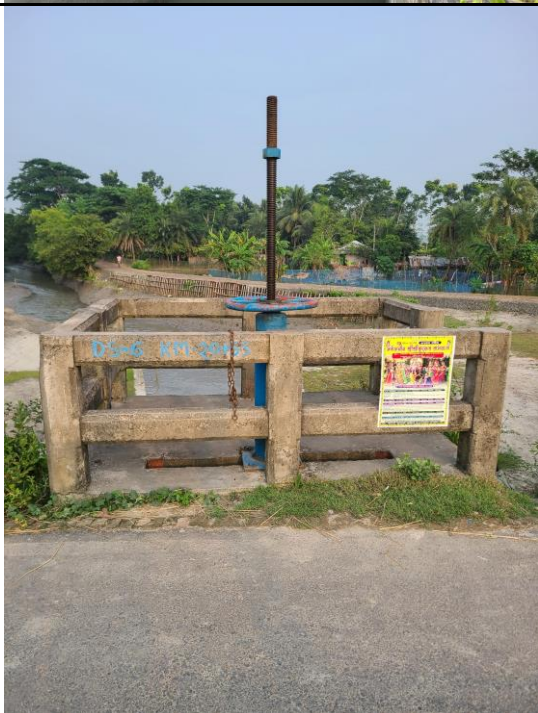
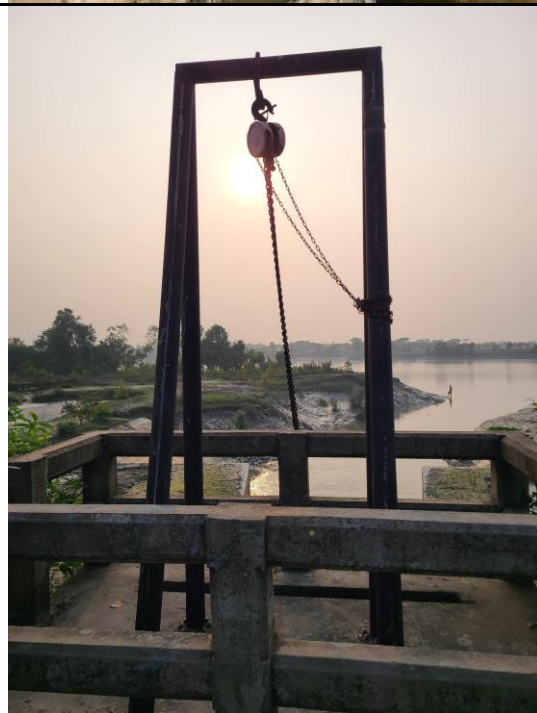
Date	Polder Name	Chainage (Km)	ID of Structure
22.11.2023	Polder 33	18.66	DS-6

**Observation:** Flap gate is closed but lift gate is partly open. There is leakage in the bottom of the flap gate. Flap gate is not closed properly due to debris in the bottom of the structure. The steel rope chain copper is rusted.

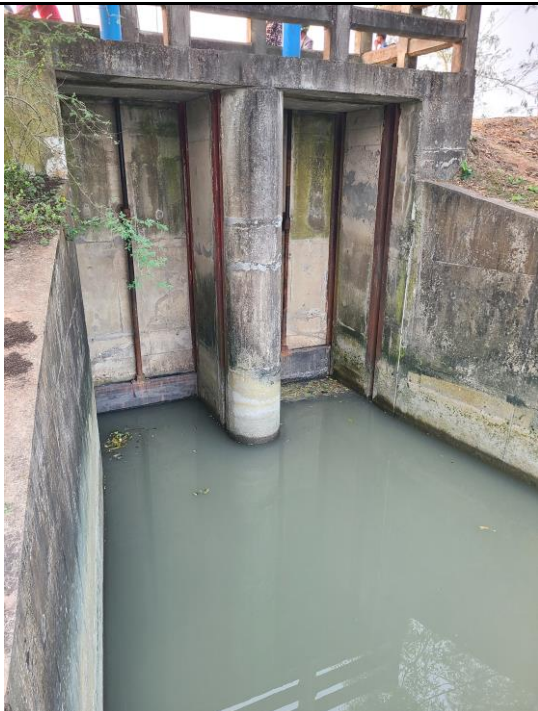
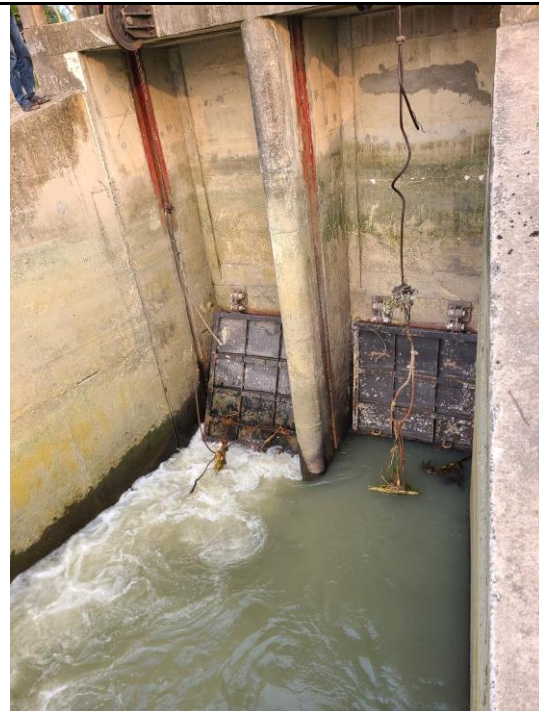
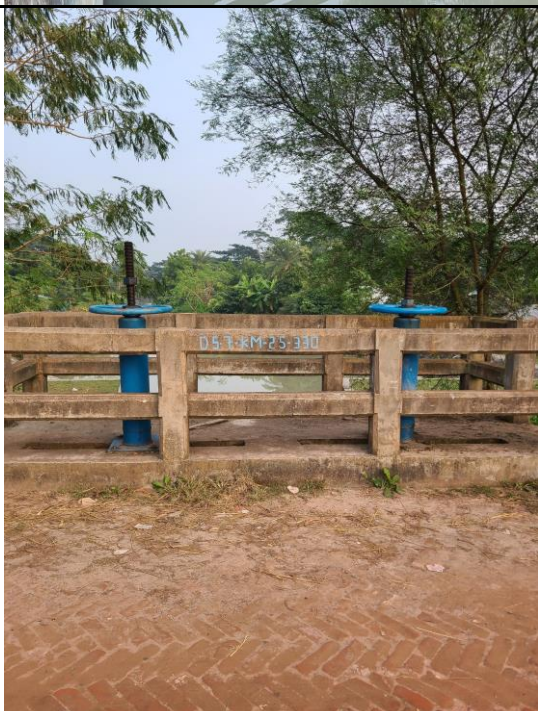
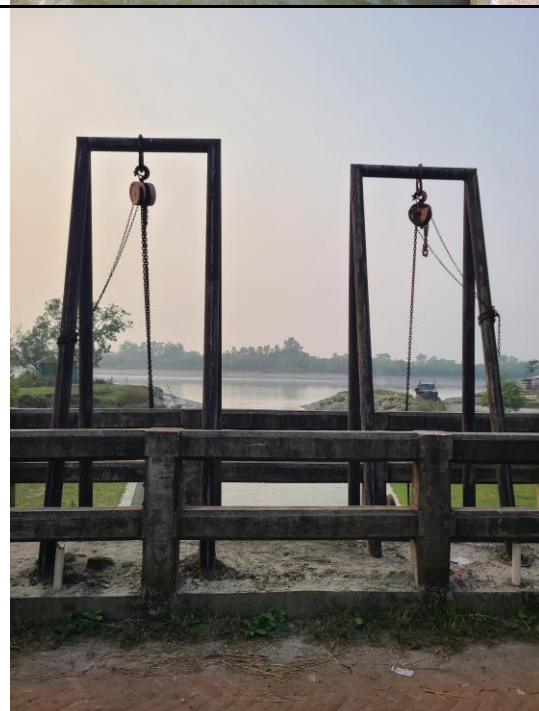
Date	Polder Name	Chainage (Km)	ID of Structure
22.11.2023	Polder 33	25.33	DS-7

**Observation:** Both gates are closed and operable. There are leakage in the flap gate . Flap gates are could not closed properly because there is debris in the bottom of the flap gates. Chain pulley block and steel rope is rusted.

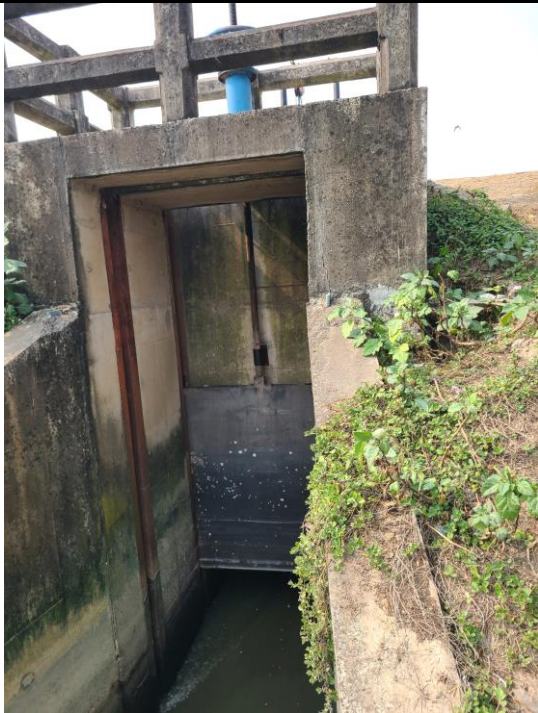
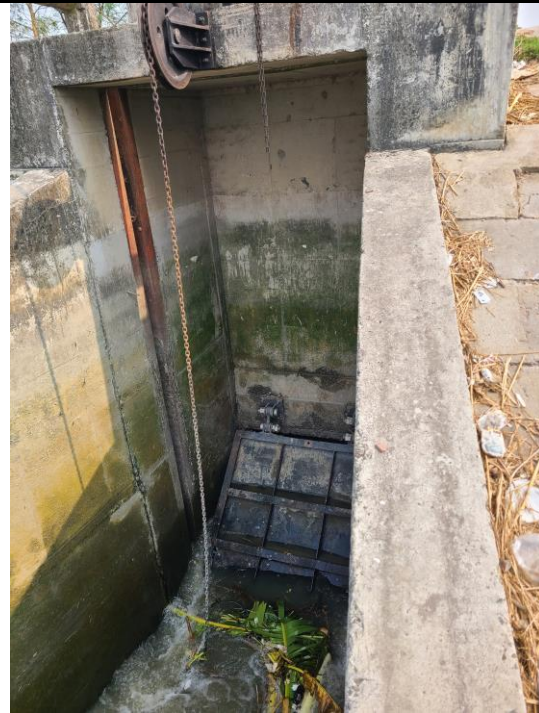
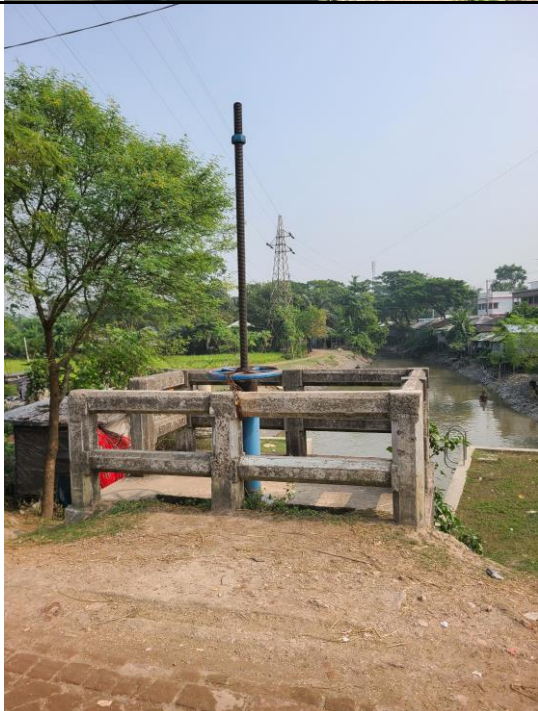
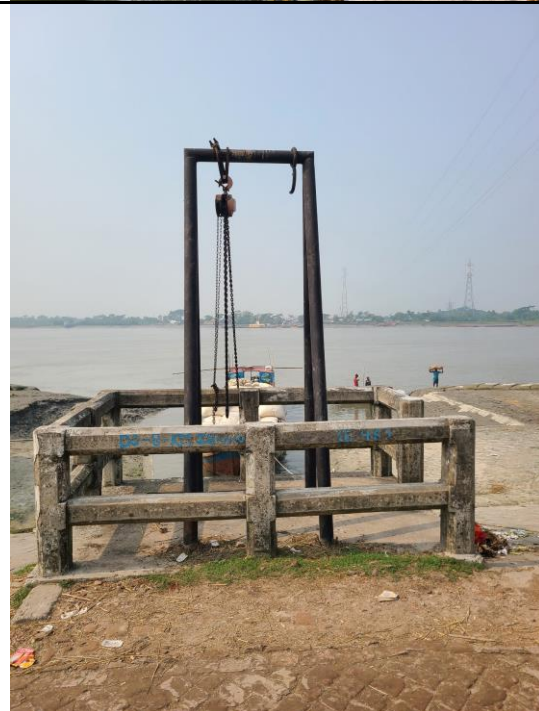
Date	Polder Name	Chainage (Km)	ID of Structure
22.11.2023	Polder 33	28.57	DS-8

**Observation:** Vertical Lift gate is open and flap gate is closed. Both gates are operable. Flap gates are could not closed properly because there is debris in the bottom of the flap gates. Chain pulley block and steel rope are medium rusted.

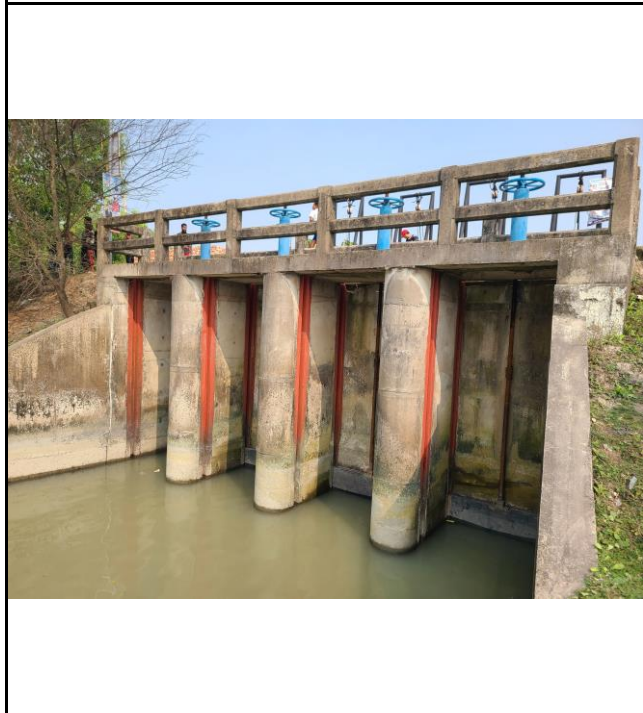
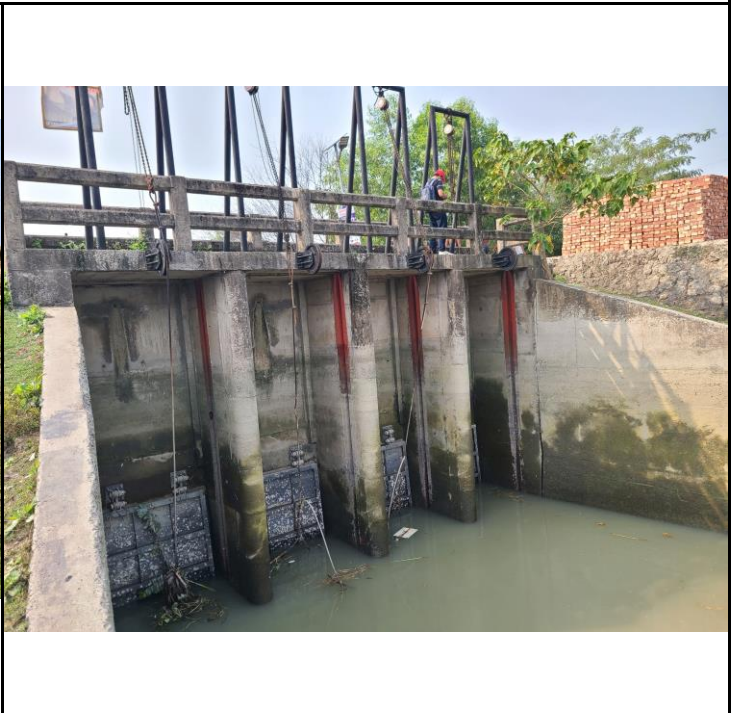
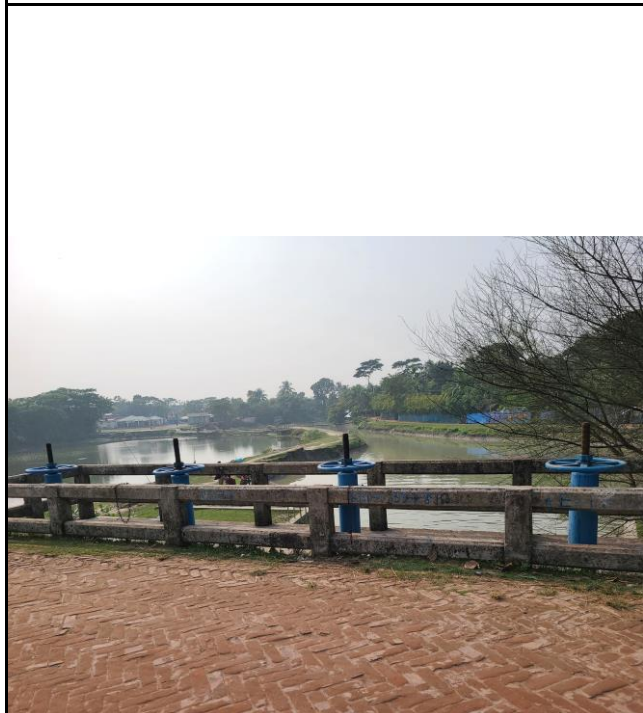
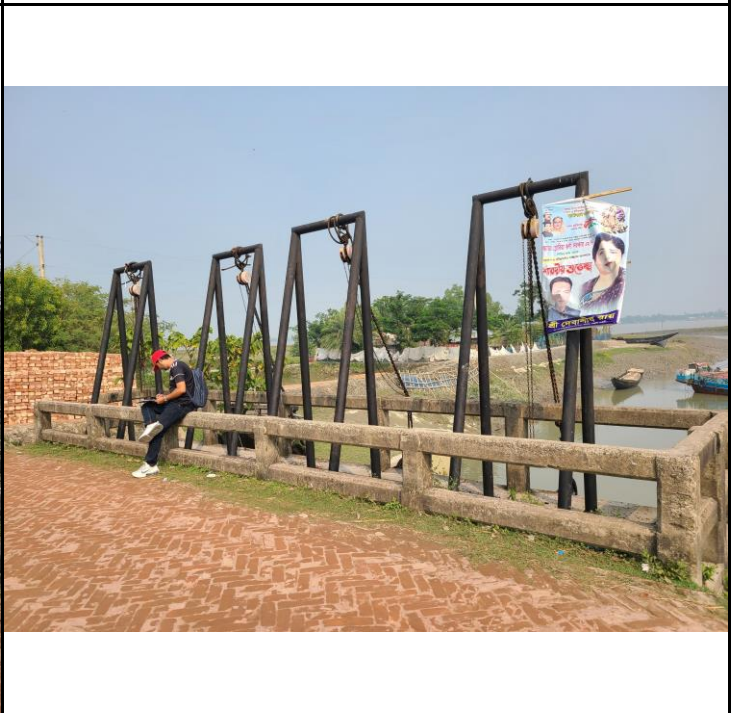
Date	Polder Name	Chainage (Km)	ID of Structure
22.11.2023	Polder 33	39.84	DS-9

**Observation:** It is a 4 vent drainage sluice. Vertical lift gates and flap gates are operable. Hoist and chain pulley block are available. There is medium rust on the steel rope, Nuts and bolts and chain pulley block.

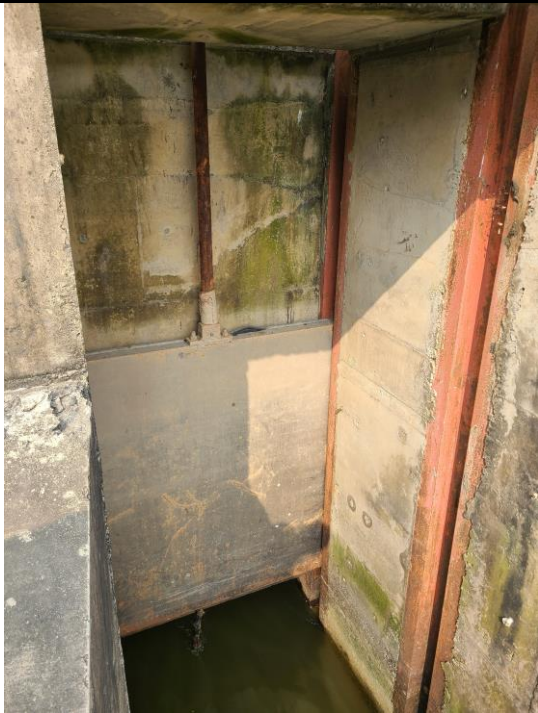
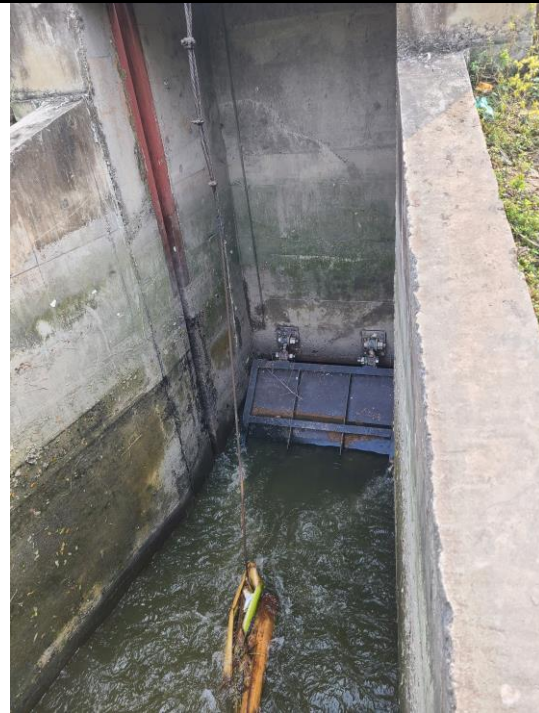
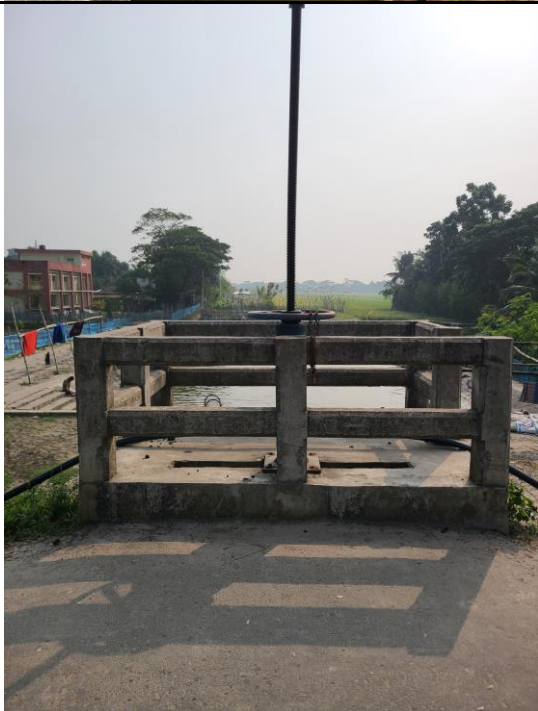
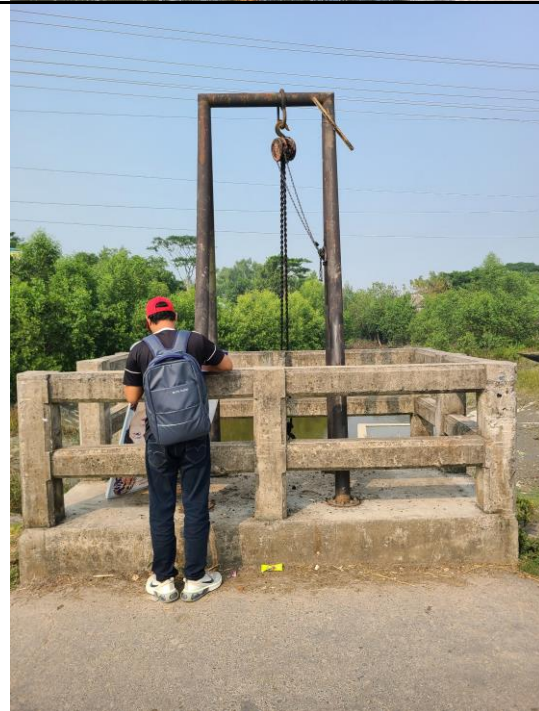
Date	Polder Name	Chainage (Km)	ID of Structure
22.11.2023	Polder 33	41.01	DS-10

**Observation:** Vertical lift gates and flap gates are operable. Hoist and chain pulley block are available. There is medium rust on the steel rope, Nuts and bolts and chain pulley block.

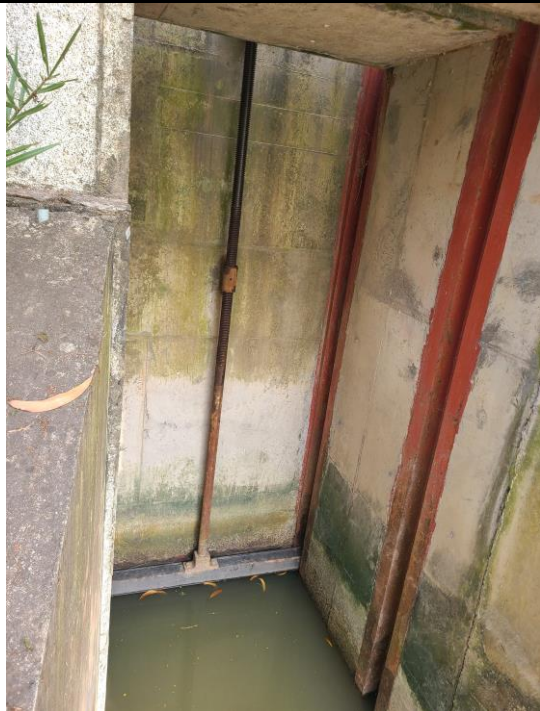
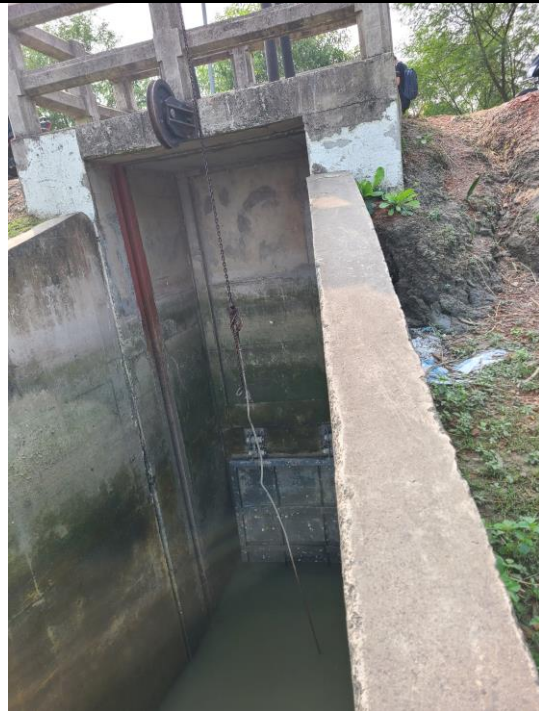
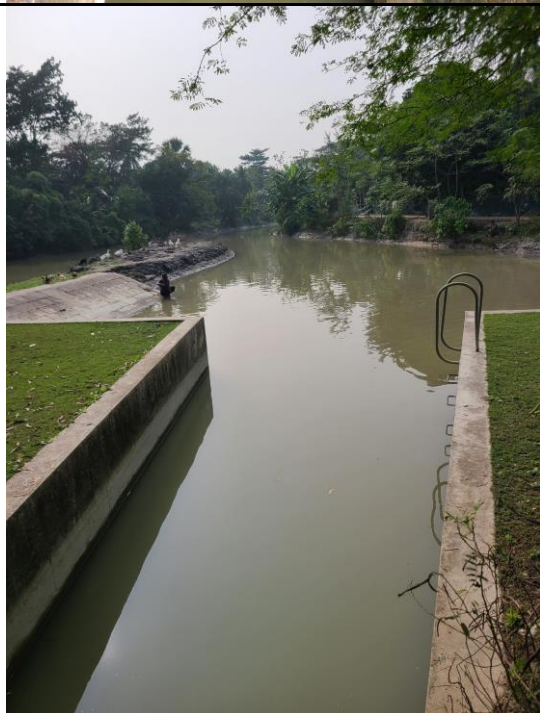
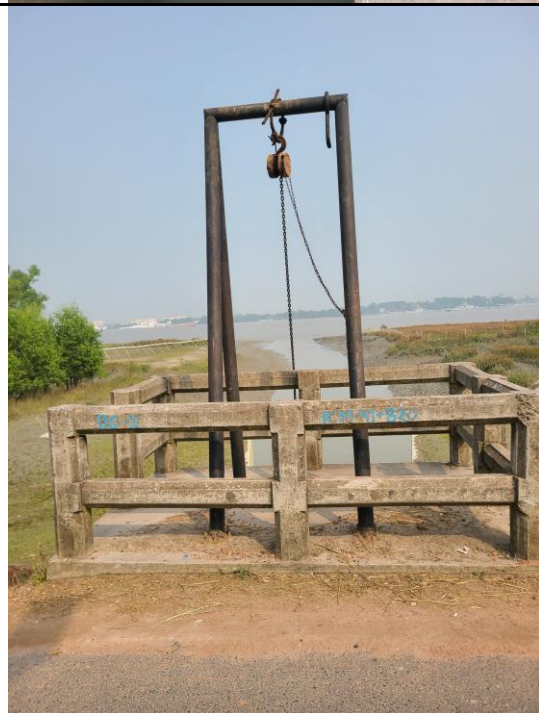
Date	Polder Name	Chainage (Km)	ID of Structure
22.11.2023	Polder 33	41.82	DS-11

**Observation:** Vertical lift gates and flap gates are operable. Hoist and chain pulley block are available. There is medium rust on the steel rope, Nuts and bolts and chain pulley block.

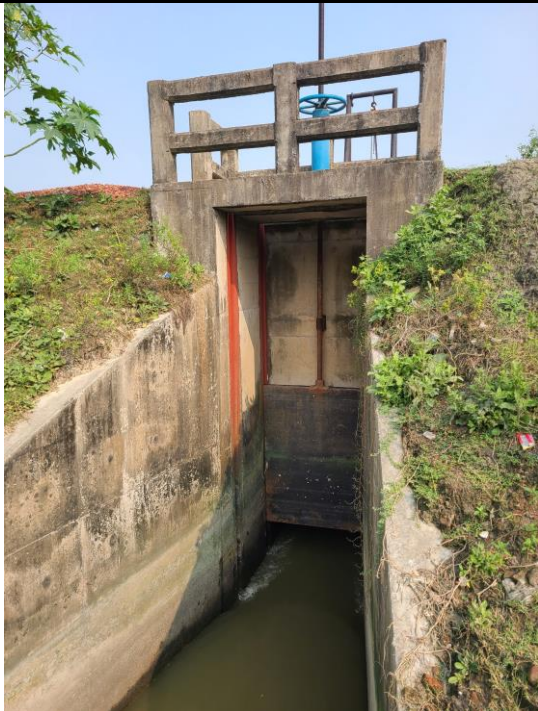
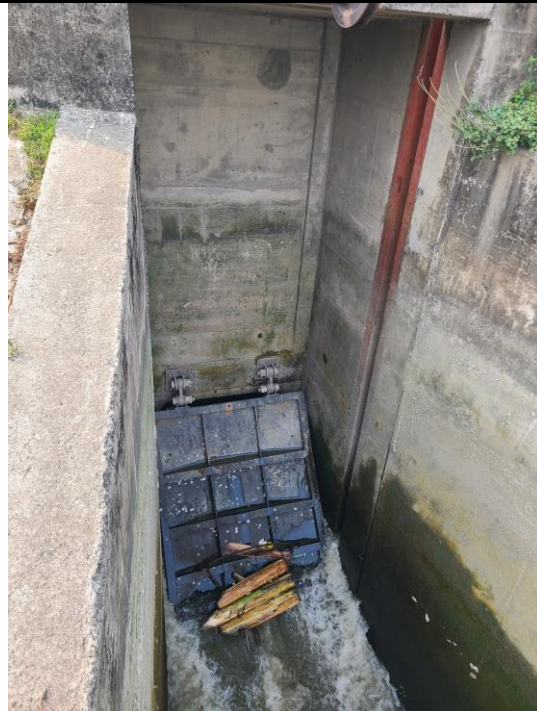
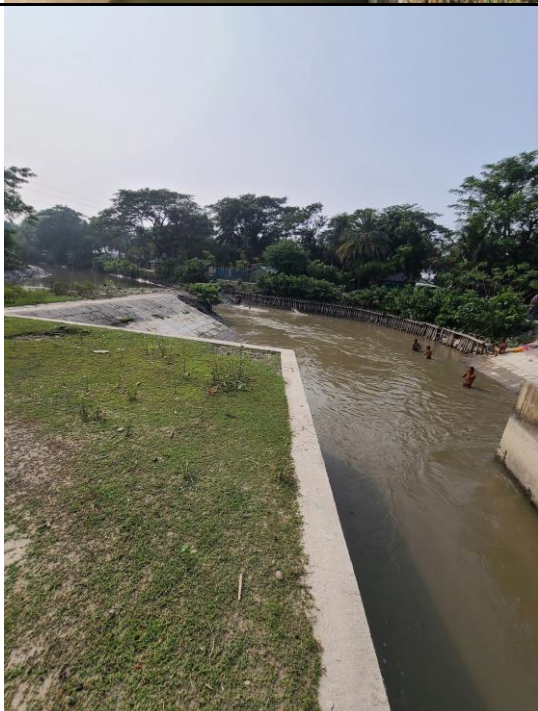
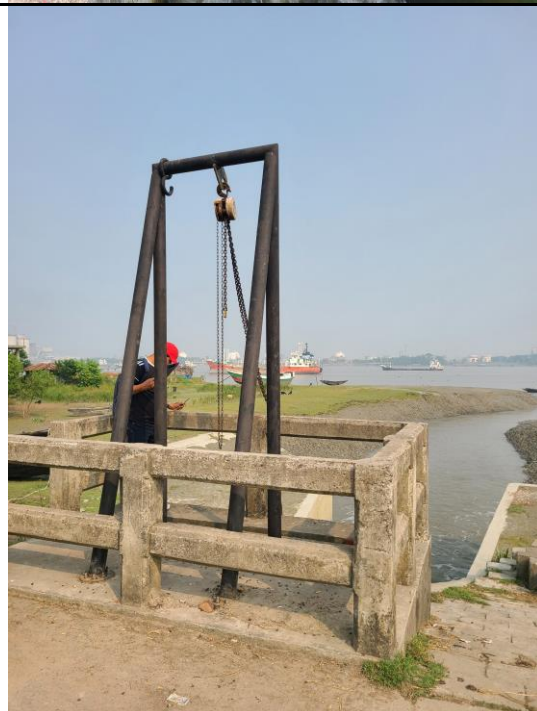
Date	Polder Name	Chainage (Km)	ID of Structure
22.11.2023	Polder 33	44.14	DS-12

**Observation:** Vertical lift gate is operable. Flap gate is not operable because steel rope is disconnected with the flap gate. Chain pulley block and steel rope are available. There is medium rust on the steel rope, Nuts and bolts and chain pulley block.

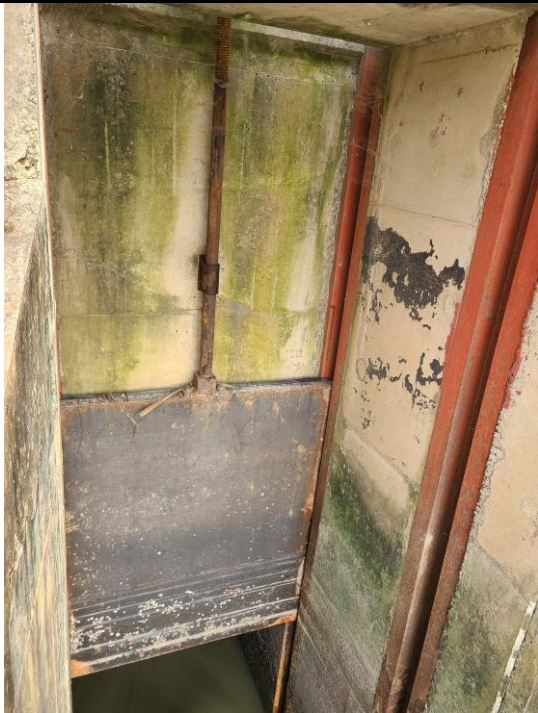
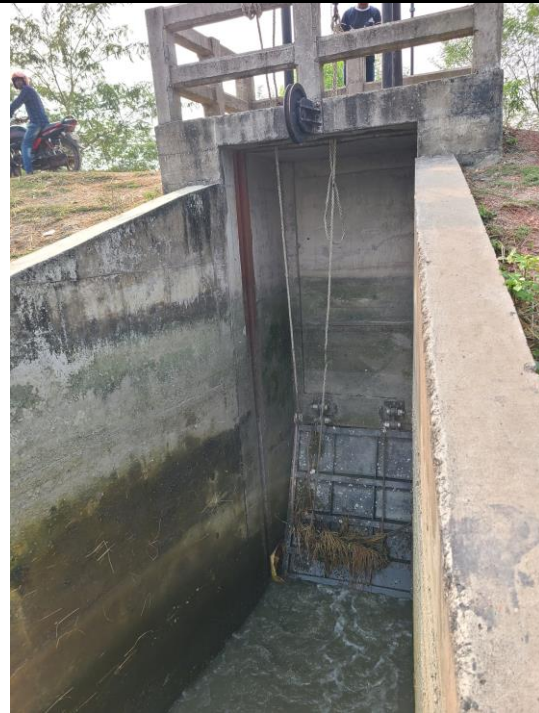
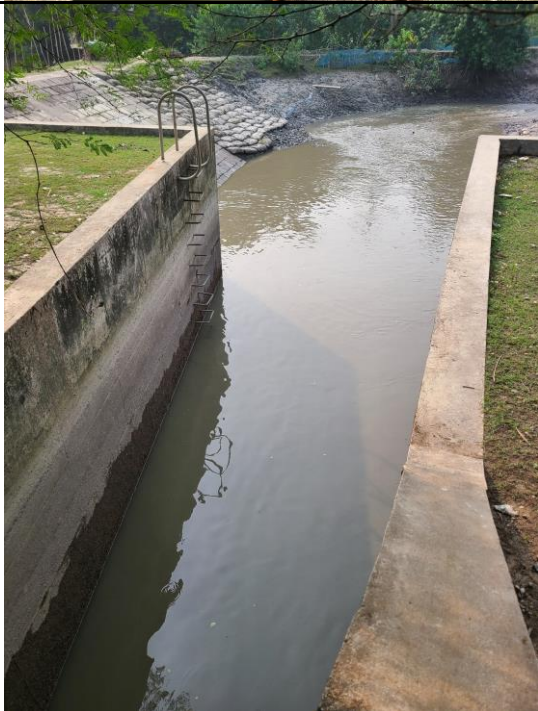
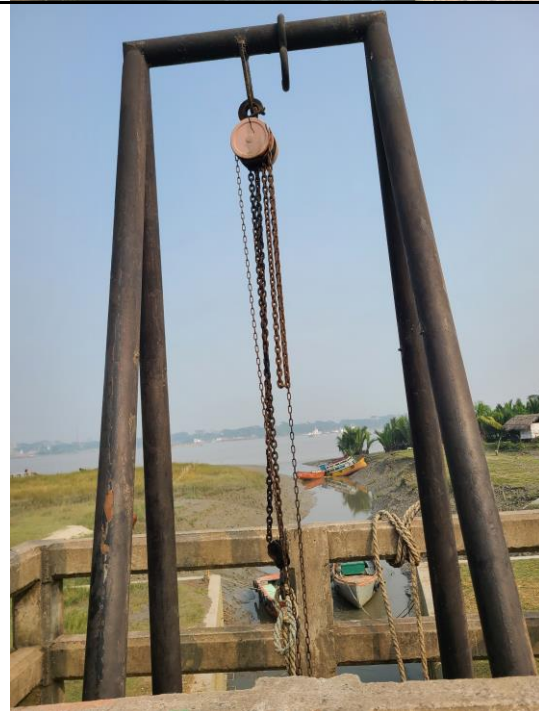
Date	Polder Name	Chainage (Km)	ID of Structure
22.11.2023	Polder 33	47.31	DS-13

**Observation:** Vertical lift gate is operable. Flap gate is not operable because steel rope and chain copper is not connected. Chain pulley block and steel rope are available. There is medium rust on the steel rope, Nuts and bolts and chain pulley block.

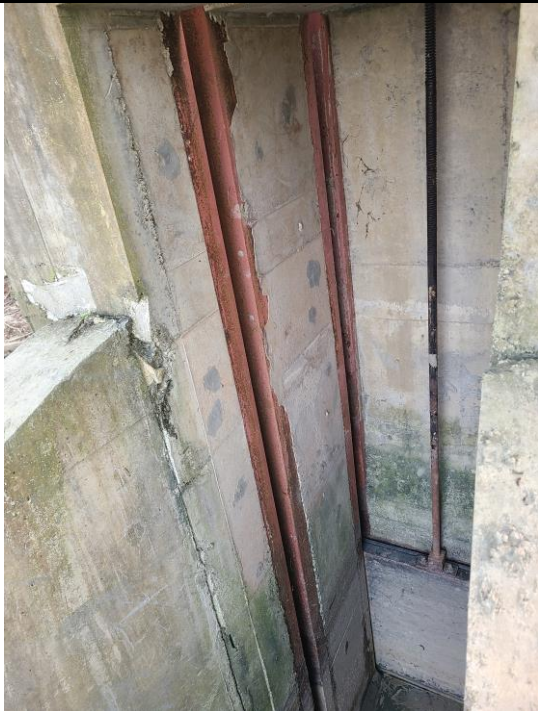
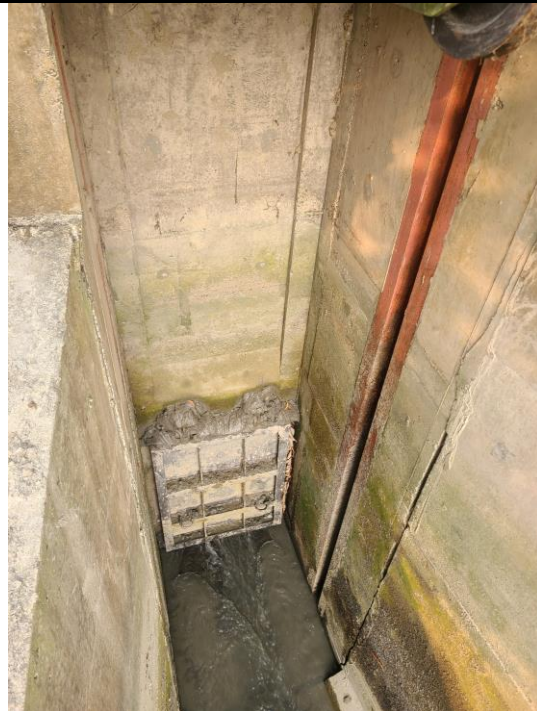
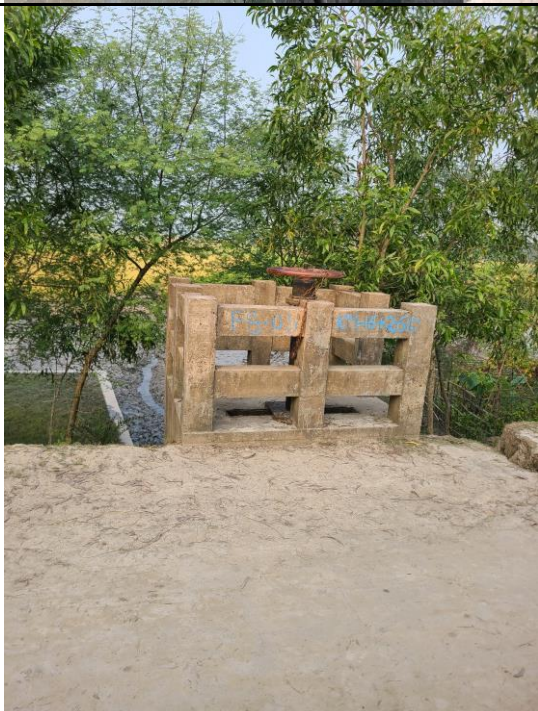
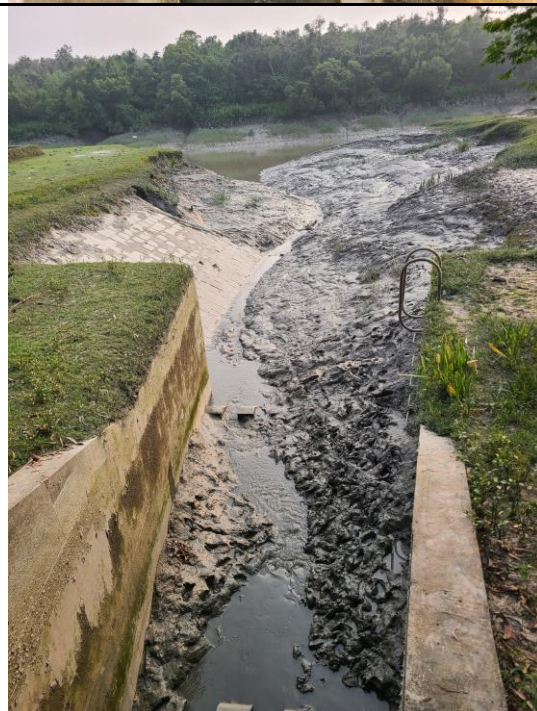
Date	Polder Name	Chainage (Km)	ID of Structure
22.11.2023	Polder 33	16.26	FS-5

**Observation:** Vertical lift gate is in good condition. The vertical lift gate is operable. Flap gate is in closed condition and flap gate is not operable. Although chain pulley block is available there but steel rope is missing from flap gate.

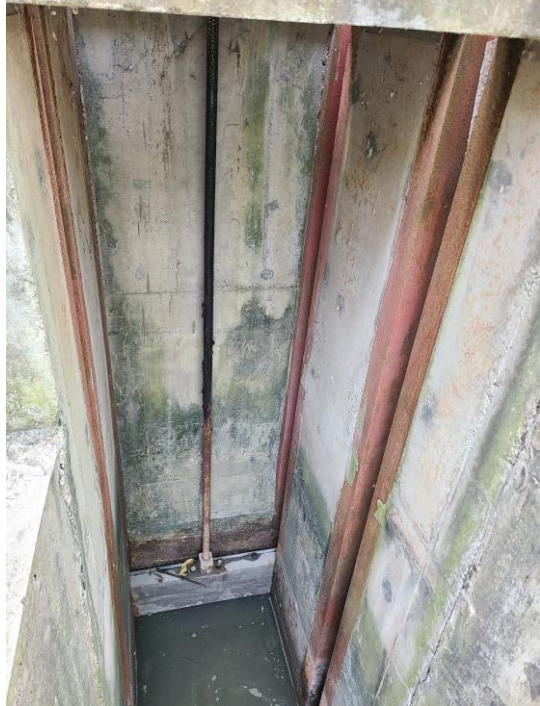
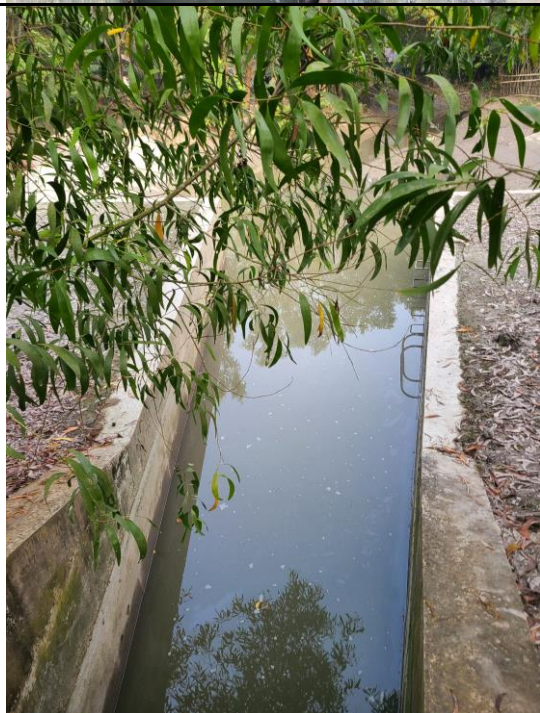
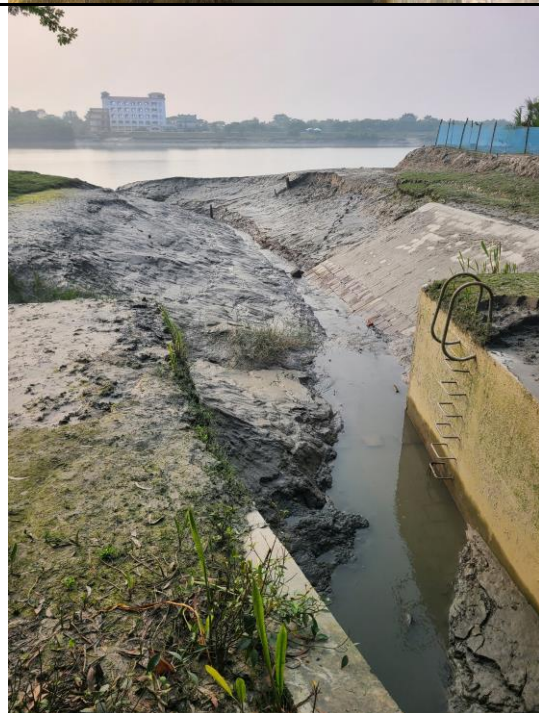
Date	Polder Name	Chainage (Km)	ID of Structure
22.11.2023	Polder 33	18.66	FS-6

**Observation:** Structure is in good condition. Both gates are closed and operable. Vertical lift gate hoist and chain pulley copper is available. Leakage could not be measured because of low level of water. Medium rust in stem, nuts bolts and chain pulley block.
