November, 2023

# POLDER 33

FIELD VISIT REPORT

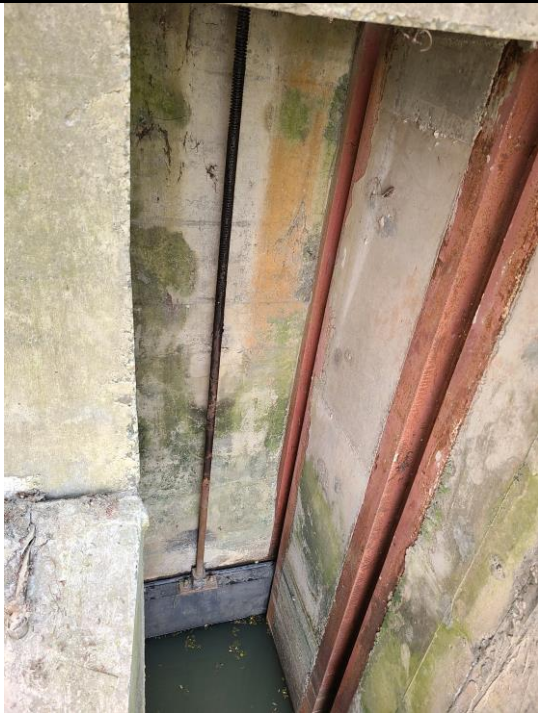
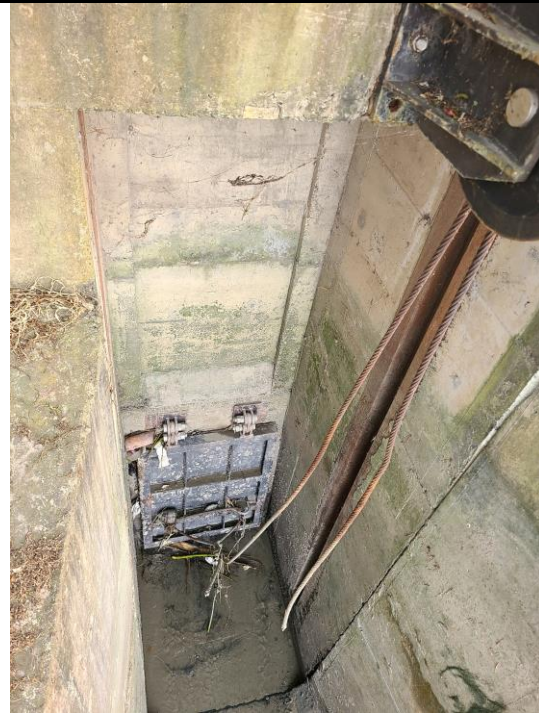
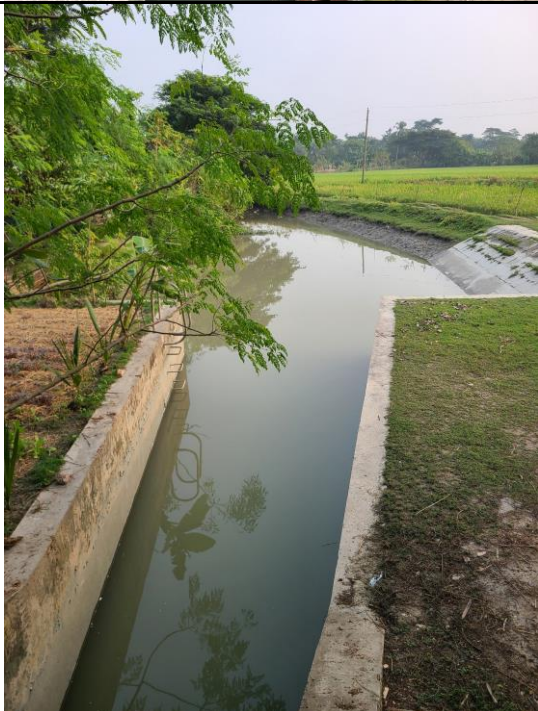
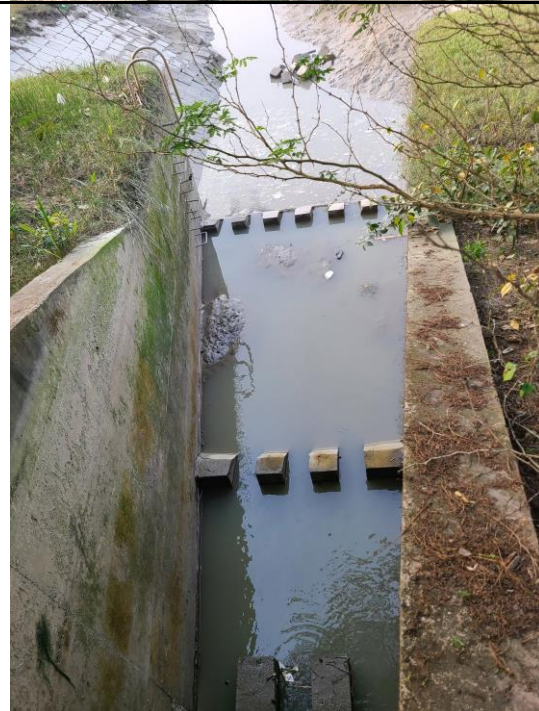
Date	Polder Name	Chainage (Km)	ID of Structure
22.11.2023	Polder 33	22.92	FS-8

**Observation:** Structure is in good condition. Both gates are closed and operable. Hoist and chain pulley is available. Leakage could not be measured because of low level water. Medium rust in stem, nuts bolts, steel rope and chain pulley block.

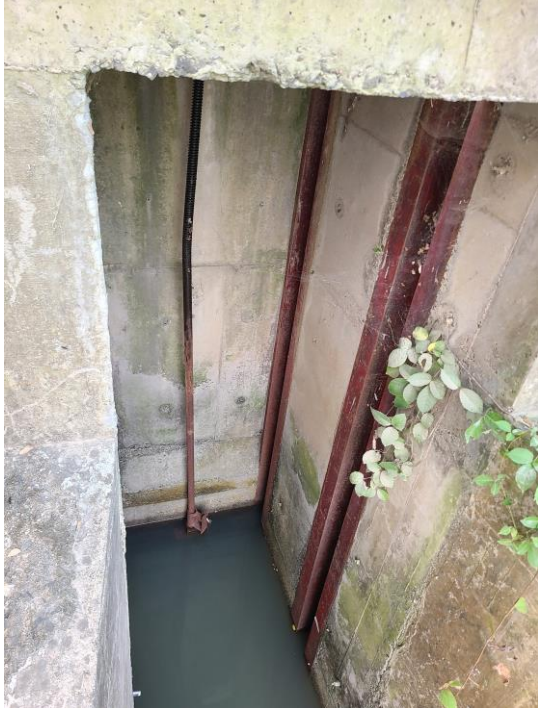
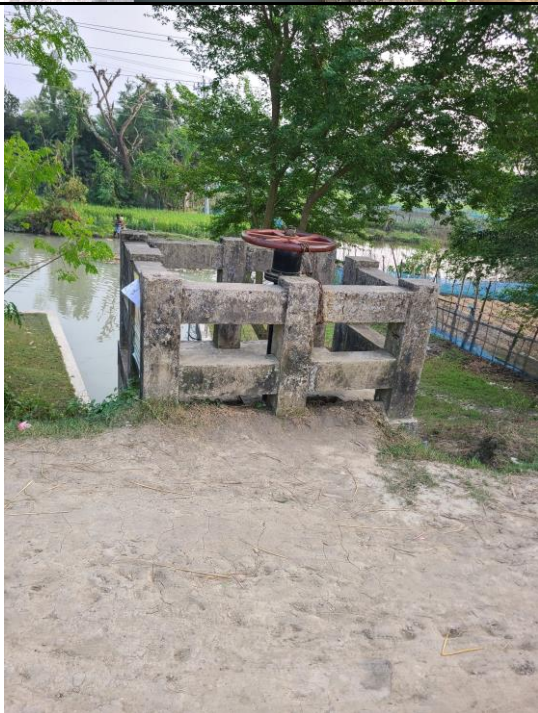
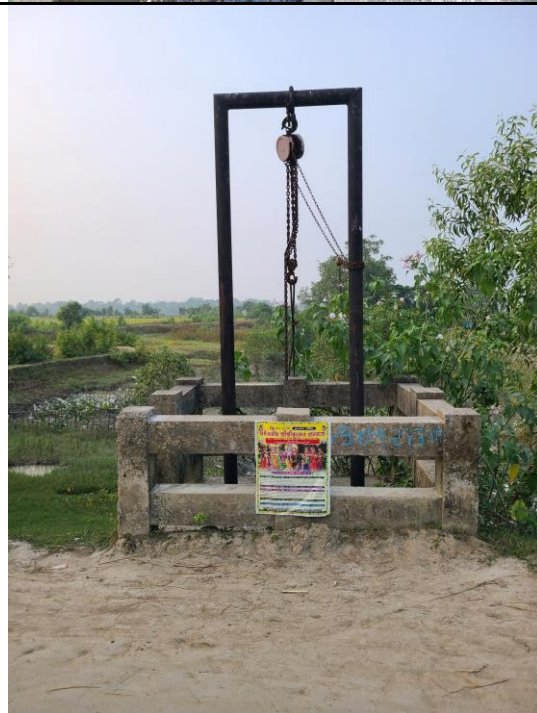
Date	Polder Name	Chainage (Km)	ID of Structure
22.11.2023	Polder 33	27.93	FS-9

**Observation:** Both gates are closed. Vertical lift gate hoist and chain pulley block is available. But vertical lift gate is not operable because the stem rod is bend and vertical gate is not open fully. Flap gate could not closed properly because vent is block by debris. Leakage could not measured because of low level water. Medium rust in stem rod, nuts & bolts, steel rope and chain pulley Block.

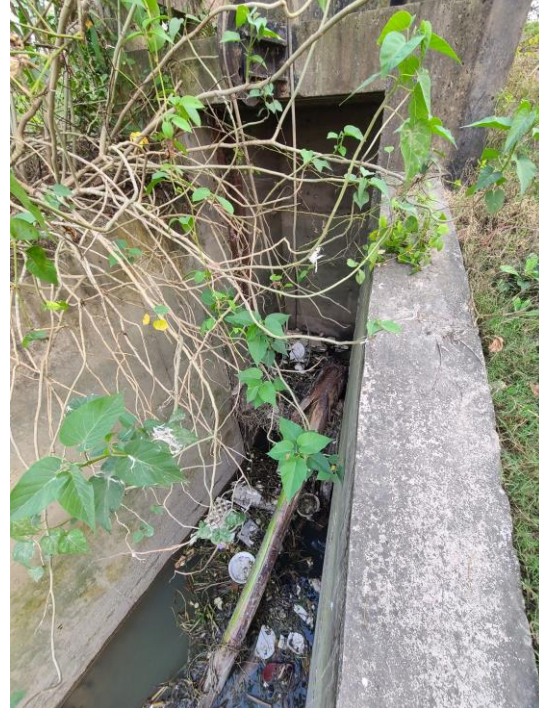
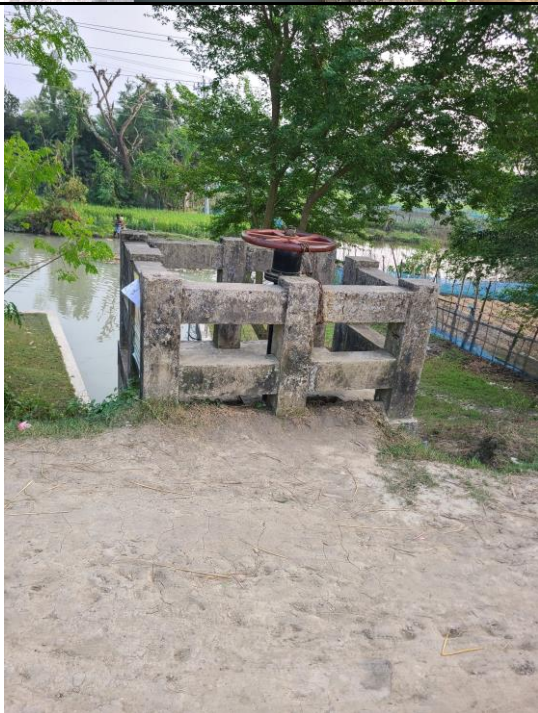
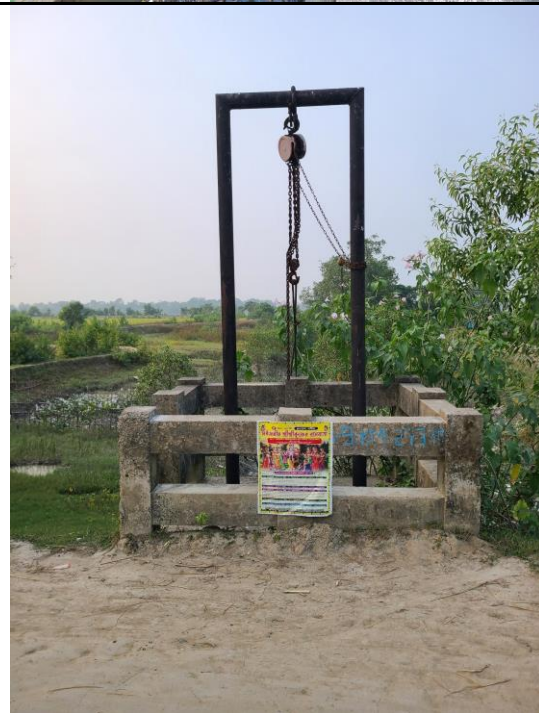
Date	Polder Name	Chainage (Km)	ID of Structure
22.11.2023	Polder 33	30.78	FS-11

**Observation:** Both gates are closed. Vertical lift gate hoist and chain pulley block is available. But vertical lift gate is not operable because the stem rod is bend and vertical gate is not open fully. Flap gate is not closed properly because of debris in the mouth of vent. Leakage could not measured because of low level of water. Medium rust in hoist rod, nuts bolts , steel rope and chain pulley block.

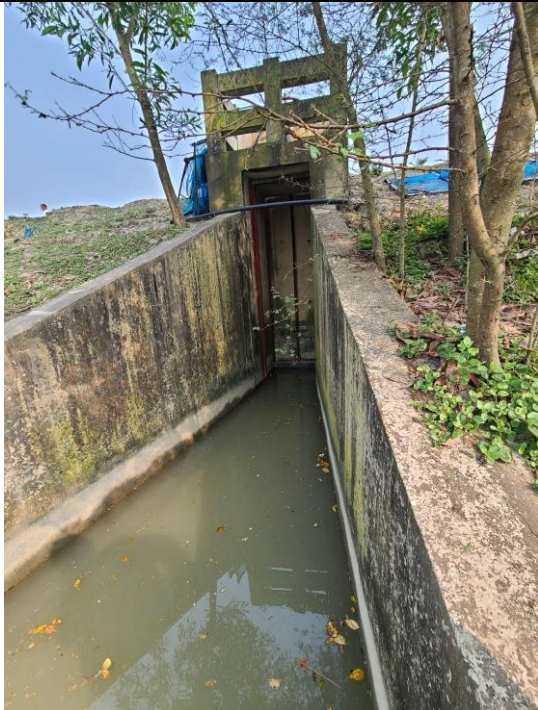
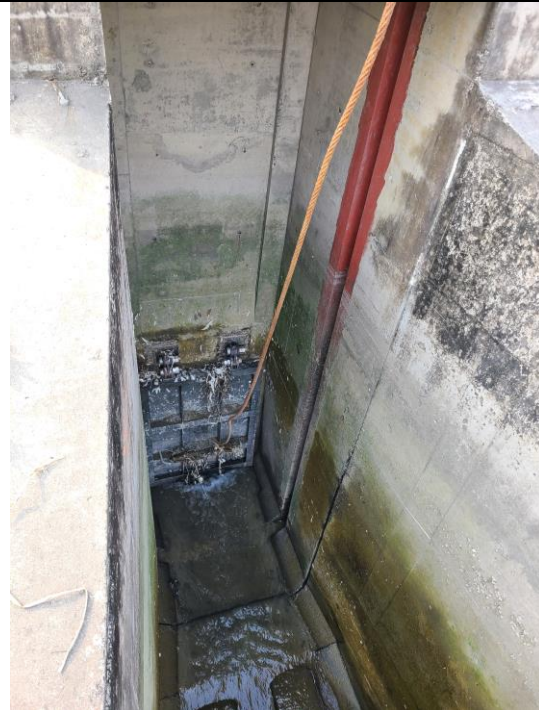
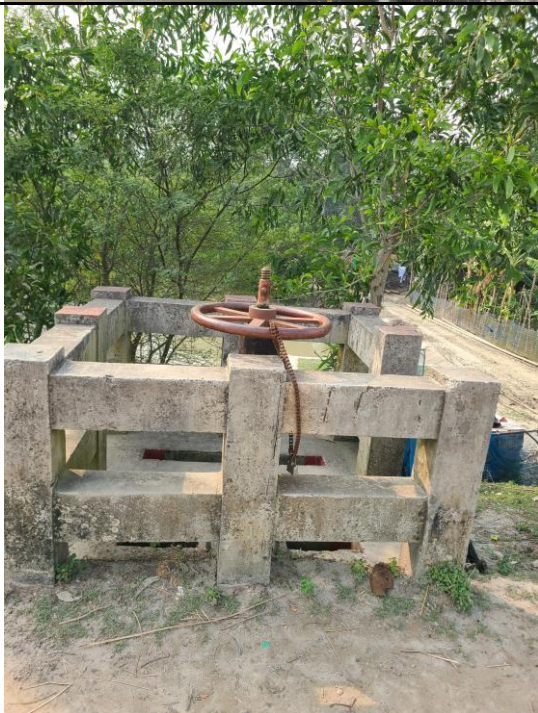
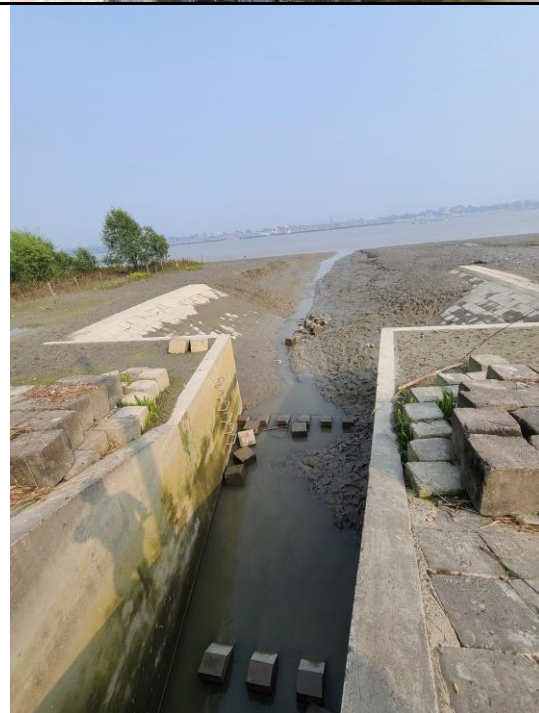
Date	Polder Name	Chainage (Km)	ID of Structure
22.11.2023	Polder 33	46.21	FS-17

**Observation:** Both gates are closed. Vertical lift gate hoist and Chain pulley block is available and gates are operable. There is minor leakage. Medium rust in hoist rod, nuts bolts , steel rope and chain pulley block.
