# Polder 35/1

Field Visit Report

tareq islam  
[COMPANY NAME]

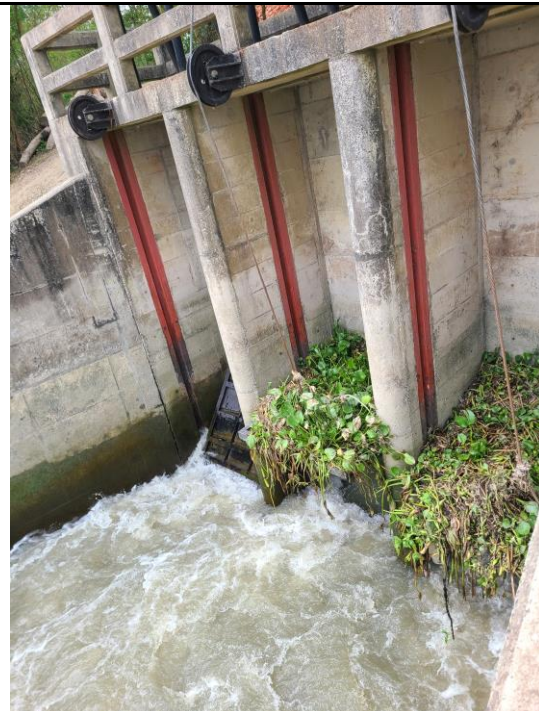
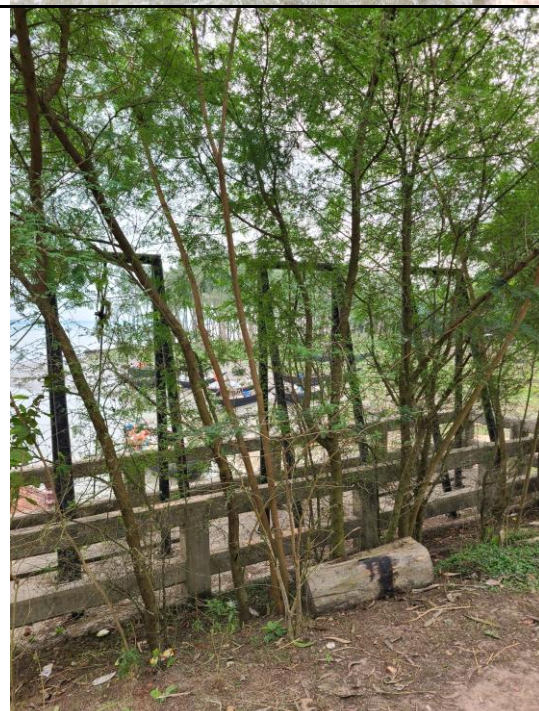
Date	Polder Name	Chainage (Km)	ID of Structure
21.11.2023	Polder 35/1	3.332	DS-2

**Observation:** All Vertical lift gate are open and operable. Two flap gate is open and debries on the flap gate. Another flap gate is closed but not properly closed. All flap gate are not operable because chain pulley block missing. Steel rope used for keeping the flap gate open. There is rust on nuts, bolts and settel rope.

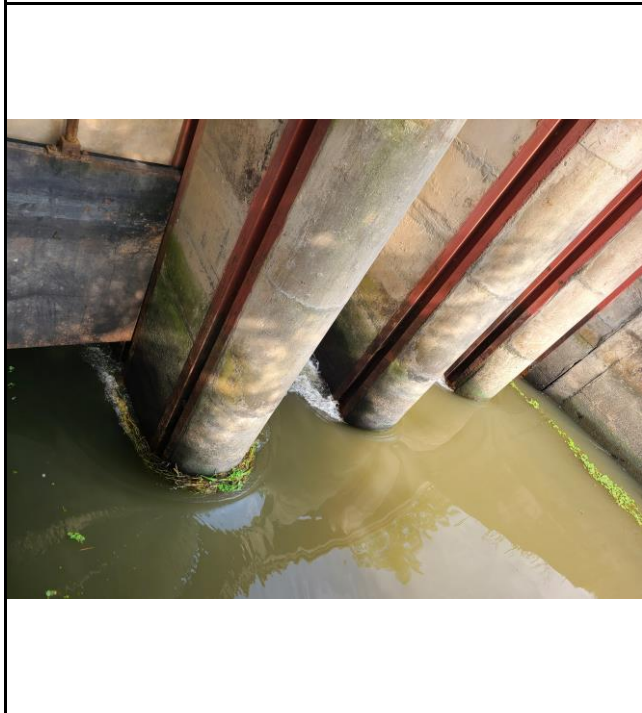
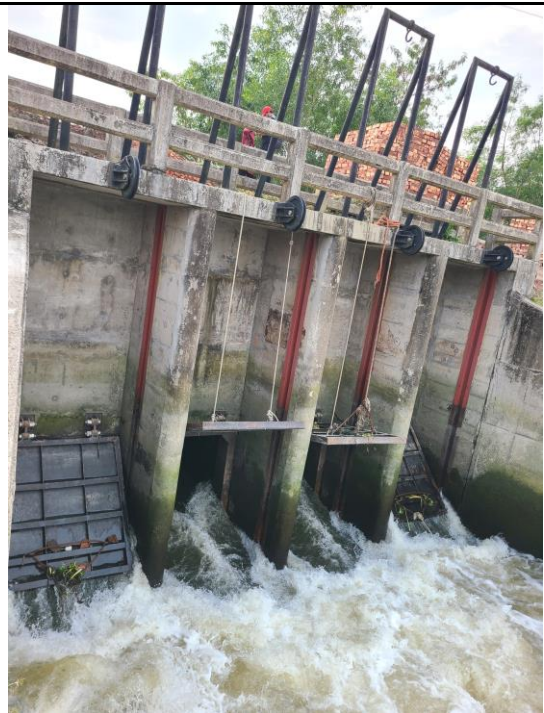
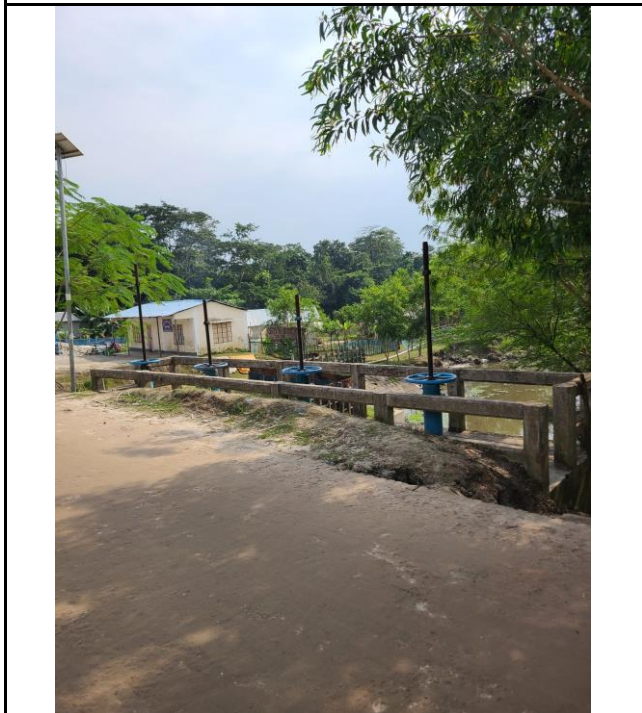
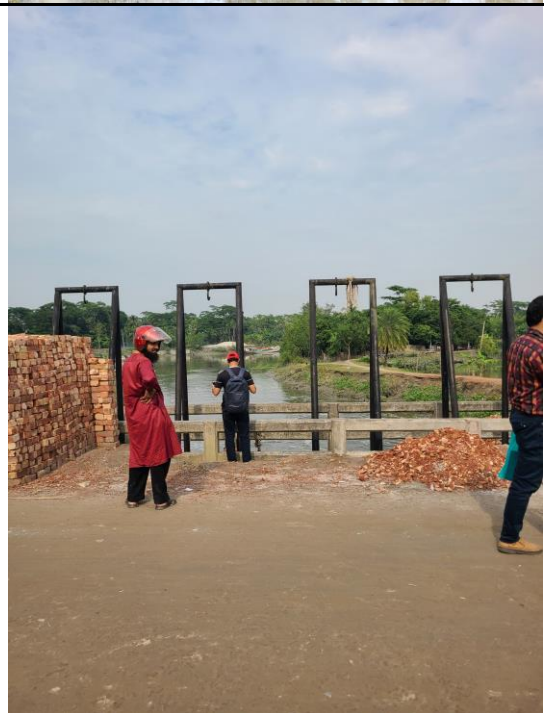
Date	Polder Name	Chainage (Km)	ID of Structure
21.11.2023	Polder 35/1	12.097	DS-4

**Observation:** All Vertical lift gate are open and operable. Two flap gate is open and two flap gates are closed. All flap gates are not operable because chain pulley block are missing. Two flap gates are tie by rope with the railing of the DS-4 structure. There are minor rust all over the steel surface.

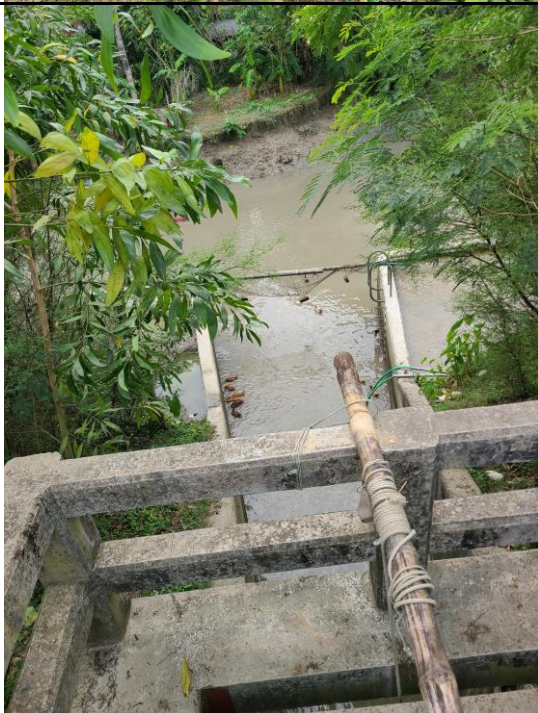
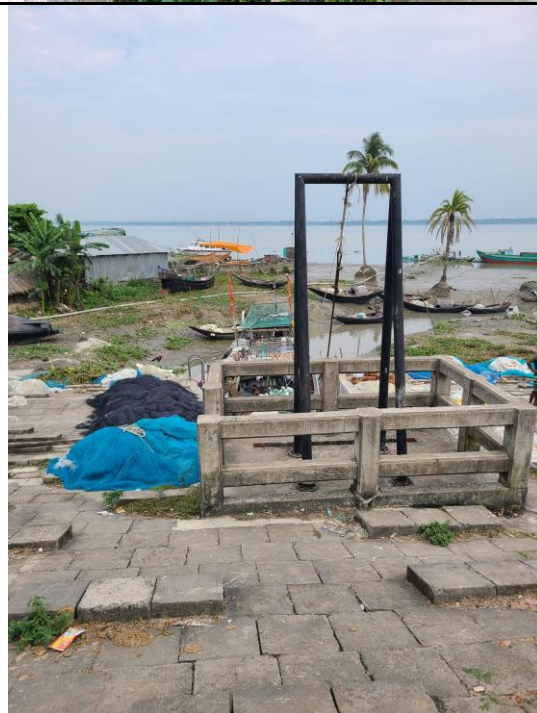
Date	Polder Name	Chainage (Km)	ID of Structure
21.11.2023	Polder 35/1	14.39	DS-5

**Observation:** In this structure vertical lift gate is open and operable. We could not take picture due to heavy bush beside the wing wall of the structure. River side flap gate is open and not operable because chain pulley block is not available. There are lots of debries on the flap gate. A steel rope is use for keeping the flap gste open.

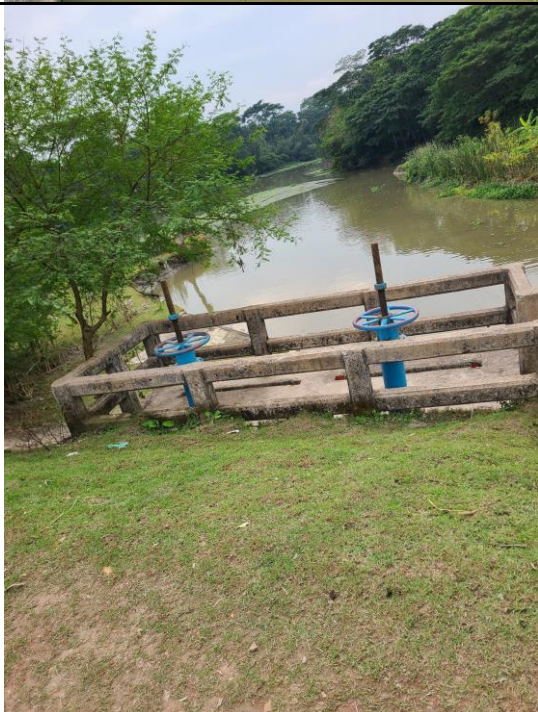
Date	Polder Name	Chainage (Km)	ID of Structure
21.11.2023	Polder 35/1	19.973	DS-6

**Observation:** In this structure vertical lift gate is partly open and operable. There are Water hyacinth on the country side lift gate. River side flap gate is open and not operable because chain pulley block is not available. There is lots of debris on flap gate. A steel rope is used for keeping the flap gates open. Steel rope, flap gates, nuts and bolts are rusted.

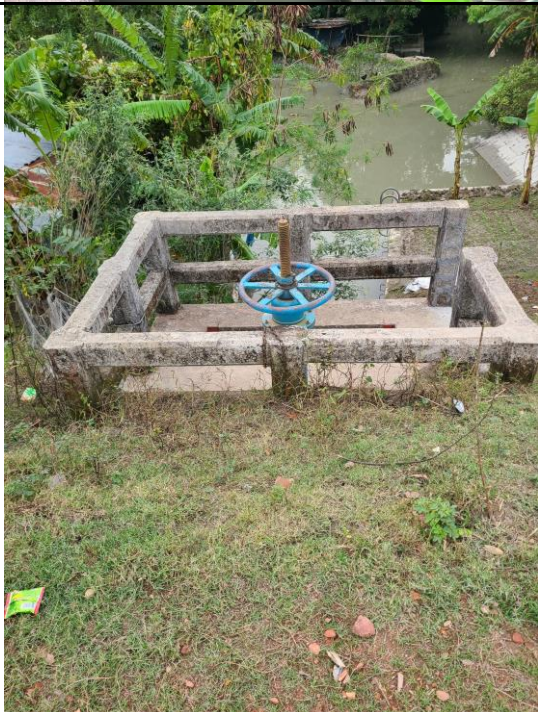
Date	Polder Name	Chainage (Km)	ID of Structure
21.11.2023	Polder 35/1	23.537	DS-7

**Observation:** In this structure vertical lift gate is closed and operable. River side flap gate is open and not operable because chain pulley block is not available. There are lots of debris and Water hyacinth on the flap gate. A steel rope is use for keeping the flap gates open. Steel rope, flap gates, nuts and bolts are rusted.

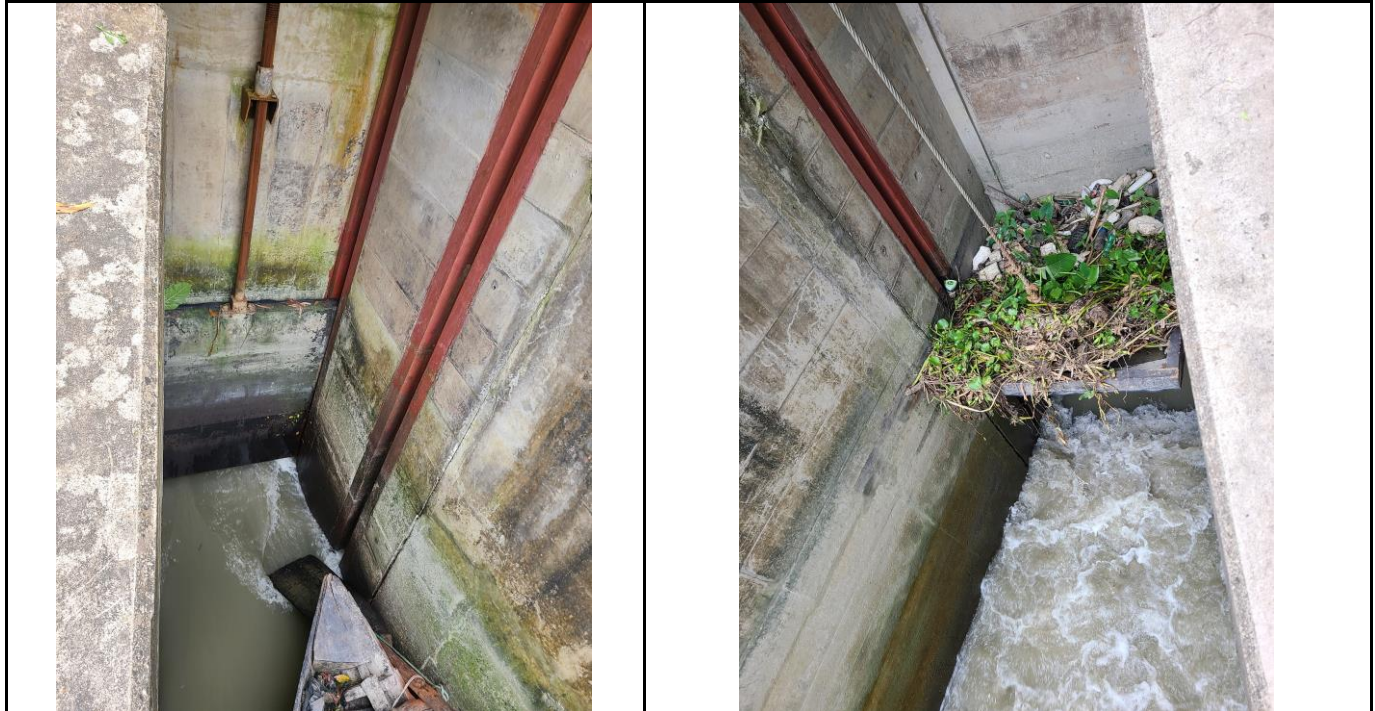
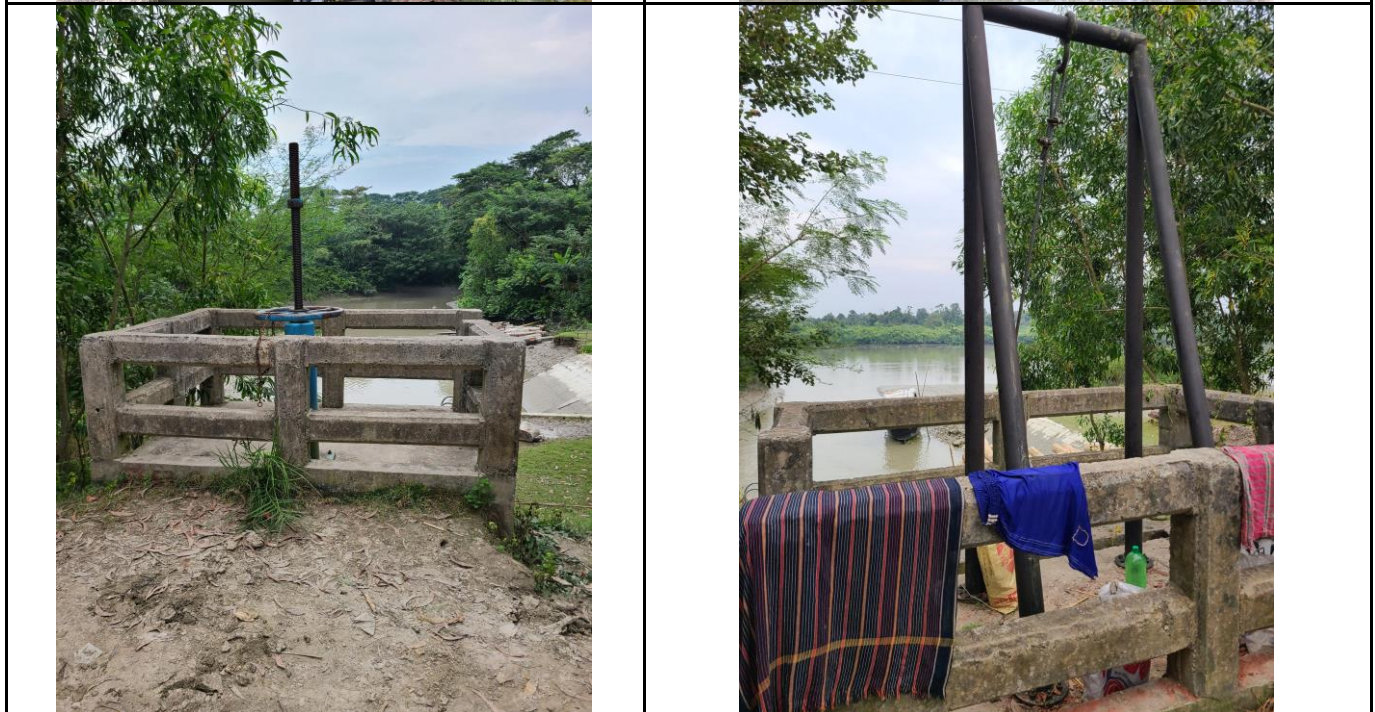
Date	Polder Name	Chainage (Km)	ID of Structure
21.11.2023	Polder 35/1	25.99	DS-8

**Observation:** Both gates are open but flap gate is not operable because chain pulley block is missing. There is debris and water hyacinth on the flap gate. Lower portion of stem rod, Nuts and bolts are rusted.

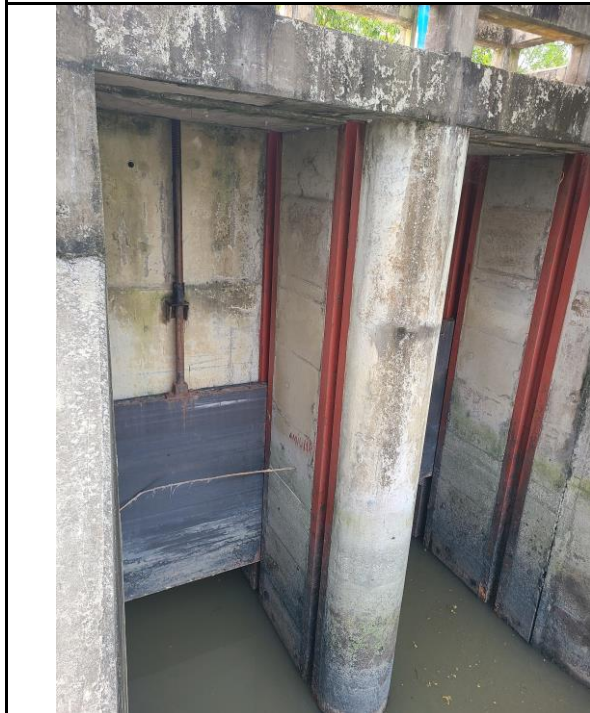
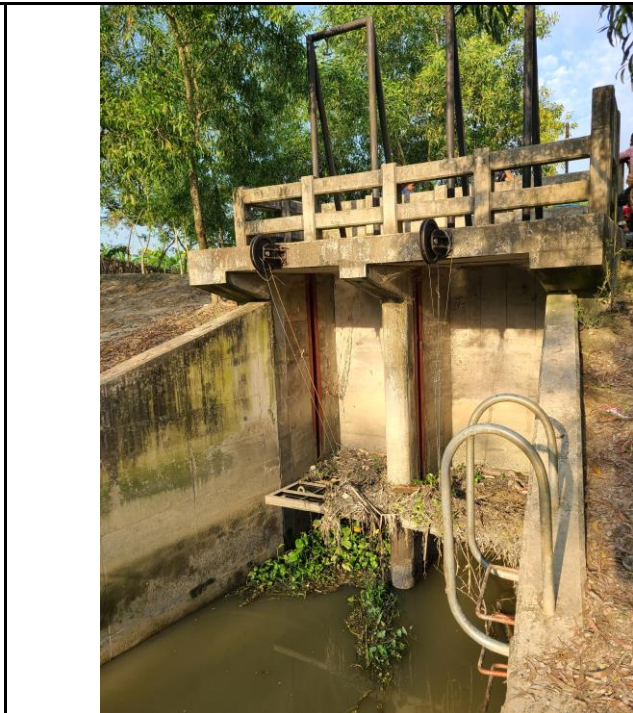
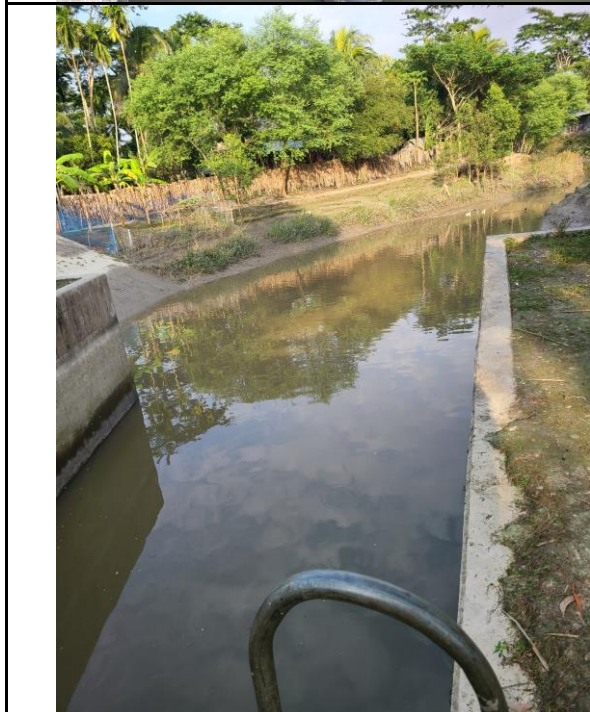
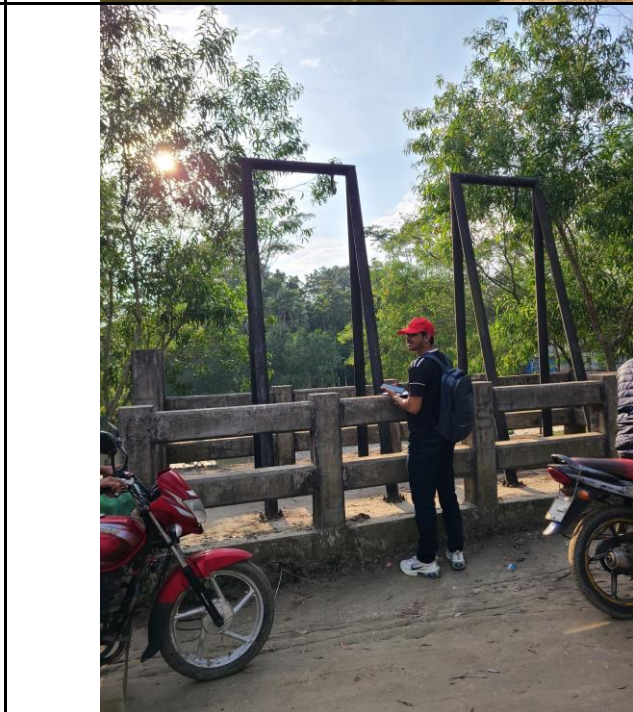
Date	Polder Name	Chainage (Km)	ID of Structure
23.11.2023	Polder 35/1	39.405	DS-11

**Observation:** Both gates are in C/S is opened and operable. Flap gates are opened but not operable because chain pulley block and steel hook are missing. There are debris and water hyacinth on the flap gate. Local People have tied the flap gate with steel rope at the railing. Nuts and bolts has rusted.

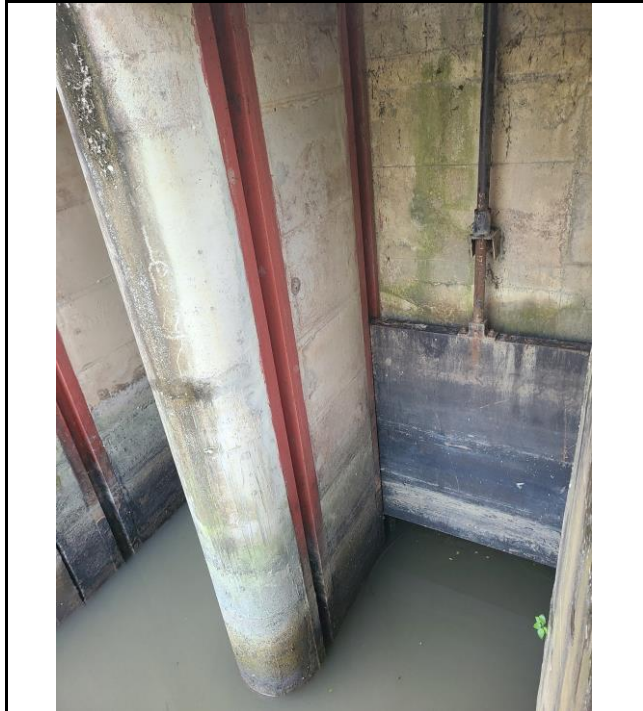
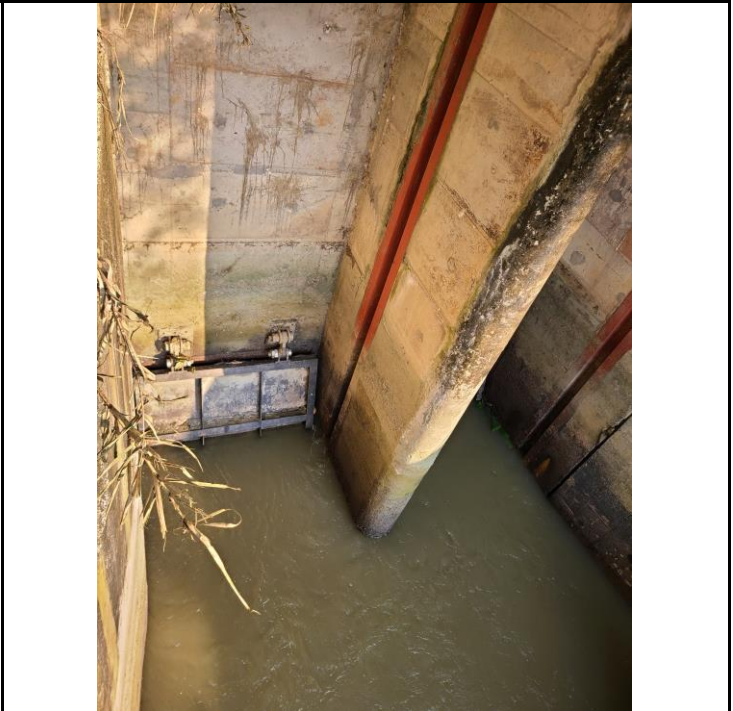
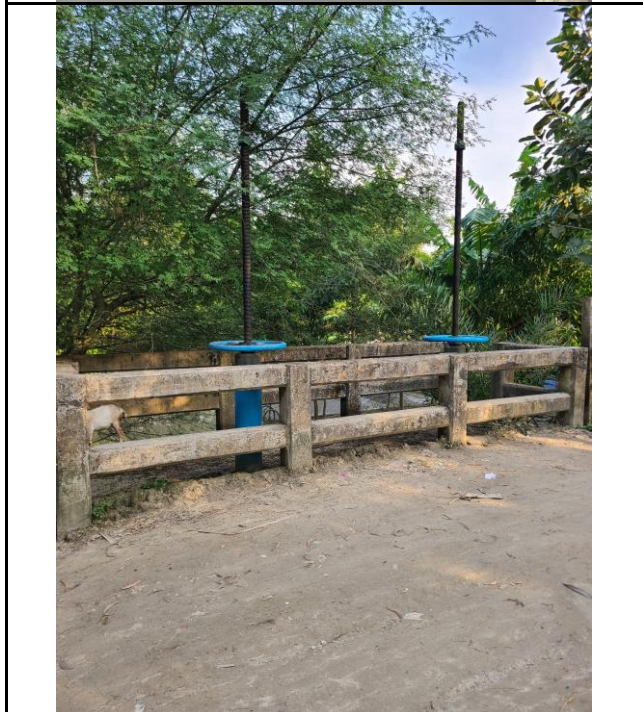
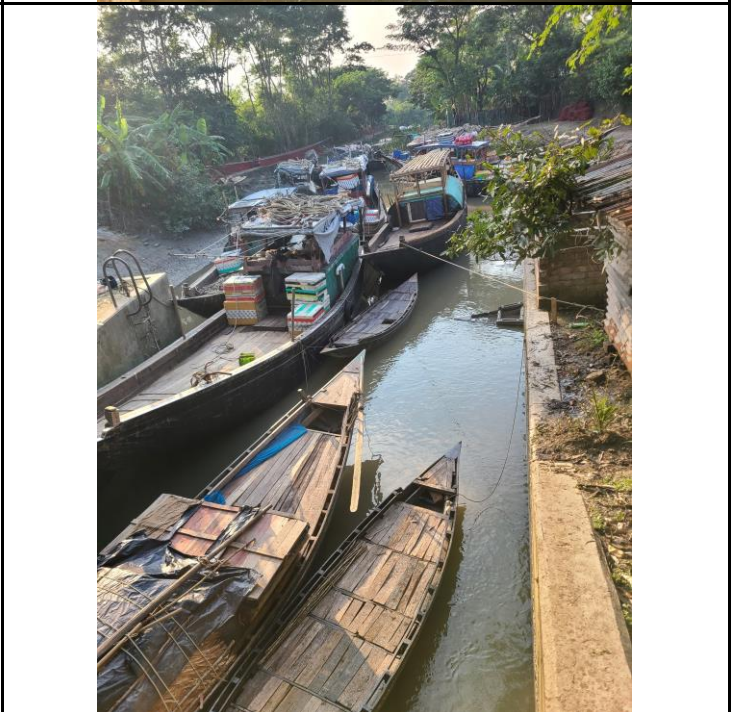
Date	Polder Name	Chainage (Km)	ID of Structure
23.11.2023	Polder 35/1	44.097	DS-12

**Observation:** Both gates are in C/S is opened and operable. River side gates or flap gates are opened but not operable Because chain pulley block and steel hook is missing. Water was running even though the flap gate was closed. There is medium rust on the Nuts and Bolts and steel surface.

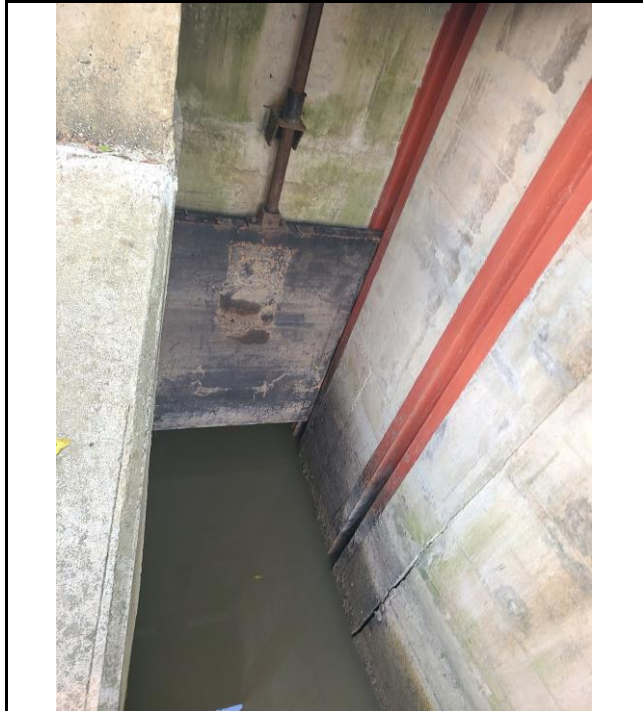
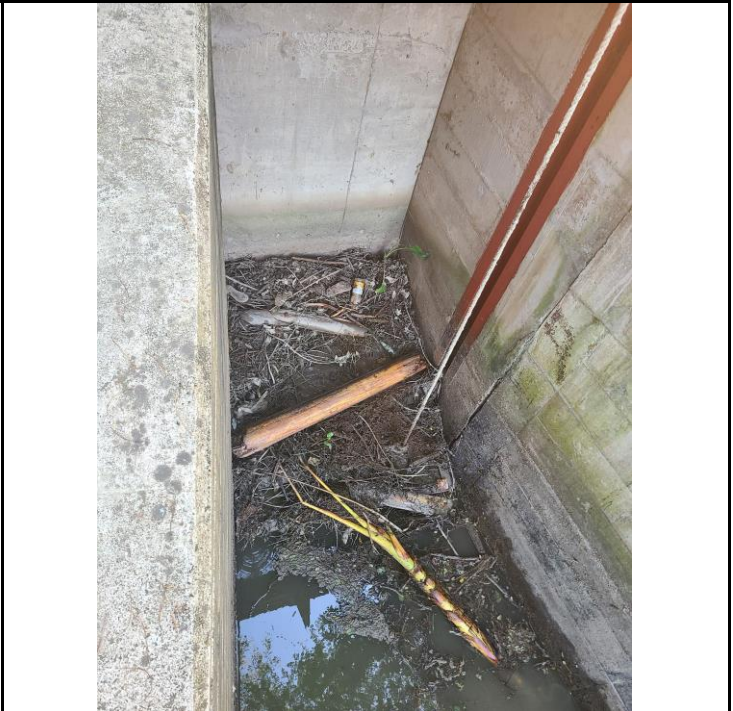
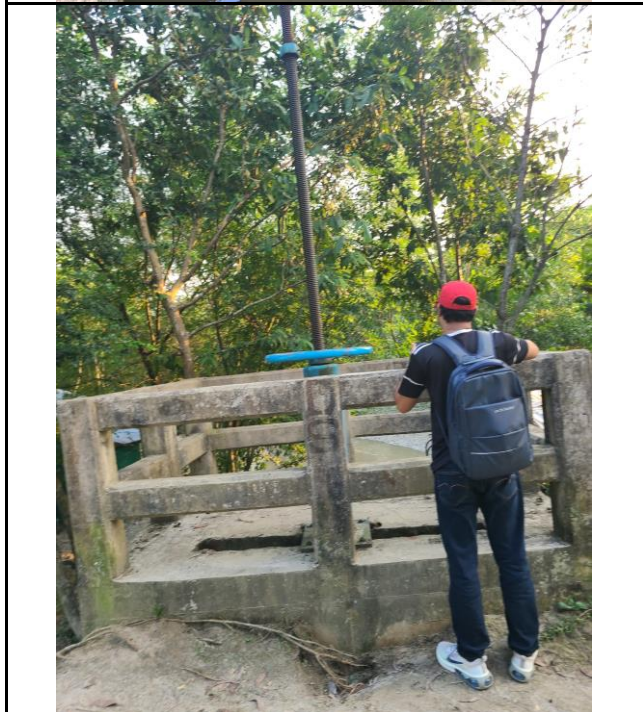
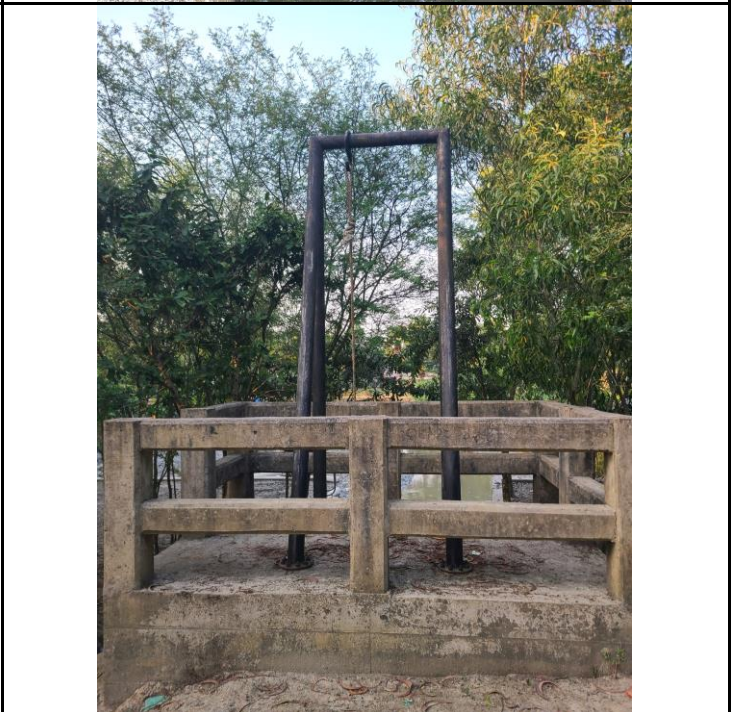
Date	Polder Name	Chainage (Km)	ID of Structure
23.11.2023	Polder 35/1	50.253	DS-16

**Observation:** Lift gate is open and operable. Flap gate is open but not operable because chain pulley block is missing. There are debris on the flap gate. Local People have tied the flap gate with steel rope at the railing. Lower portion of stem rod and lift gate are seen severely rusted. Nuts and bolts are rusted.

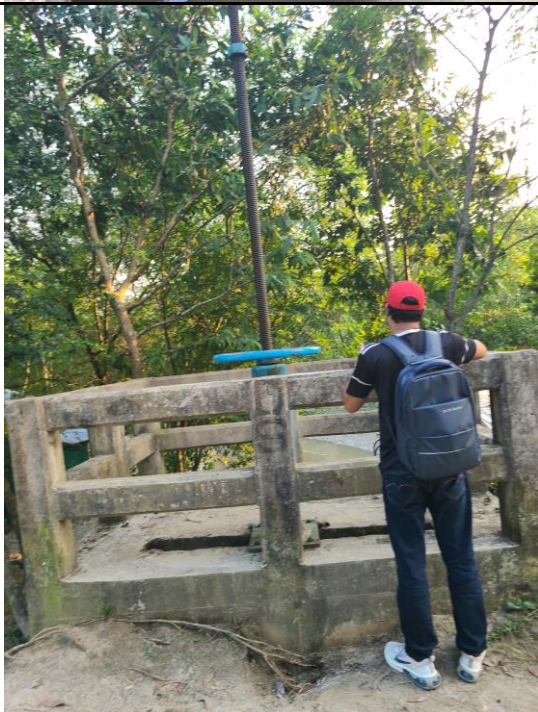
Date	Polder Name	Chainage (Km)	ID of Structure
23.11.2023	Polder 35/1	50.253	DS-17

**Observation:** Lift gate is open and operable and flap gate is open but not operable, because chain pulley block is missing. There are debris on the flap gate. Local People have tied the flap gate with steel rope at the hook. Lower portion of stem rod and lift gate are seen severely rusted, Nuts and bolts are rusted.

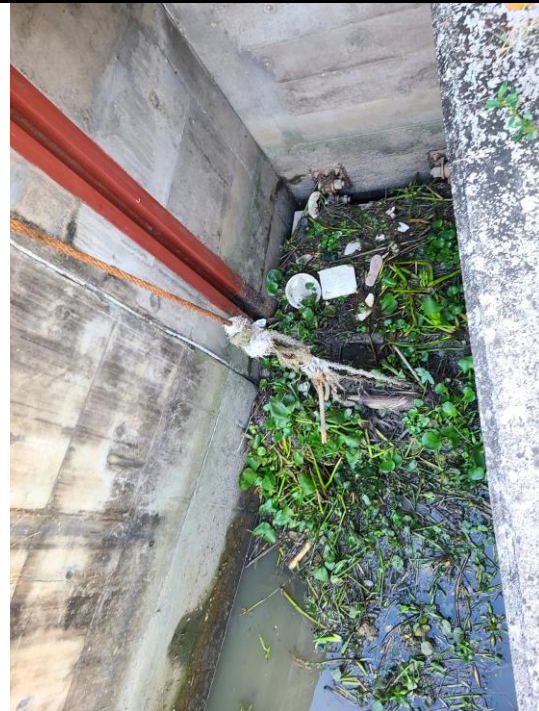
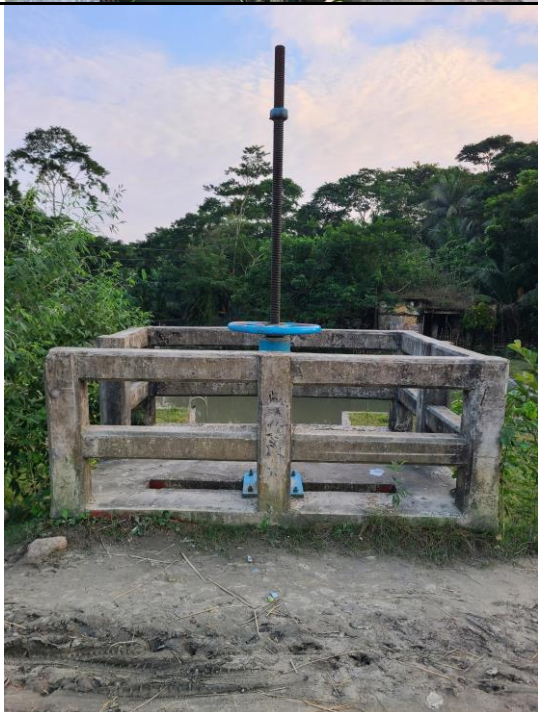
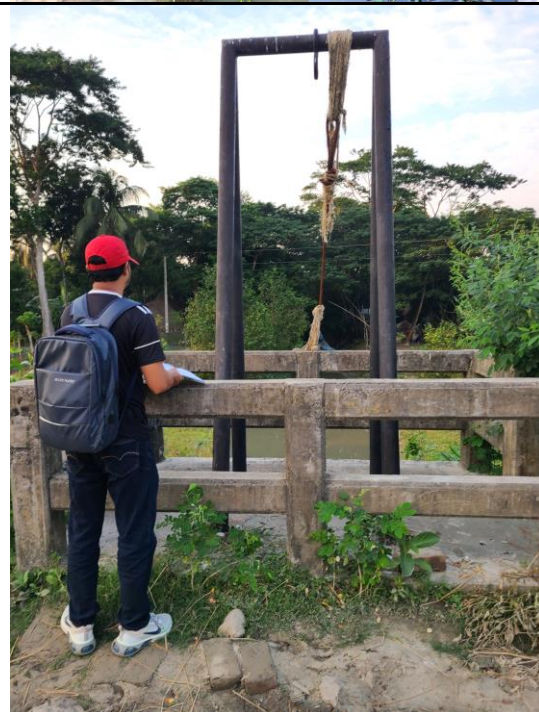
Date	Polder Name	Chainage (Km)	ID of Structure
23.11.2023	Polder 35/1	53.94	DS-13

**Observation:** Lift gate is open and operable and flap gate is also open but not operable, because chain pulley block is missing. There are debris in the both gates. Local People have tied the flap gate with steel rope at the hook. The lower portion of stem rod and lift gate are seen severely rusted. Nuts and bolts are rusted.

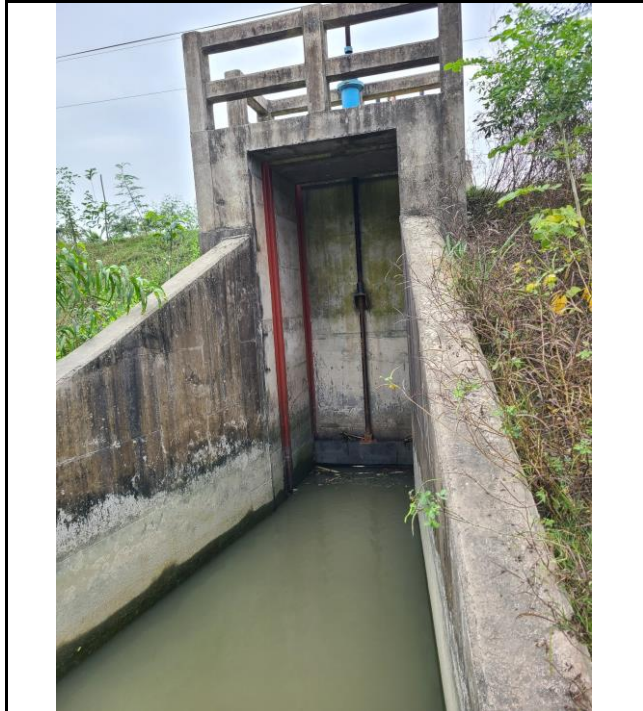
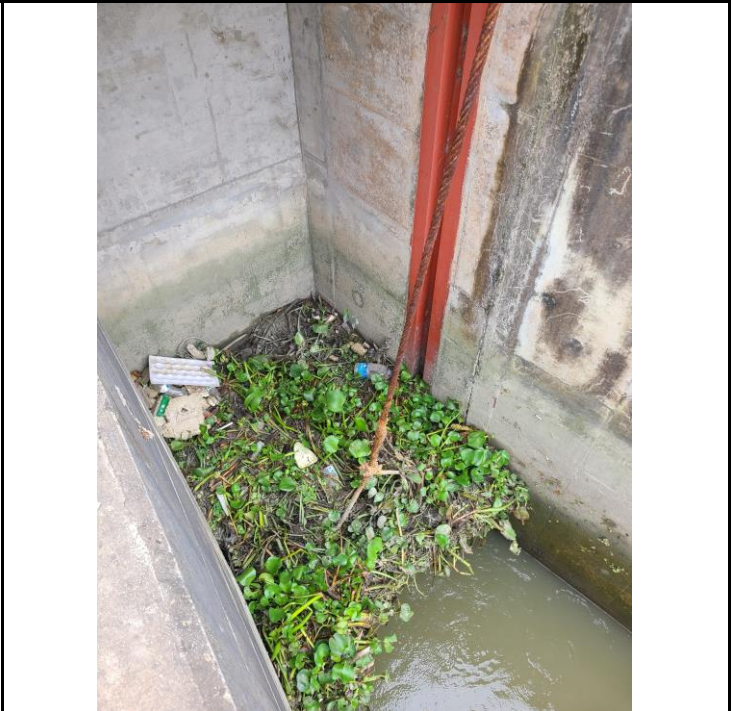
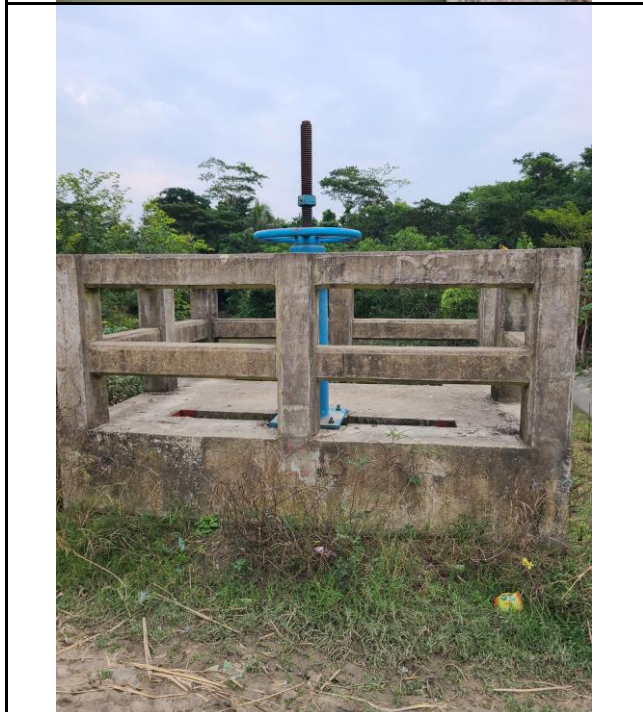
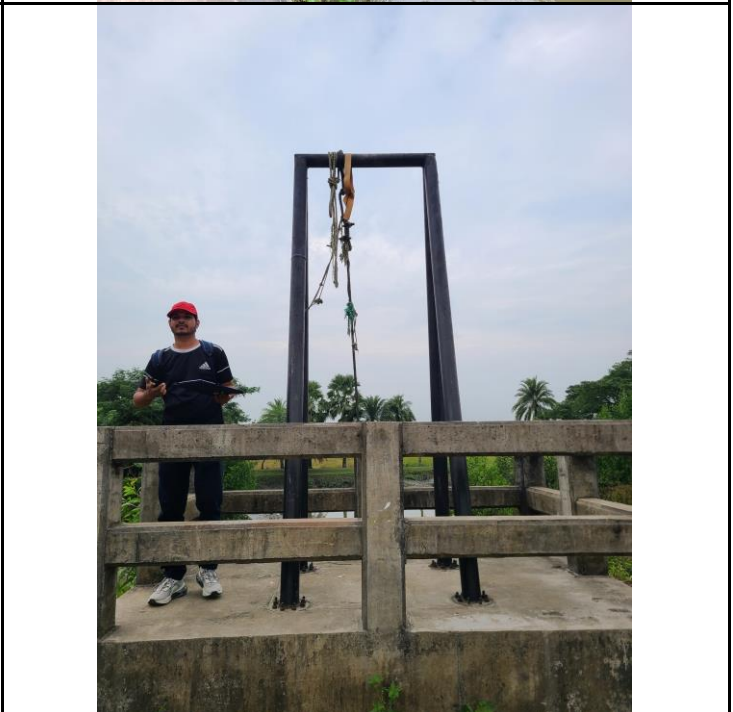
Date	Polder Name	Chainage (Km)	ID of Structure
23.11.2023	Polder 35/1	57.252	DS-14

**Observation:** Lift gate is closed and operable and flap gate is also open but not operable, Because chain pulley block is missing. There are debris on the flap gate. Local People have tied the flap gate with steel rope with at the hook. The lower portion of stem rod and lift gate are seen severely rusted. Nuts and bolts are rusted.

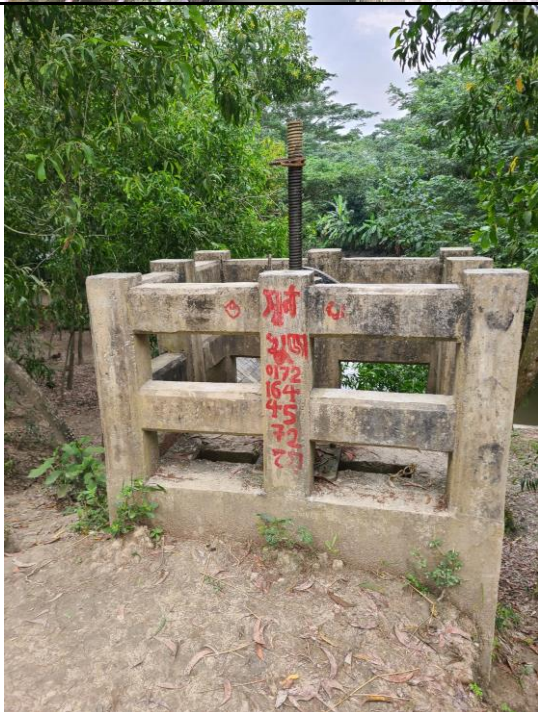
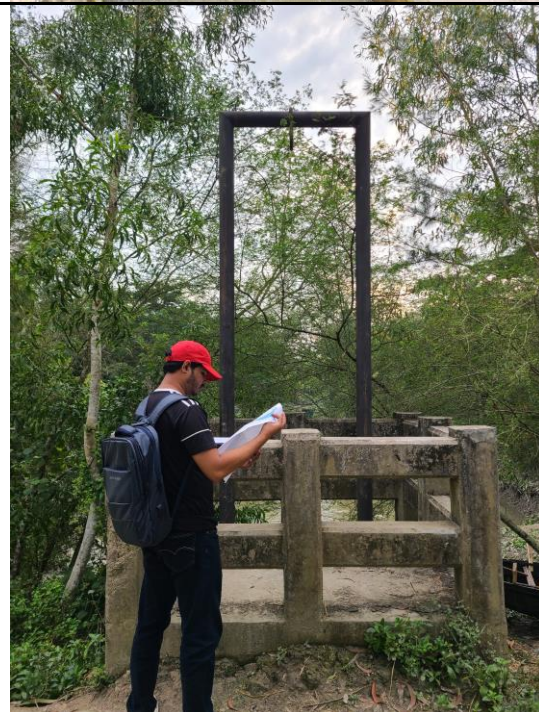
Date	Polder Name	Chainage (Km)	ID of Structure
21.11.2023	Polder 35/1	59.745	DS-15

**Observation:** Both gates are open but flap gate is not operable, because the chain pulley block is missing. There are debris and water hyacinth on the flap gate. Local People have tied the flap gate with steel rope at the railing. Lower portion of stem rod and lift gate are seen severely rusted. Nuts and bolts are rusted.

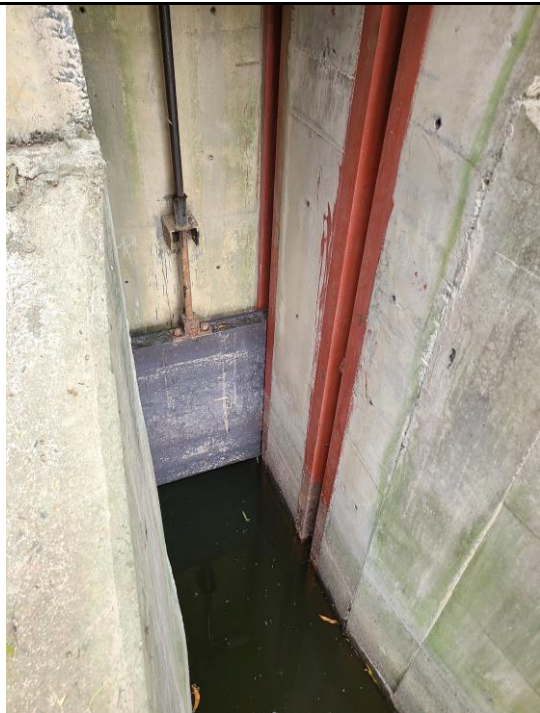
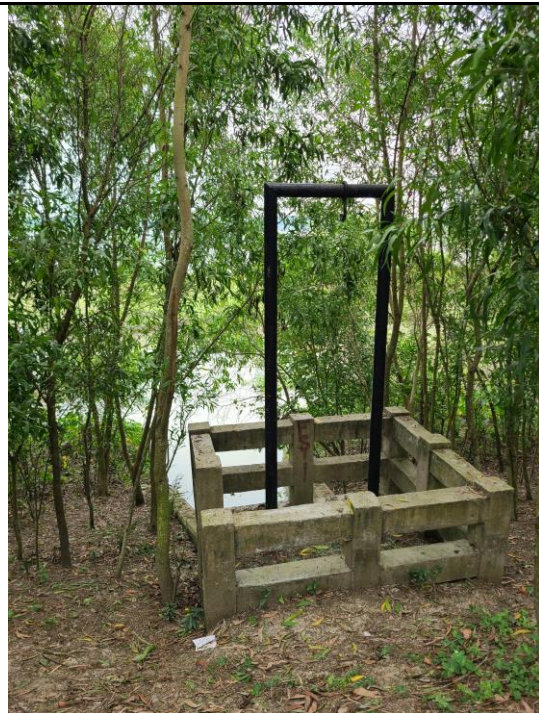
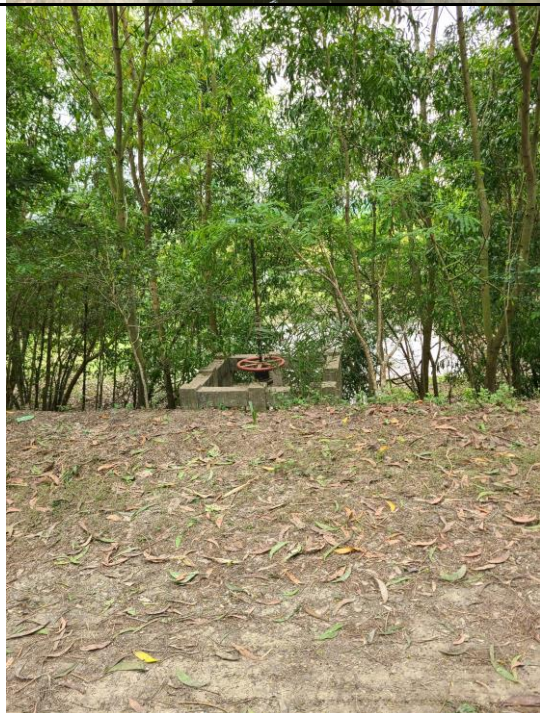
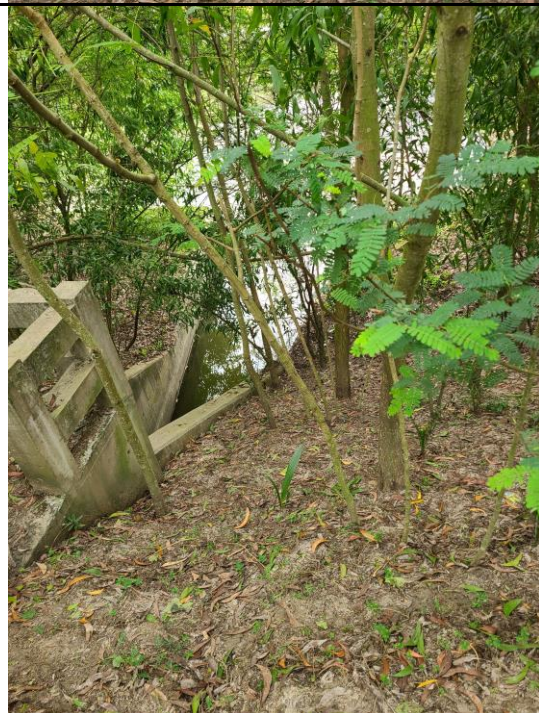
Date	Polder Name	Chainage (Km)	ID of Structure
21.11.2023	Polder 35/1	0.735	FS-1

**Observation:** Vertical lift gate is in good condition. The vertical lift gate is operable. Flap gate is in closed condition and flap gate is not operable because chain pulley block and steel rope is missing from flap gate.

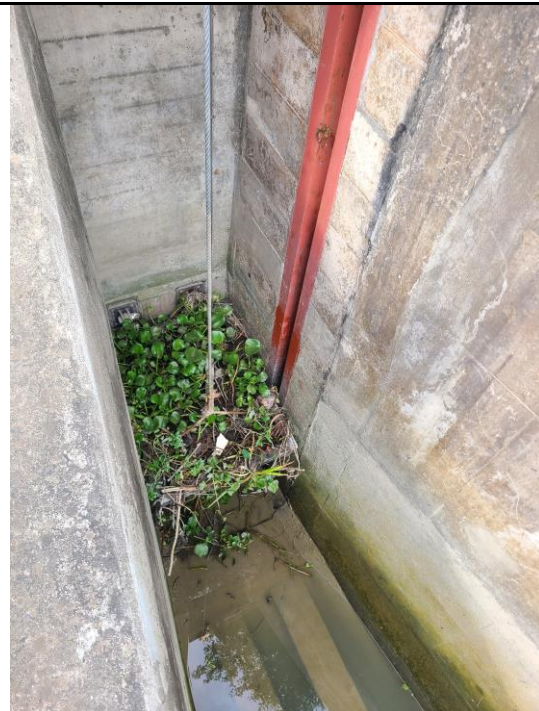
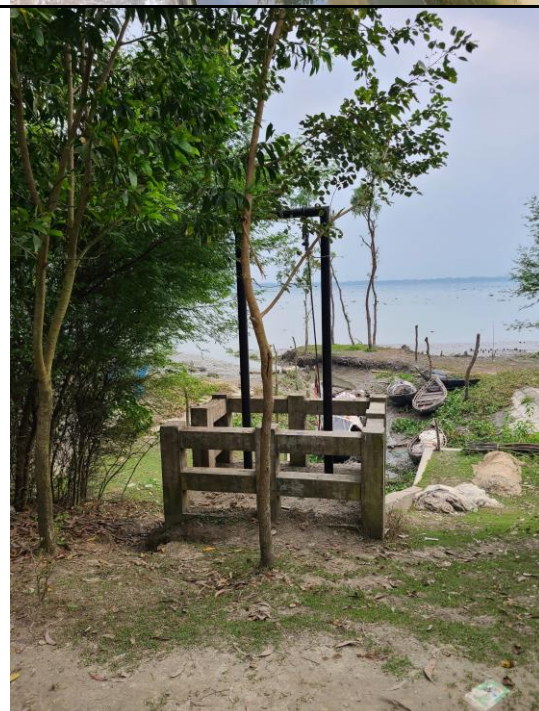
Date	Polder Name	Chainage (Km)	ID of Structure
21.11.2023	Polder 35/1	5.743	FS-2

**Observation:** Vertical lift gate is in good condition. The vertical lift gate is operable. Flap gate is open and flap gate is not operable because chain pulley block is missing. There are debries and water hyacinth on the flap gate. There is rust on the steel surface, stem rod and nuts and bolts.

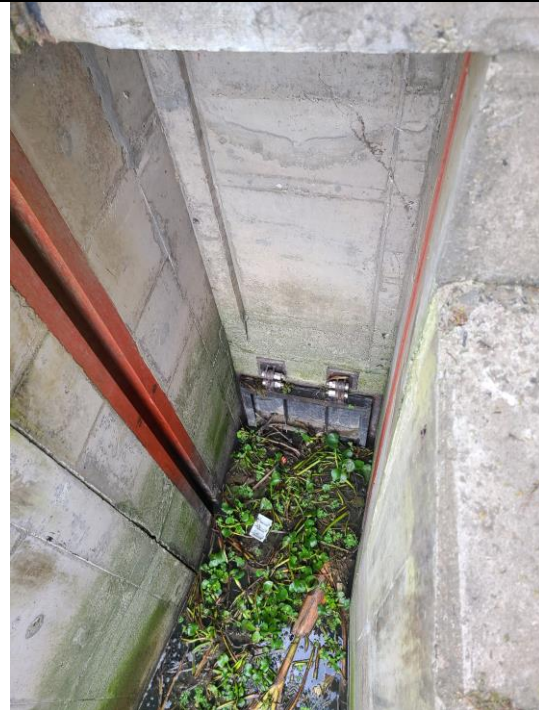
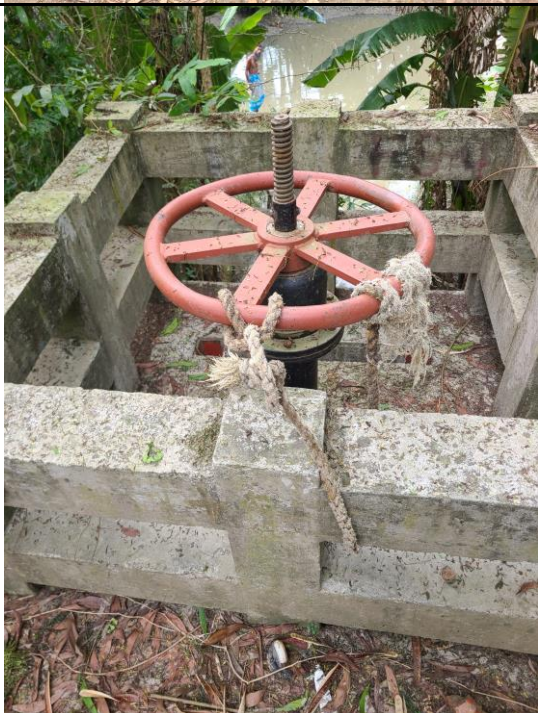
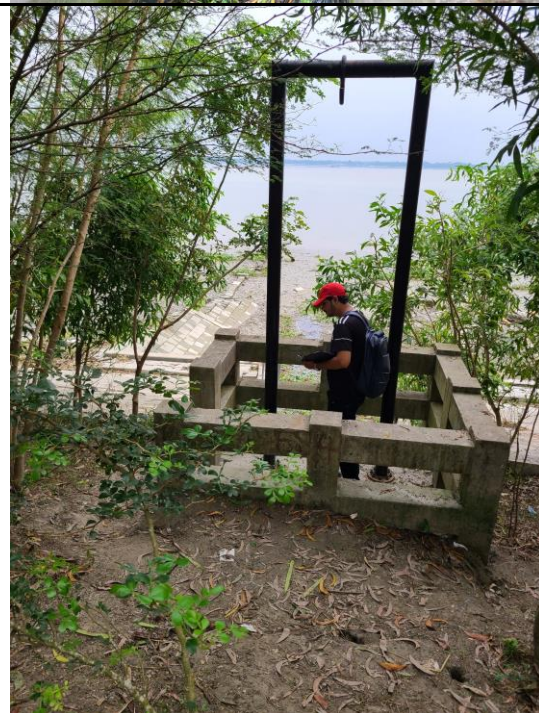
Date	Polder Name	Chainage (Km)	ID of Structure
21.11.2023	Polder 35/1	9.44	FS-4

**Observation:** Vertical lift gate is in good condition. The vertical lift gate is operable but we could not take lift gate photo for bush beside the wing wall of the sluice. Flap gate is closed and flap gate is not operable because Chain pulley block is missing . There are debries and water hyacinth on the flap gate. There is rust on the steel surface, stem rod and nuts and bolts.

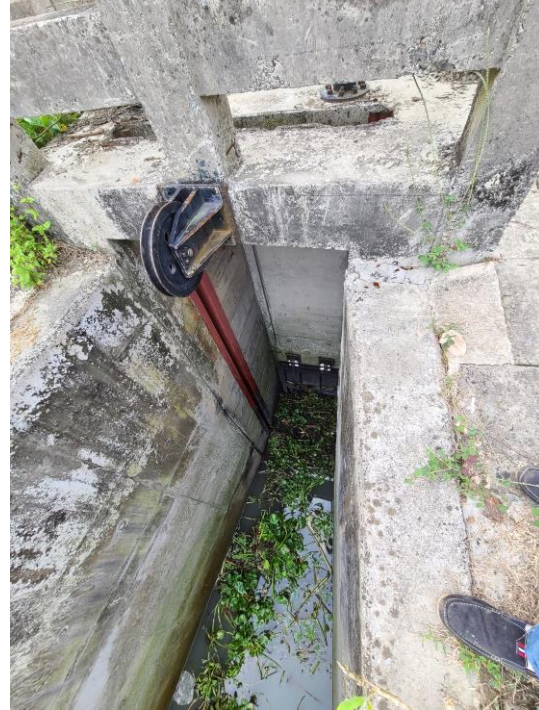
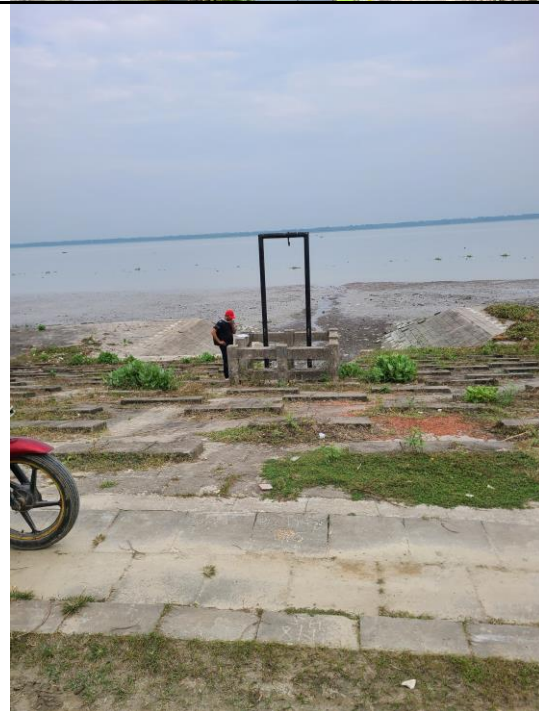
Date	Polder Name	Chainage (Km)	ID of Structure
21.11.2023	Polder 35/1	16.744	FS-5

**Observation:** Vertical lift gate is in good condition. The vertical lift gate is operable . Flap gate is closed and flap gate is not operable because Chain pulley block is missing from flap gate. There is debris and water hyacinth on the flap gate. There is rust on the steel surface, stem rod and nuts and bolts.
