# Polder 35/1

Field Visit Report

tareq islam  
[COMPANY NAME]

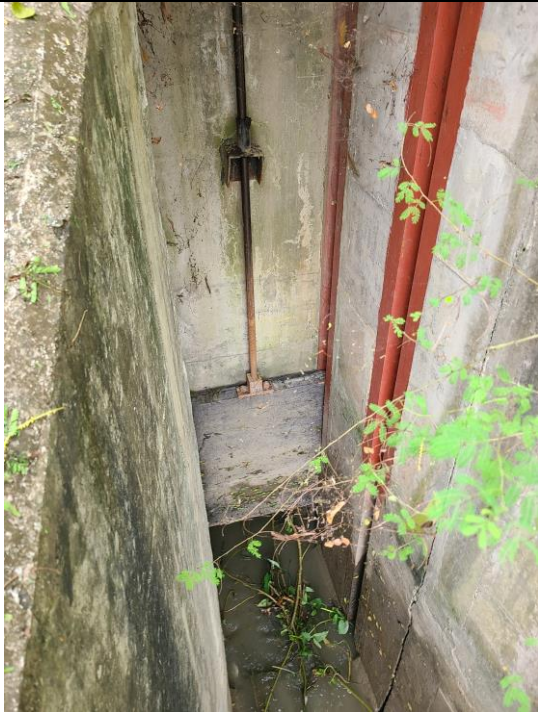
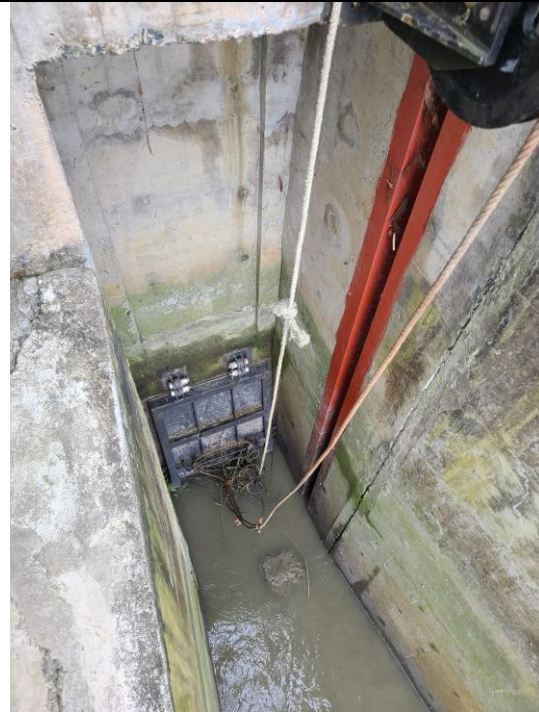
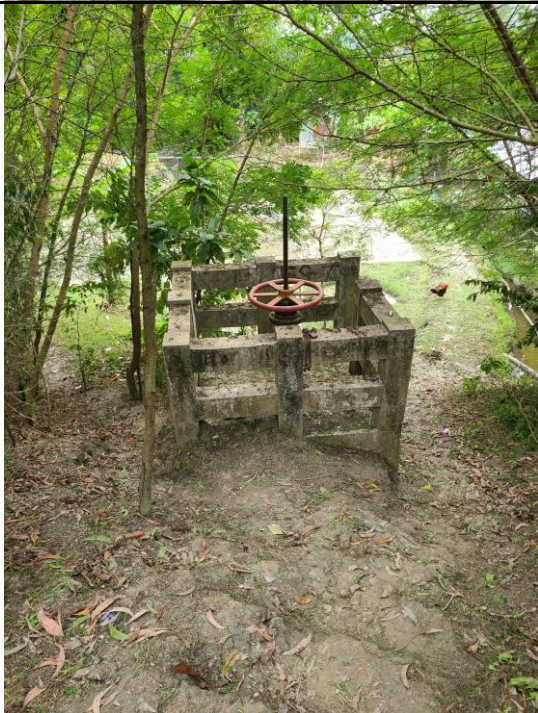
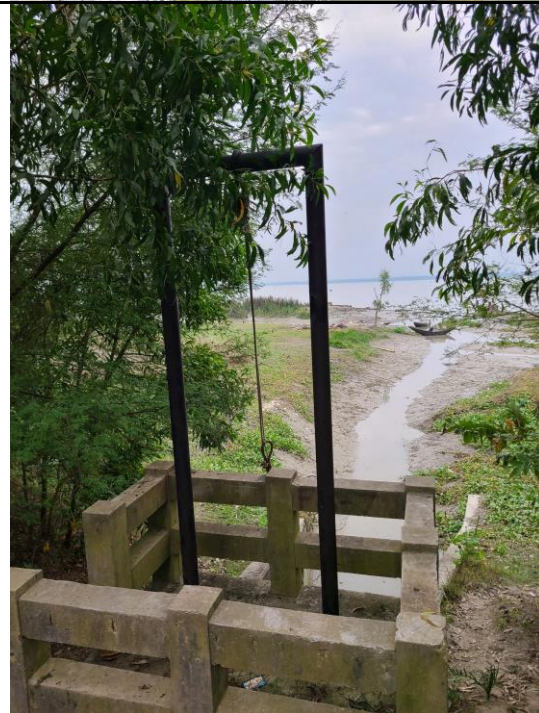
Date	Polder Name	Chainage (Km)	ID of Structure
21.11.2023	Polder 35/1	20.214	FS-7

**Observation:** Vertical lift gate is in good condition. The vertical lift gate is operable . Flap gate is closed and flap gate is not operable because Chain pulley block is missing from flap gate. There is debries and water hyacinth on the flap gate. There is rust on the steel surface, stem rod and nuts and bolts.

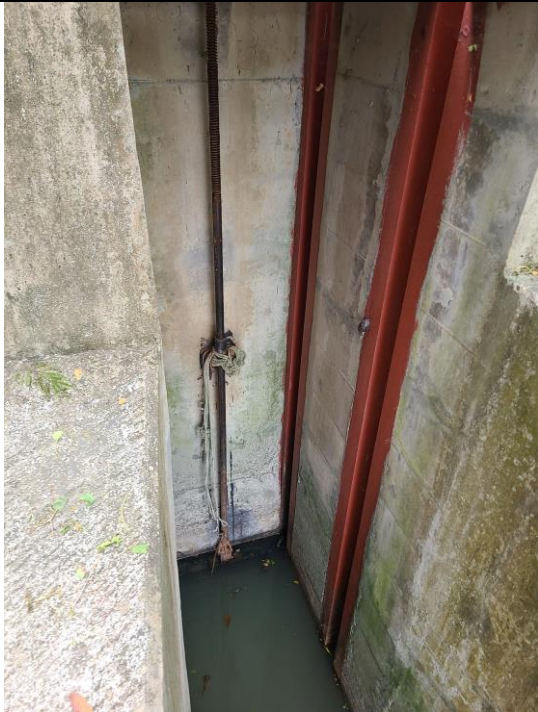
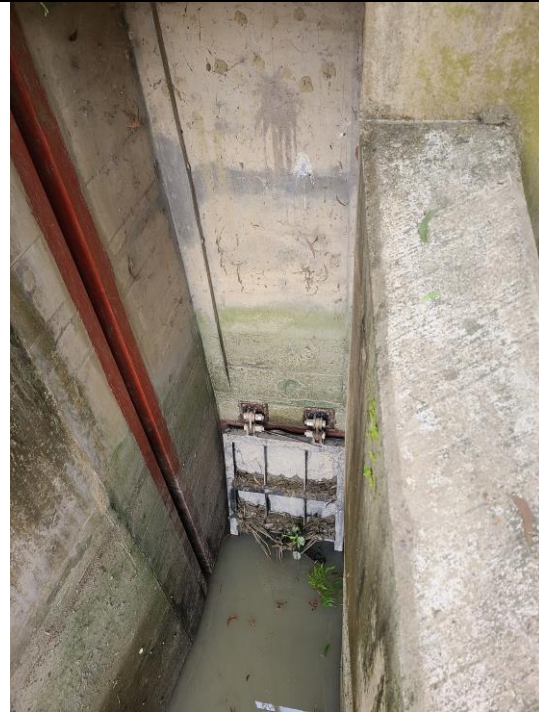
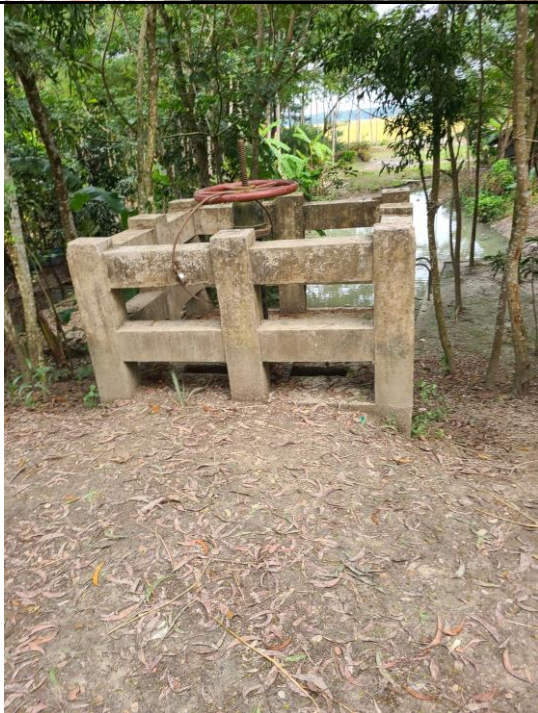
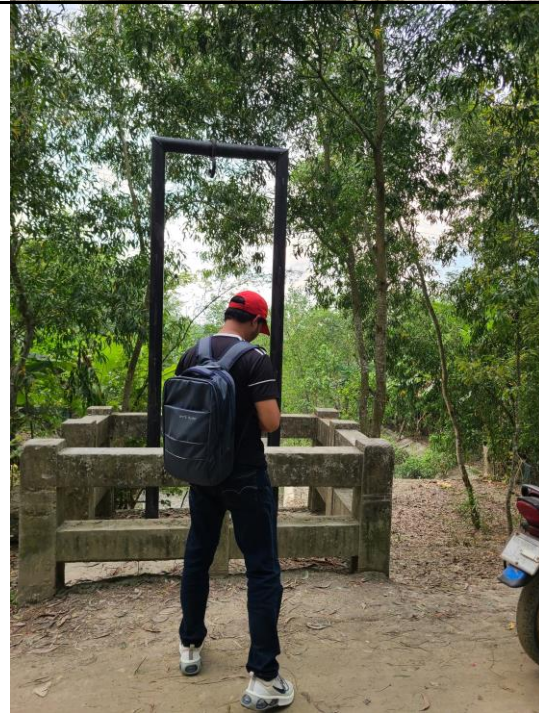
Date	Polder Name	Chainage (Km)	ID of Structure
23.11.2023	Polder 35/1	30.71	FS-7

**Observation:** Vertical lift gate is in good condition. The vertical lift gate is operable . Flap gate is closed and flap gate is not operable because Chain pulley block is missing from flap gate. There are debris and water hyacinth on the flap gate. There is rust on the steel surface, stem rod and nuts and bolts.

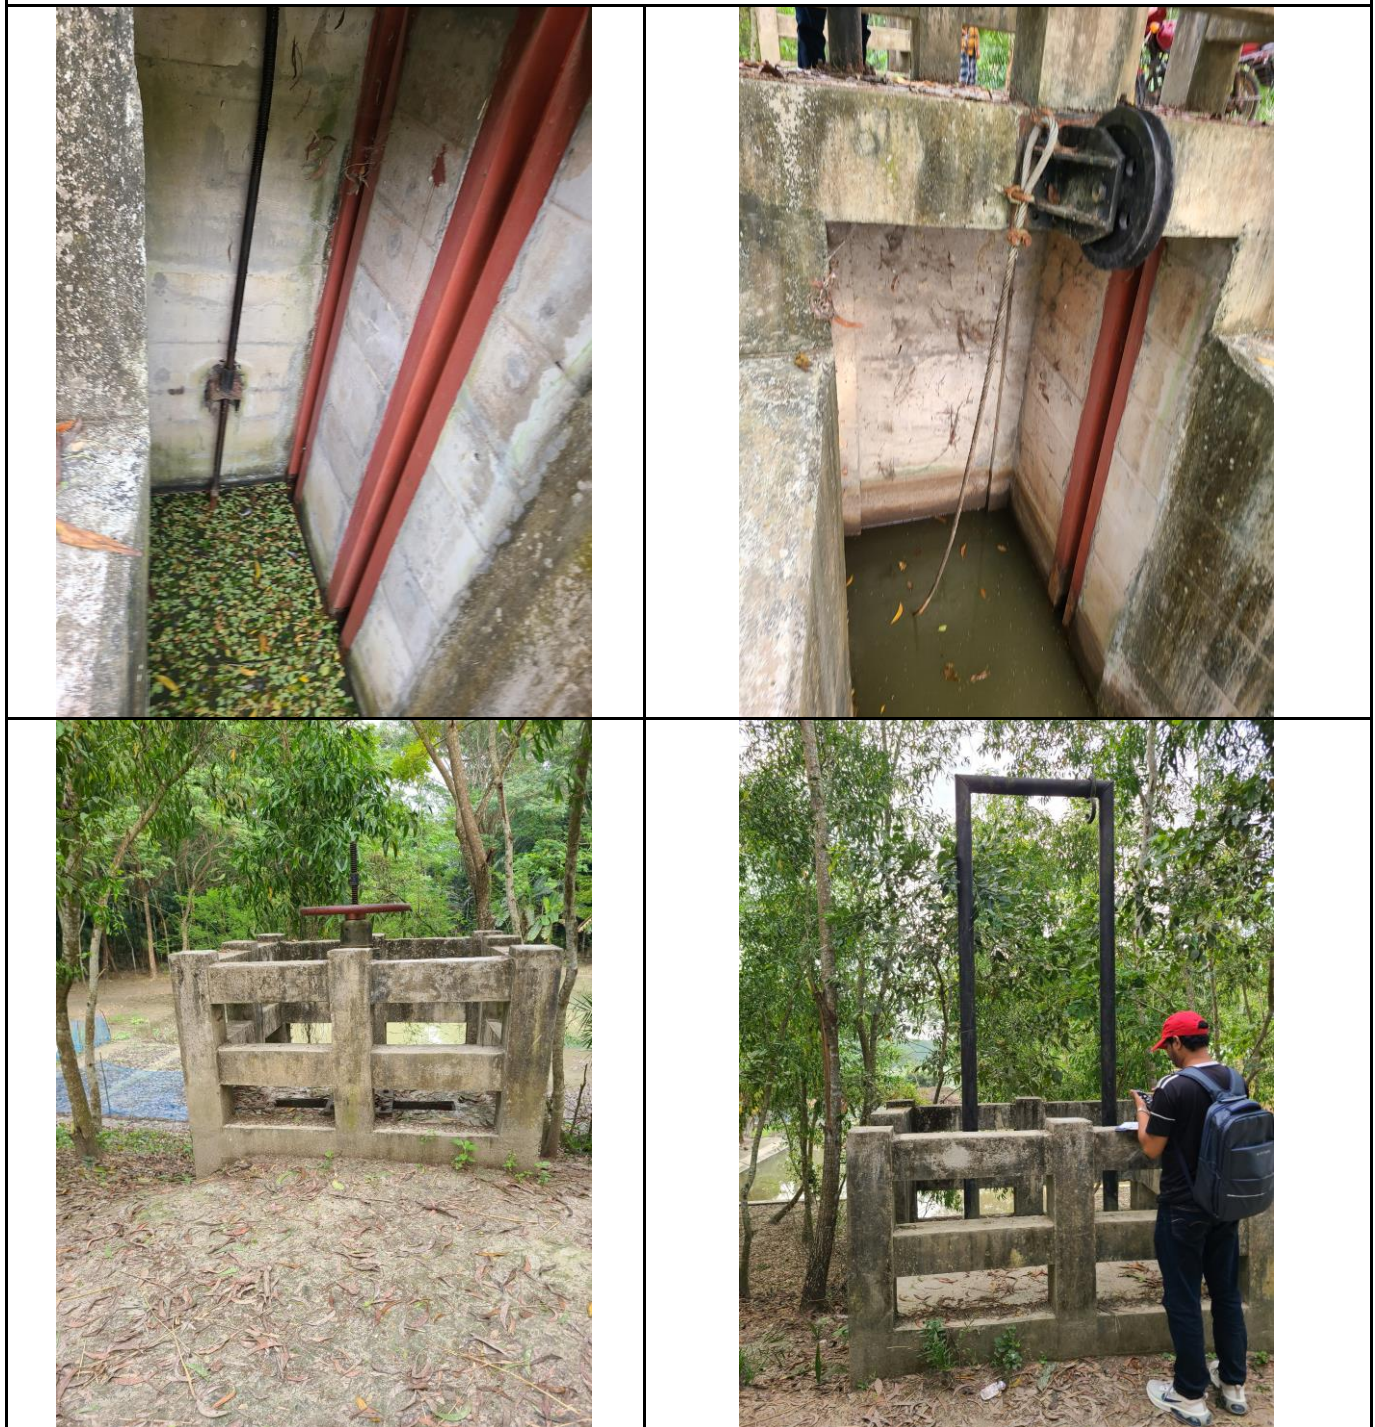
Date	Polder Name	Chainage (Km)	ID of Structure
23.11.2023	Polder 35/1	31.821	FS-12

**Observation:** Vertical lift gate is in good condition. The vertical lift gate is operable . Flap gate is closed and flap gate is not operable because Chain pulley block is missing. Flap gate is under water. There are debries and water hyacinth. There is rust on the steel surface, stem rod and nuts and bolts.

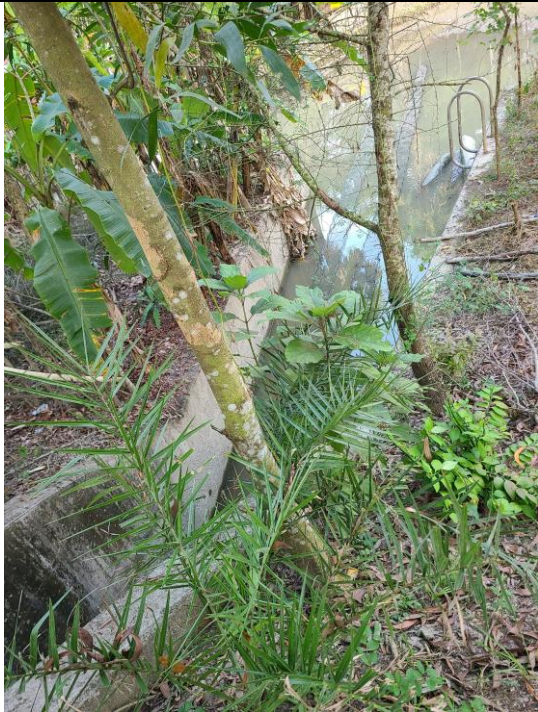
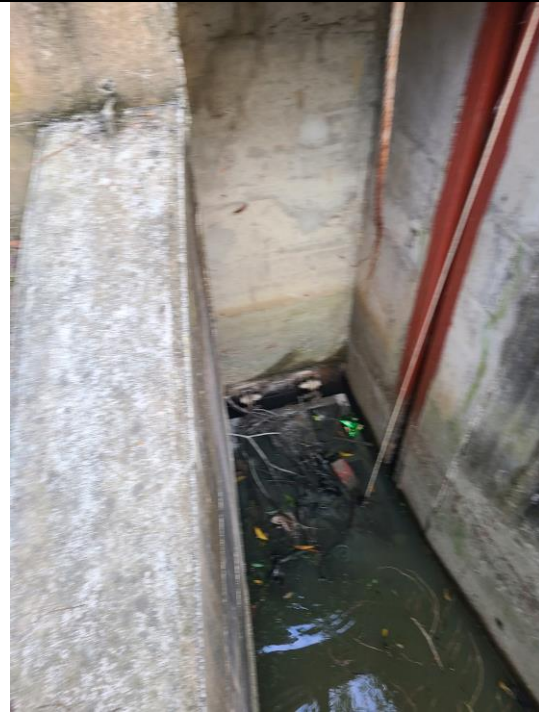
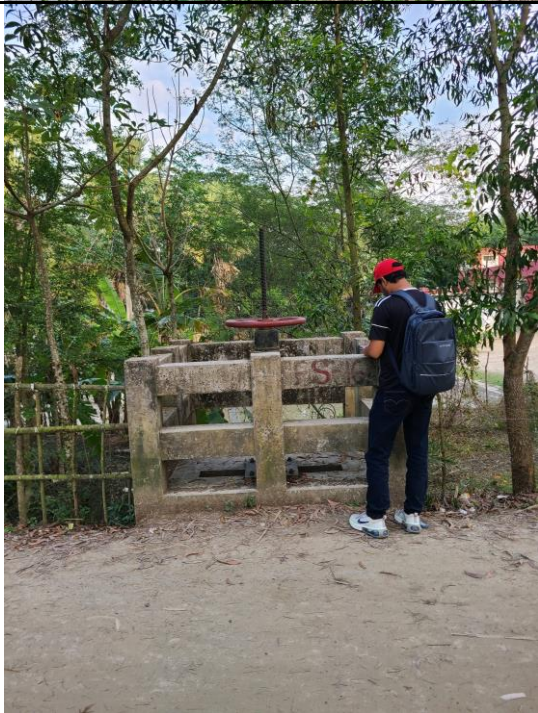
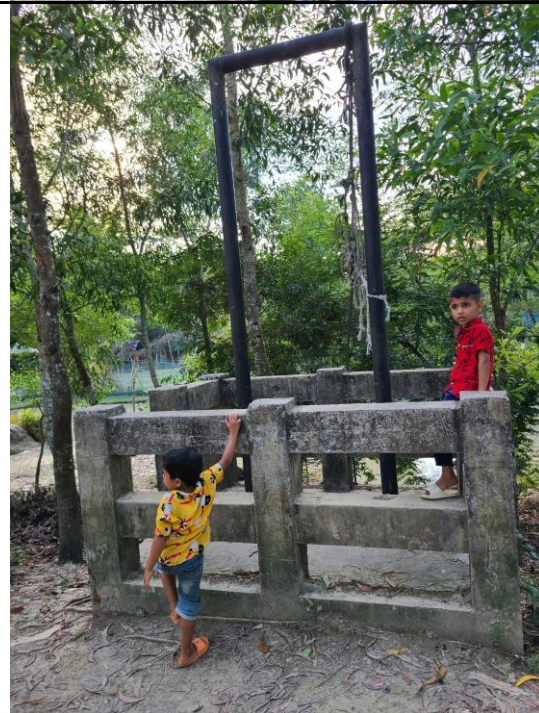
Date	Polder Name	Chainage (Km)	ID of Structure
23.11.2023	Polder 35/1	42.808	FS-16

**Observation:** Vertical lift gate is in good condition. The vertical lift gate is operable . Flap gate is open and flap gate is not operable. Flap gate is under water . Chain pulley block is missing from flap gate. There are debries and water hyacinth. There is rust on the steel surface, stem rod and nuts and bolts.

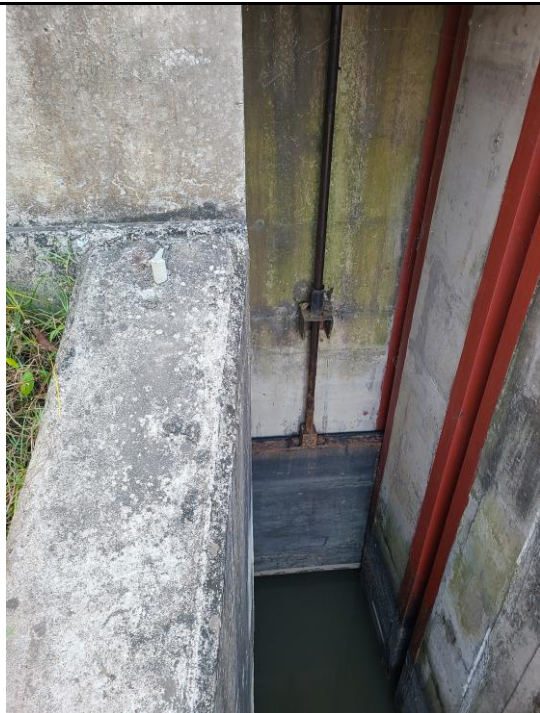
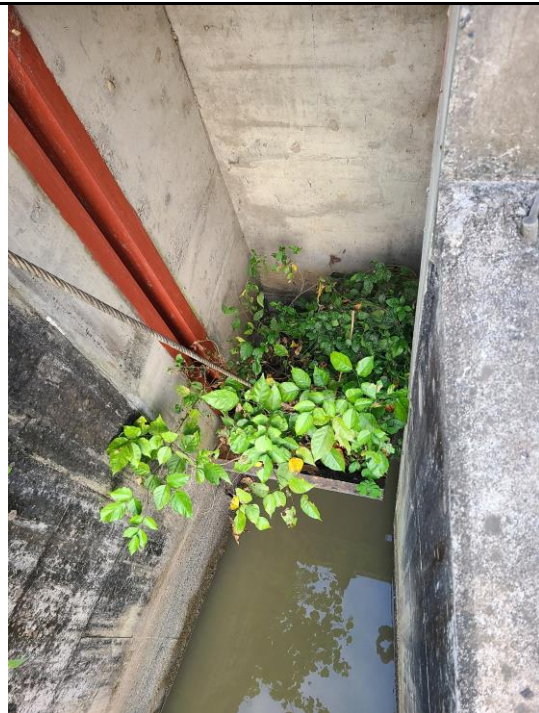
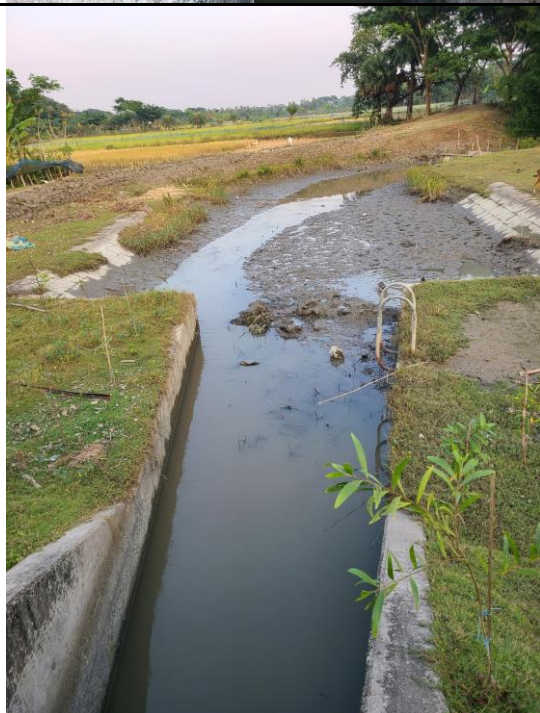
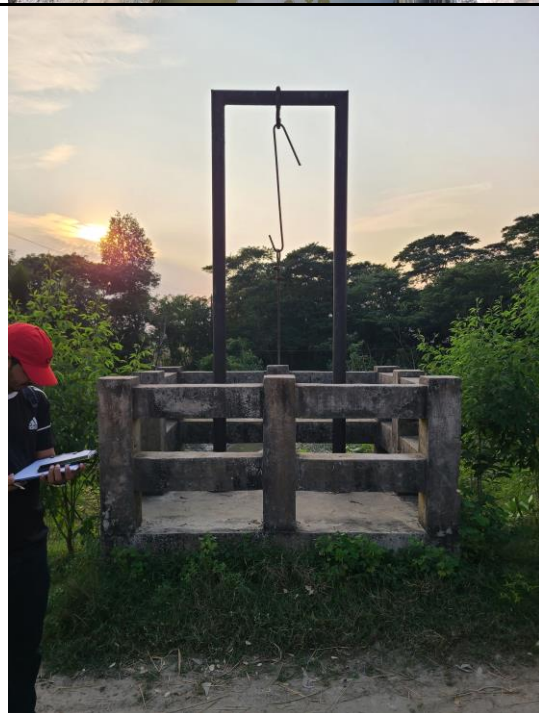
Date	Polder Name	Chainage (Km)	ID of Structure
23.11.2023	Polder 35/1	51.4	FS-17

**Observation:** Vertical lift gate is in good condition. The vertical lift gate is operable . Flap gate is open and flap gate is not operable because Chain pulley block is missing. There are debries and water hyacinth. There is rust on the steel surface, stem rod and nuts and bolts.

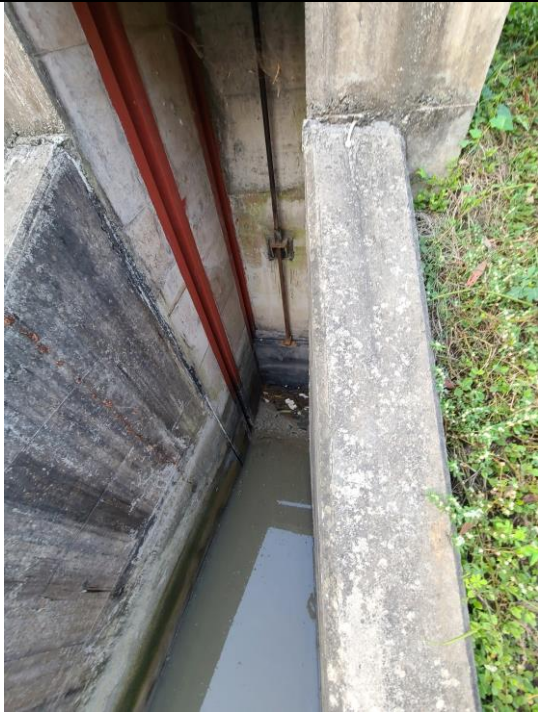
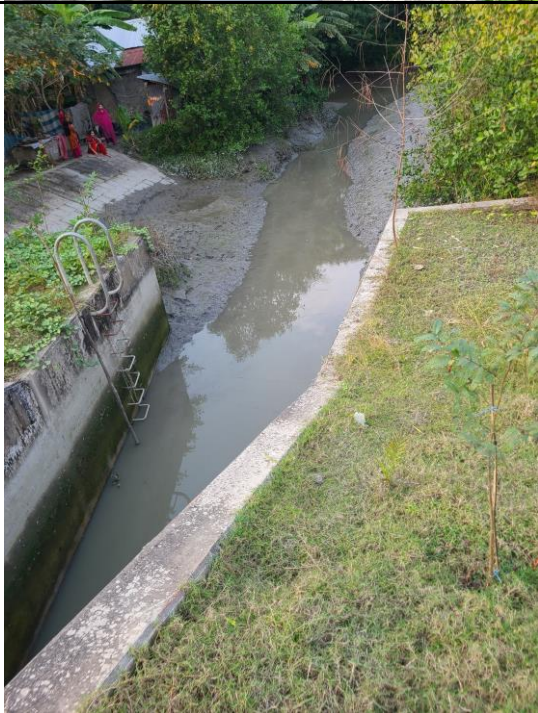
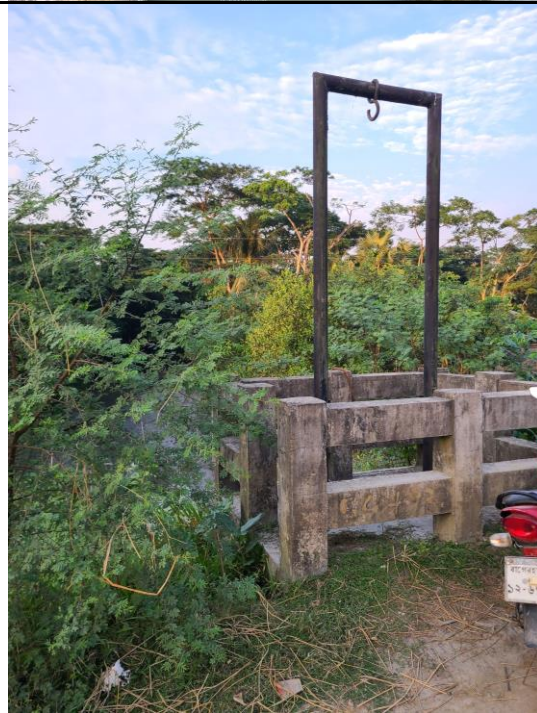
Date	Polder Name	Chainage (Km)	ID of Structure
23.11.2023	Polder 35/1	55	FS-18

**Observation:** Vertical lift gate is in good condition and closed. The vertical lift gate is operable . Flap gate is open and flap gate is not operable because Chain pulley block is missing. There are debris and water hyacinth. There is rust on the steel surface, stem rod and nuts and bolts.

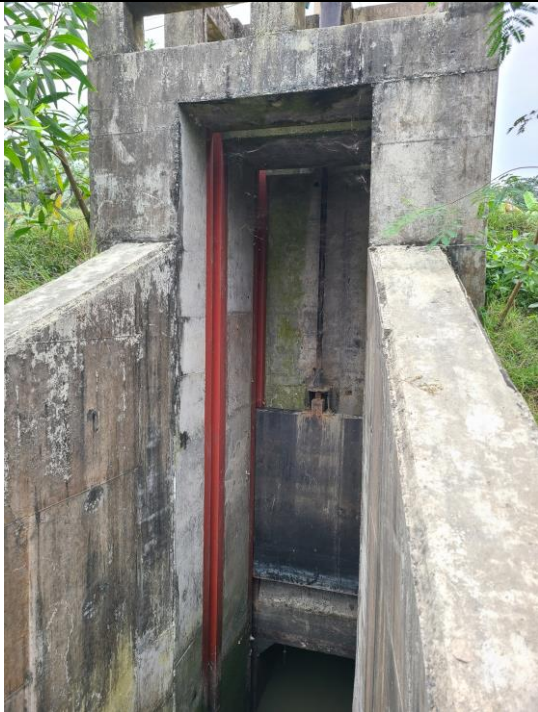
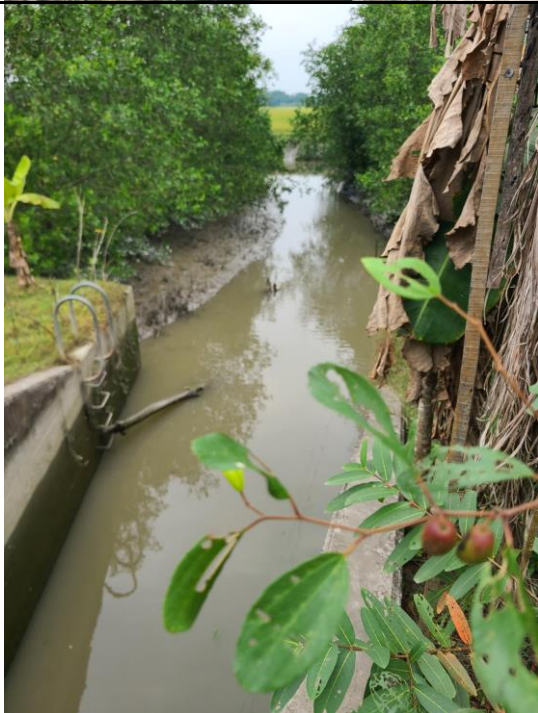
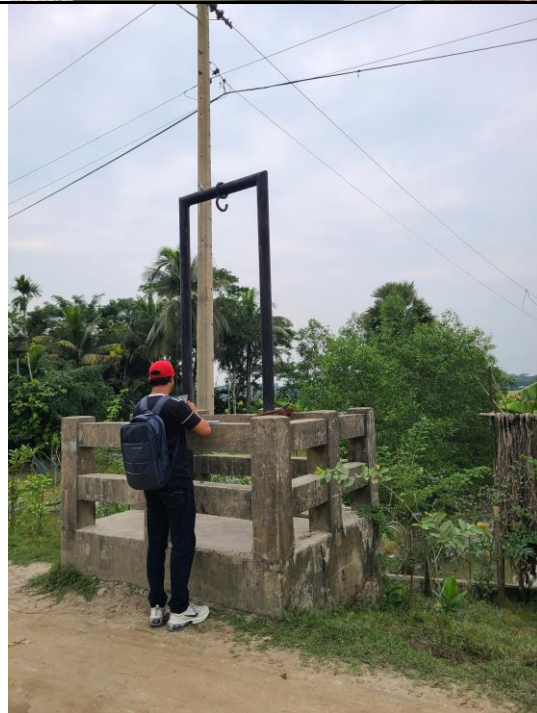
Date	Polder Name	Chainage (Km)	ID of Structure
23.11.2023	Polder 35/1	56	FS-19

**Observation:** Vertical lift gate is in good condition and open. The vertical lift gate is operable . Flap gate is open and flap gate is not operable because Chain pulley block is missing . There are debris and water hyacinth. There is rust on the steel surface, stem rod and nuts and bolts. Local People tie flap gate with a steel rope at the structure railings.

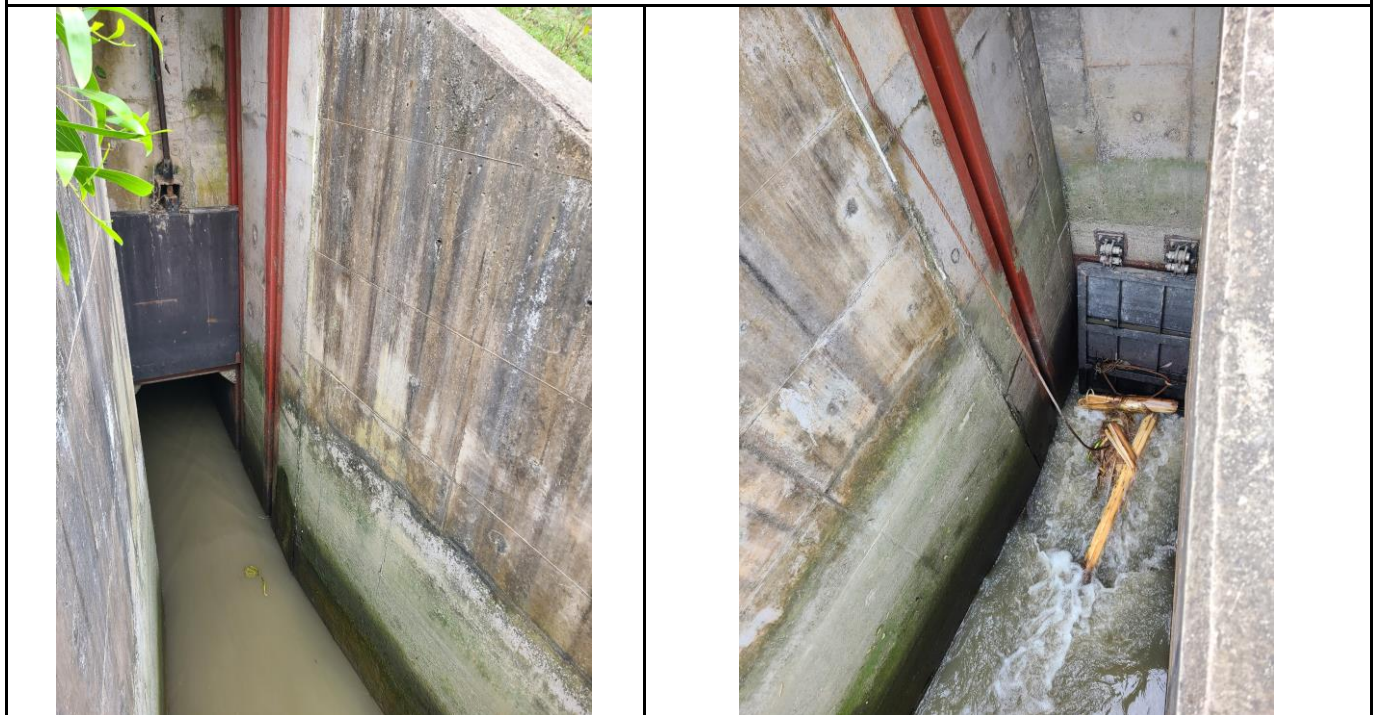
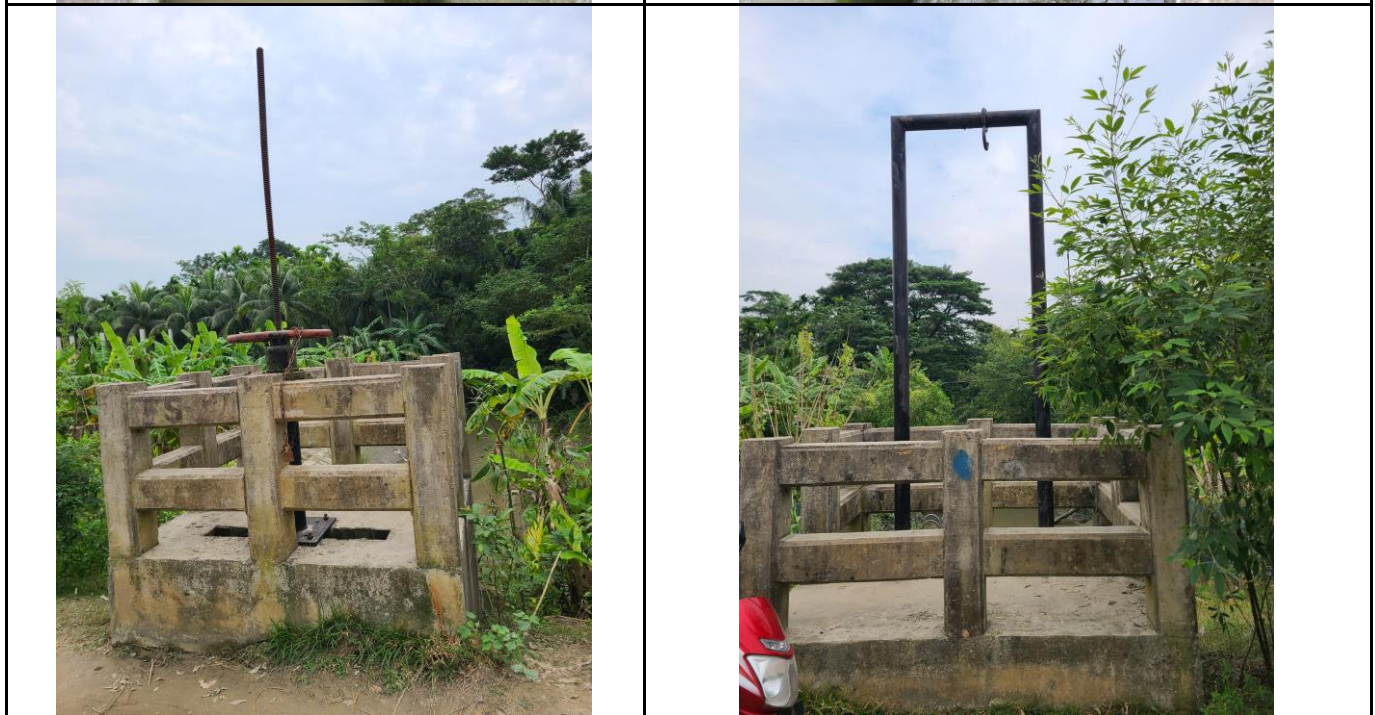
Date	Polder Name	Chainage (Km)	ID of Structure
23.11.2023	Polder 35/1	61.24	FS-22

**Observation:** Vertical lift gate is in good condition and open. The vertical lift gate is operable . Flap gate is closed and flap gate is not operable because Chain pulley block is missing. There are debris in the bottom of flap gate. There is rust on the steel surface, stem rod and nuts and bolts. Local People tie flap gate with a steel rope at the structure railings.
