Bangladesh Water Development Board (BWDB)

Coastal Embankment Improvement Project, Phase-1 (CEIP-1)

Bi-annual Environmental Monitoring Report for January - June 2022

August 2022

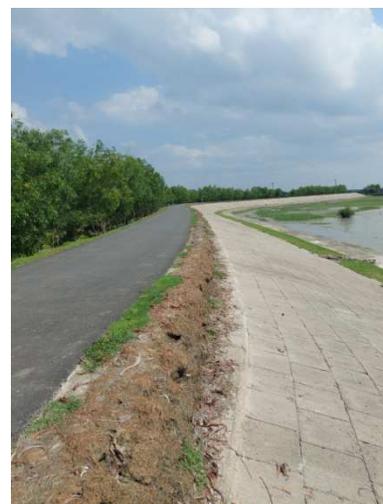
Figure 3: Protected polder due to CEIP-1 intervention

The physical work of polder 32, 33, 35/1 and 35/3 under Package-1 is almost completed. It is now observed that a remarkable positive Environmental changes have been taken place in the polder areas due to CEIP-1 interventions. We know Bangladesh is one of the most disasters prone and climate vulnerable countries in the world and especially the package-1 area is located beside 2 mighty rivers namely Boleshwar and Shibsra and in the vicinity of the Bay of Bengal. The area was often subjected to natural disaster which caused cyclones along with loss of lives, properties and suffered from severe deterioration of agricultural crops due to saline water intrusion. There are also experienced in river bank erosion which resulted loss of agricultural lands, lives and other hazards along with. The successful implementation of the project through its intervention such as sustainable flood embankment, proper drainage structure and adequate river bank protection work created opportunity of environmental friendly atmosphere all around the area. The areas have enormous improvement of agriculture production by reducing saline water intrusion and drain out excess water. The river bank protection work confirmed protection of lives and properties of the local communities. Indeed CEIP-1 interventions facilitate the production of sweet water crops, which will increase the cropping intensity in the polder areas.

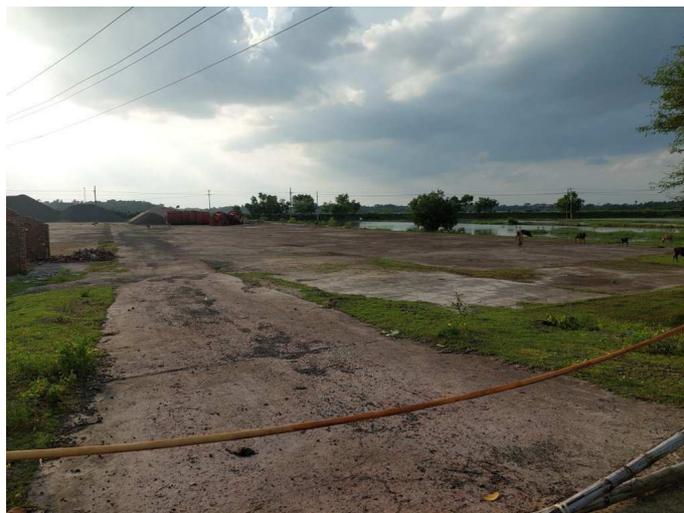
Figure 14: Pankhali yard no. 1 that needs to be demolished

Accordingly rental policy and environmental safeguard sense the sites need to be transformed to original condition. Among the leased sites, two sites that have already been demolished and handed over to land owners (sl nos. I & IV). Tafalbari yard (sl no. 4) is under demolishing and maximum portions are used for growing rice plants. Now the contract should be alert to demolish three yards (Pankhali yard nos. 1 & 2) and Daratana yard while the liability periods are terminated.

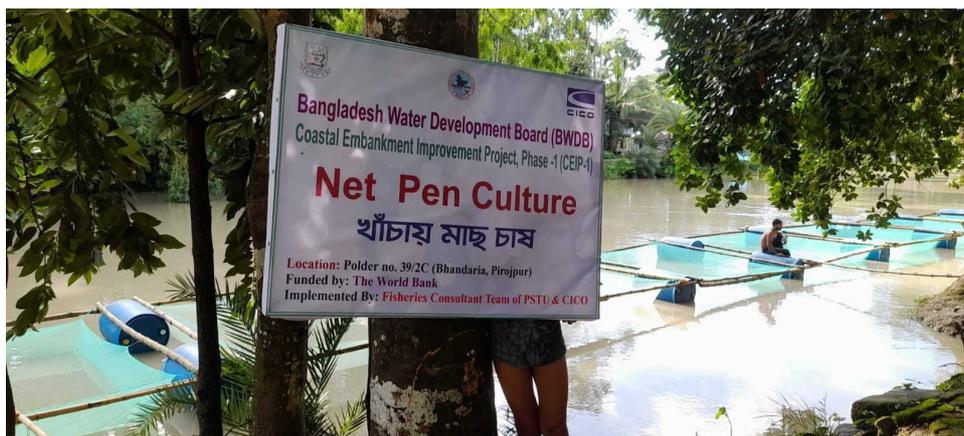
Figure 21: Net pen culture in P-39/2C

8.2.10 Pen Culture of fish production: Various preparations for establishing pen culture for enhanced fish production have been carried out by the Contractor, Package-2. For the purpose rearing of fish fingerlings as well as purchasing of net, bamboo has already been carried out under the supervision of Chairman, Department of Aquaculture, Patuakhali Science & Technology University. This activity is being implemented from the month of August, 2022.

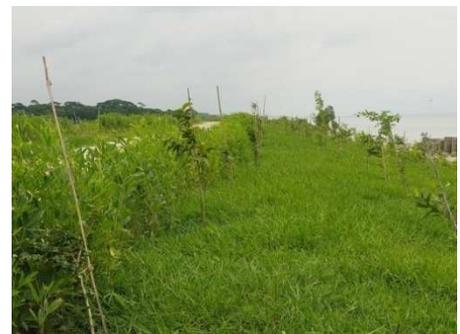
Figure 31: Good turfing in P-35/1

The contractors implemented the turfing works during the reporting period, which are in very good state and this will extend the embankment sustainability. The contract also sat with WMA to ensure their demand regarding sustainable water management during the on-going liability period. The contractor of package W-01 also implemented the related

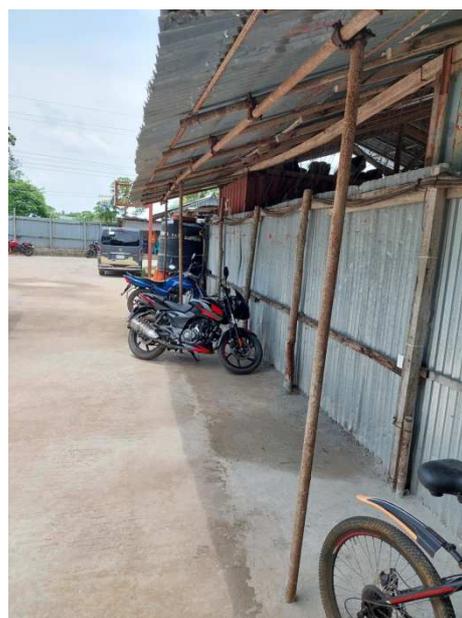
Figure 34: Designated parking in P-39/2C

work locations. They are maintaining the designated parking areas within the camp sites. Noise levels are monitored monthly and results are reported in the consultants monthly progress report (MPR). Noise levels in few locations where it exceeds 60 dBa (permissible for mixed area); the Contractor has established noise barrier and shifting facility of workers which have been checked by the Environmental Specialist of PMU, DDCS&PMS Consultants and Third Party M&E Consultants during their field visits.
