Bangladesh Water Development Board (BWDB)

Coastal Embankment Improvement Project, Phase-1 (CEIP-1) 2nd Revised

Bi-annual Environmental Monitoring Report for July - December 2022

October 17, 2023

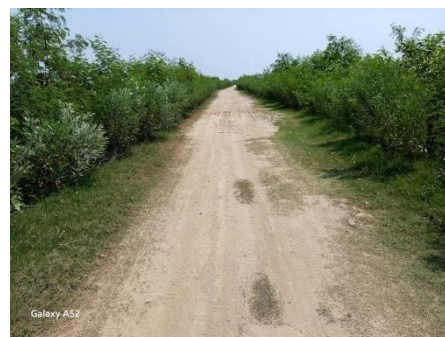
Figure 3: Protected polder due to CEIP-1 intervention in P-35/1

The physical work of polder 32, 33, 35/1 and 35/3 under Package-1 has been completed (97.52%). It is now observed that a remarkable positive Environmental changes have taken place in the polder areas due to CEIP-1 interventions. We know Bangladesh is one of the most disasters prone and climate vulnerable countries in the world and especially the package-1 area is located beside 2 mighty rivers namely Boleshwar and Shibsha and in the vicinity of the Bay of Bengal. The area was often subjected to natural disaster which caused cyclones along with loss of lives, properties and suffered from severe deterioration of agricultural crops due to saline water intrusion. There are also experienced in river bank erosion which resulted loss of agricultural lands, lives and other hazards along with. The successful implementation of the project through its intervention such as sustainable flood embankment, proper drainage structure and adequate river bank protection work created opportunity of environmental friendly atmosphere all around the area. The areas have enormous improvement of agriculture production by reducing saline water intrusion and drain out excess water. The river bank protection work confirmed protection of lives and properties of the local communities. Indeed CEIP-1 interventions facilitate the production of sweet water crops, which has increased the cropping intensity in the polder areas. The land is ready for growing intensive as well as various crops. The recruited NGOs (five NGOs for ten Polders) motivated the

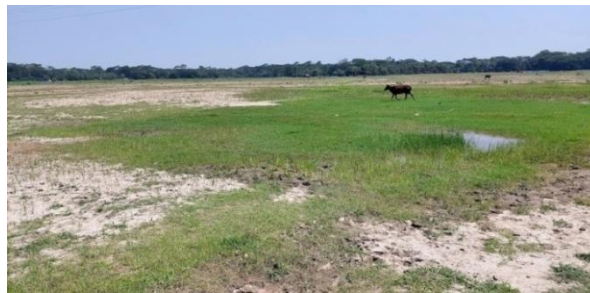
Figure 13: Demolished CC block yard of P-35/1

Two automated CC plants (established in earlier for manufacturing of CC blocks) have been demobilized from Pankhali CC block manufacturing worksite of Polder 32 along with all equipment and most of the housing structures. But some concrete and brick works, toilets and an office building yet to be cleared as required to be converted to the farmland (the pre-project status). There is no pending decommissioning issue in Polder 33. In Tafalbari automated CC block manufacturing yard, a major area of the worksite has been converted to farmland having a high quality of demobilization/decommissioning. Out of total 3,000 square meters 2,000 square meters have been cleared and remaining 1000 sq. meters is occupied for maintaining the office, workshop area and some equipment and toilet facilities. They are in a process of shifting various equipments to the Doratana site from where the materials are being disposed. There is no sign of demobilization of the worksite in the Daratana automated CC block manufacturing worksite of Polder 35/3, rather all equipment and vehicles have been stored in the worksite. Automated CC block manufacturing plant stopped production from December, 2021 and vehicles, equipment and construction materials from Pankhali (Polder 32) and Tafalbari (Polder 35/1) automated CC manufacturing plants have been dumped in site and they are being sold from this location.

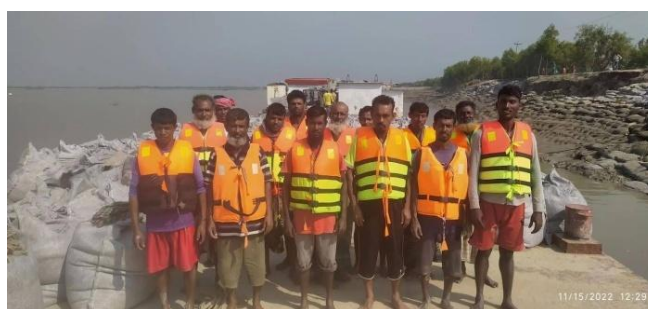
Figure 16: Safety arrangements for emergency works (P-32)

9.1.4 Safety arrangements for emergency works: The contractor of Package W-01 area is implementing some emergency works in Package 1 area during defect liability period. The Package-1 contractor has been suggested to carry out their emergency works following the code of EHS compliance as they followed during construction period done earlier. The works status is as follows:

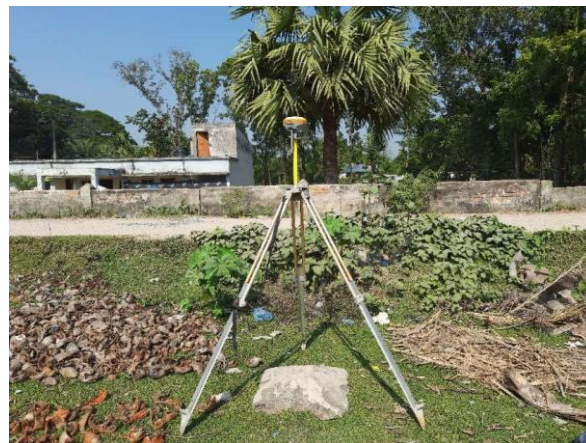
Figure 18: River erosion monitoring in Polder 39/2C

9.2.4 Submission of the methodology of River bank erosion monitoring work under Mitigation works (Package-2): The Contractor, Package-2, CEIP-1 has submitted methodology of River Bank erosion monitoring according contract agreement to BoQ item no-18 under Environmental Mitigation works as a response to our requirement. The methodology submitted has been reviewed and agreed upon by the DDCS&PMS Consultants to be followed in the specified works to be completed by the Contractor (Contractor has been informed of the issue by letter vide memo no. RDCOR_BC5883-100_Loo4163_JHL_MIP dated 29th December, 2022).

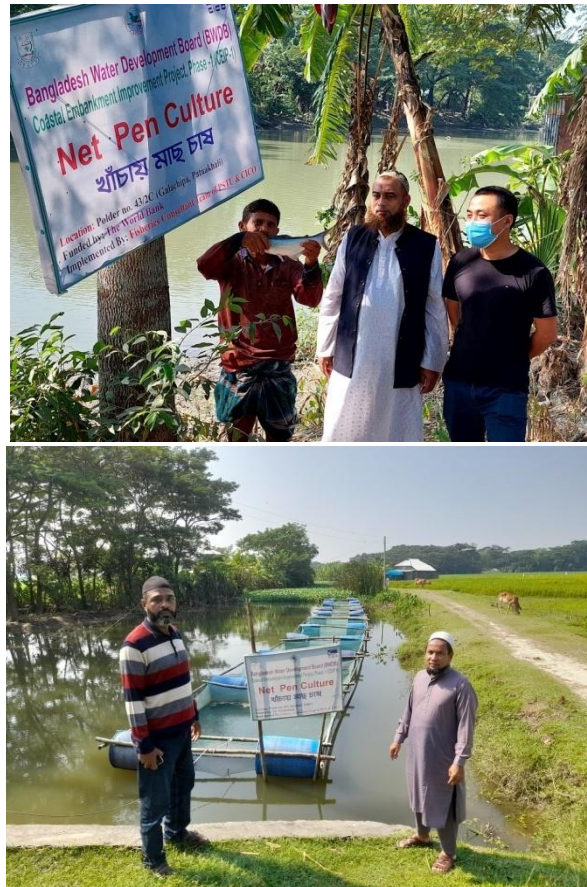
Figure 19: Net pen fish culture on excavated khal of CEIP-1

9.2.7 Net pen culture: Net pen culture were done in 6 polders to ensure the proper utilization of vast water bodies in this polder area without intervening the other uses of those water bodies and to create an alternative livelihood for the polder community. Net pen were setup in different lake such as Nadmula Khal (DS-12) in 39/2C, Charduani Bazar Khal (DS-4) in 40/2, Amajhuri Khal (DS-1) in 41/1, Golkhali Beribadh Khal (DS-3) in 43/2C, Dalbugonj High School Khal (DS-3) in 47/2, Barohar Khal (DS-3/3) in 48. 10 (ten) net pen of 10 ft x 10ft x 6ft were setup in each polder.

The netting materials are purchased from the factory. A finer meshed net of 0.5-meter height is attached to the upper inner side of cages to protect the floating feed pellets escaping out. A larger meshed (5 cm) net is used to cover the cages on top to protect from birds e.g. pelicans, eagles and others. As stocking size of fingerlings is 15-20 grams and stocking density was 500 fish per cage. Tilapia and pangas fish were stock in the cages. Floating feed was used in cage. Feeding was done twice daily to satiation level spreading over the water surface in each cage. During feeding the cages are not disturbed by any other activities.

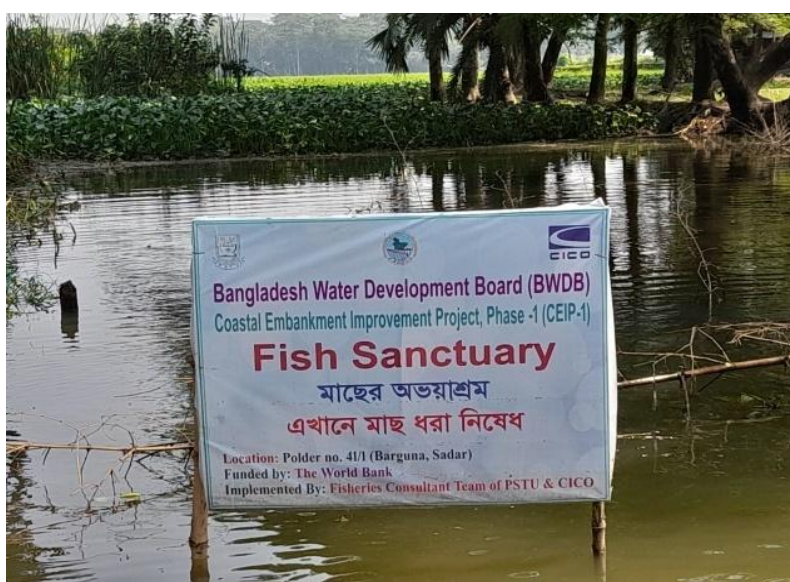
Figure 20: Construction of Fish sanctuaries in Pkg. 2 areas

9.2.8 Fish sanctuary: The abundance and distribution of fishes from different khals of polder area are decreasing day by day due to the environmental degradation and anthropogenic activities such as overfishing, indiscriminate use of chemicals, destruction of natural feeding and breeding ground of fishes etc. Six fish sanctuaries were constructed in different perennial khals of six polders to save the existing fish diversity in a water body and in some cases restoration of habitat and also to protect the fish species of polders from further losses. Fish sanctuaries were setup in different lake such as Nadmula Khal (DS-12) in 39/2C, Charduani Bazar Khal
