Coastal Embankment Improvement Project, Phase-I (CEIP-I)

Long Term Monitoring, Research and Analysis of Bangladesh Coastal Zone (Sustainable Polders Adapted to Coastal Dynamics)

Monitoring Results on Sedimentation rate in Rivers and Floodplain (Revised)

December 2020

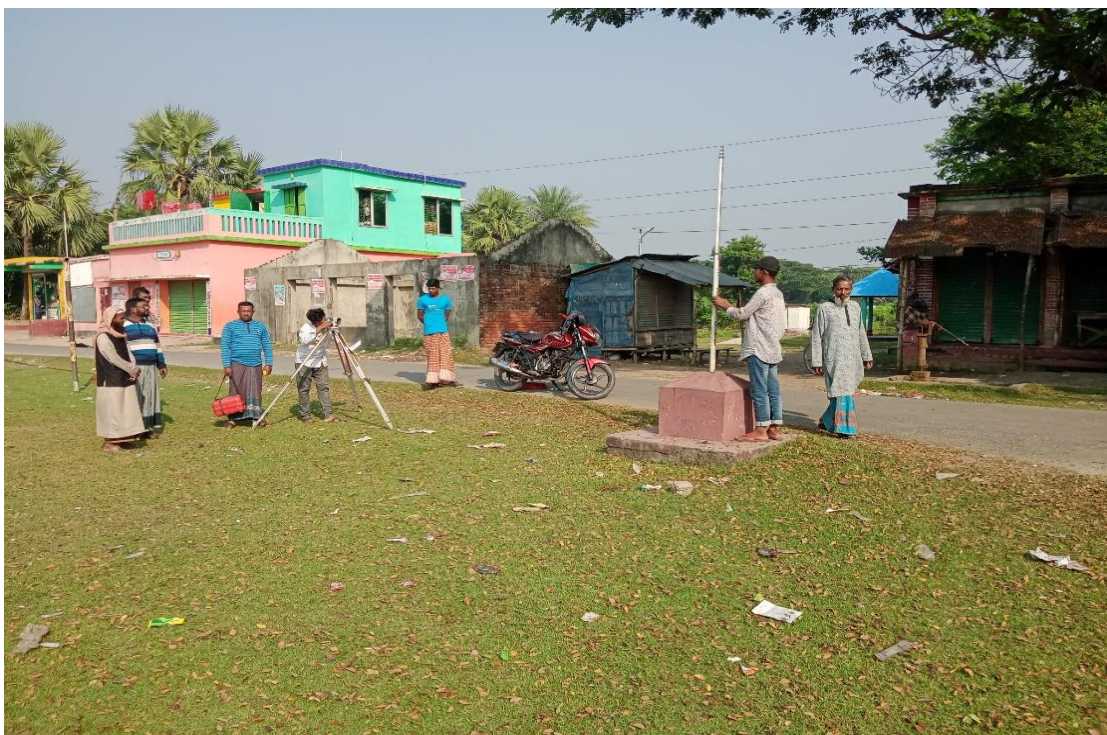
Figure 2-1: SOB Bench Mark at Dumuria, Khulna; used as reference to establish TBM for the Gangril and Badurgacha river sections

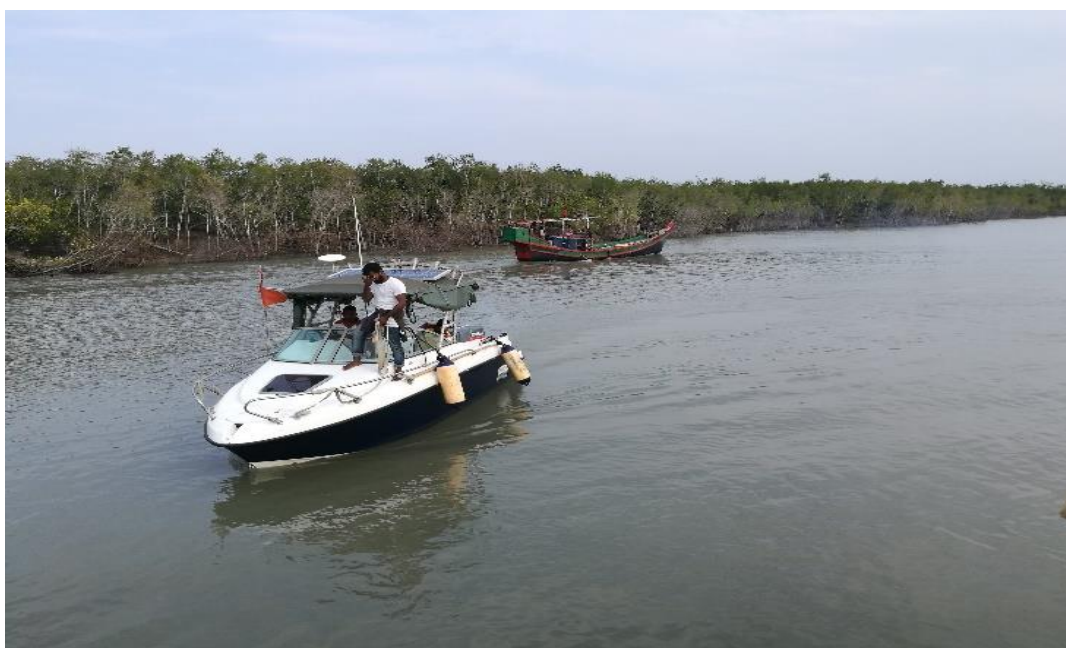
Figure 2-2: Monitoring cross section survey (water part) being carried out in at the Pussur River

Digital Echo-sounder supported by DGPS and notebook computer with Trimble Hydro Pro software have been used for the survey in the river part. The various components of equipment are fitted on a suitable boat (usually Engine driven wooden boat). The Hydro Pro Navigation software guides the survey boat along the desired transects. The survey data is stored in tabular format in MS Access database during survey. The Nav Edit module of the software compiles depth of water column and position of sounding with time. The depth and position data can be viewed both graphically and in tabular format in the software. The erroneous data is removed by checking the sections during processing. River bottom surface level is obtained by deducting water depth from the water level. The edited data is then exported into ASCII format from the Nav-edit module of Hydro-Pro software. Time-varying cross-sections (between two consecutive times), thus obtained, are superimposed in order to notice the change over the said time.

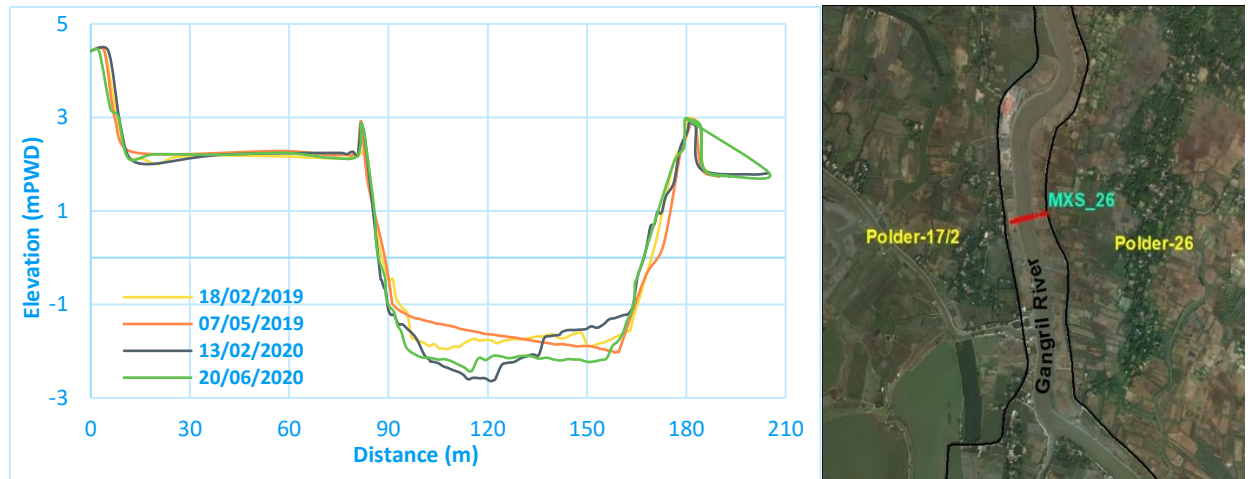
Figure 3-3: Superimposed monitoring section-26 of Gangril River with location

The monitoring section-26 in Gangril River was surveyed four time during the period from 18 February 2019 to 20 June 2020. The superimposed sections with location are shown in Figure 3-3. Table 3-3 summarizes the findings of the analysis from monitoring section-26 of Gangril River. The cross sectional analyses of the river portion shows that the top width at bankfull stage is increased by 2.08 m due to bank erosion during May 2019; later in February 2020 and June 2020, bank erosion caused the top width to increase by 1.57 m and 0.05 m respectively as compared to the top width in February 2019. The overall monitoring surveys in 16 months demonstrate an average increase in top width by 1.23 m indicating the tendency in bank erosion. As compared with the section in February 2019, the overall section of the river experienced sedimentation of 0.87 m² in May 2019 followed by erosions during February 2020 and June 2020 by 19.70 m² and 23.67 m² respectively. An average enlargement in cross-sectional area by 14.17 m² during the monitoring period indicates the process of scouring/erosion. Gangril River is tidal in nature and the erosion and sedimentation process is governed mostly by the scale of tidal flow. Findings from the monitoring surveys show that the thalweg level as compared to February 2019 is increased in May 2019, February 2020 and June 2020 by 0.08 m, 1.04 m and 0.48 m respectively. The average change in the thalweg level during the monitoring period has been found to be elevated by 0.53 m. The thalweg is shifting frequently ranging from 1 m to the left to 50 m to the right with an average of 19.53 m to the right as compared to the thalweg in February 2019. Flood plain sedimentation with respect to the initial survey (Feb 2019) appears to be insignificant. However, the left flood plain experienced maximum sedimentation of 0.07 m in May 2019. The average changes in left and right flood plain elevations during the monitoring period are found to be accreted by 0.03 m and 0.01 m respectively.

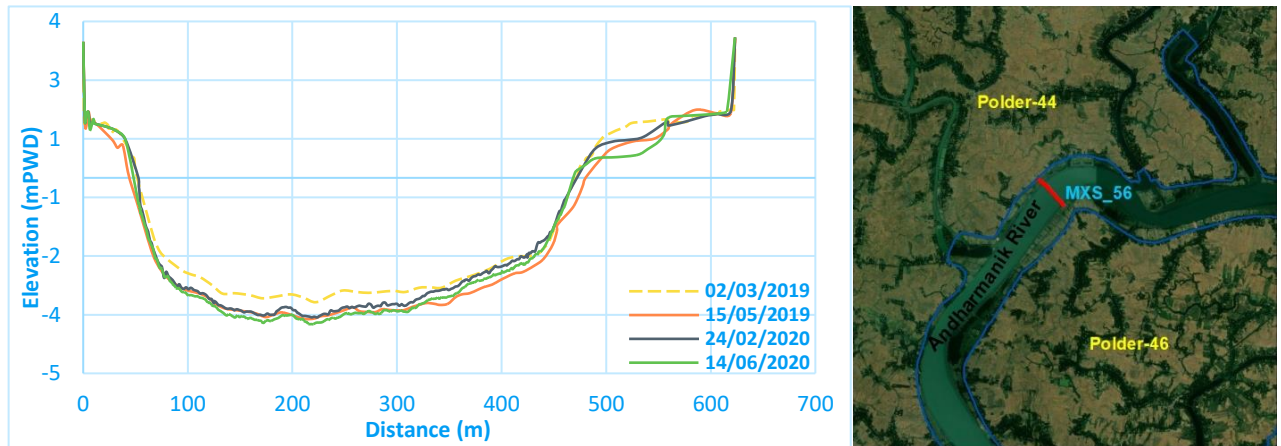
Figure 3-7: Superimposed monitoring section-56 of Andharmanik River with location

The monitoring section-56 in Andharmanik River was surveyed on four occasions during the period from 2 March 2019 to 14 June 2020. Figure 3-7 shows the superimposed section with location. Findings of the analysis from monitoring section-56 of Andharmanik River are summarized in Table 3-7. The cross-sectional analysis of the river portion shows that the top width at bankfull stage is increased in May 2019 due to bank erosion by 50 m; later in February 2020 and June 2020 bank erosion caused the top width to enlarge by 43 m and 44 m respectively as compared with the initial survey in March 2019. The overall monitoring survey in 16 months demonstrates an average increase in top width by 45.3 m indicating bank erosion. As compared with the survey in March 2019, the overall section of the river shows erosion on all occasions of survey in May 2019, February 2020 and June 2020 by 237 m² and 128 m² and 219 m² respectively. The average cross-sectional area during the monitoring period has been found to be enlarged by 194.9 m² indicating the trend towards erosion. Andharmanik River is tidal in nature and erosion/ deposition is mainly governed by the extent of tidal flow. Findings from the monitoring surveys show that the thalweg levels as compared to March 2019 are increased on all events of the surveys in May 2019, February 2020 and June 2020 by 0.4 m, 0.4 m and 0.6 m respectively. The monitoring survey demonstrates lowering in the thalweg level by 0.46 m in 16 months. Thalwegs at the section in comparison with the thalweg in March 2019 are found to be shifted to the left on all occasions of survey by 10 m in May 2019, 4 m in February 2020 and 6.5 m in June 2020. The overall monitoring survey demonstrates an average shifting of the thalweg by 6.8 m to the left of the thalweg in February 2019. The frequent shifting of the thalweg indicates the dynamic nature of the river. The table shows the changes of right flood plain with respect to the flood plain in March 2019. No significant changes in elevation of the right flood plain are observed. An average raise in the right flood plain elevation by 0.01 m is found during the monitoring period as compared to elevation in 02 March 2019. Survey on left flood plain is not done. There exists embankment close to left bank of the section. Beyond the embankment flood plain are not surveyed.

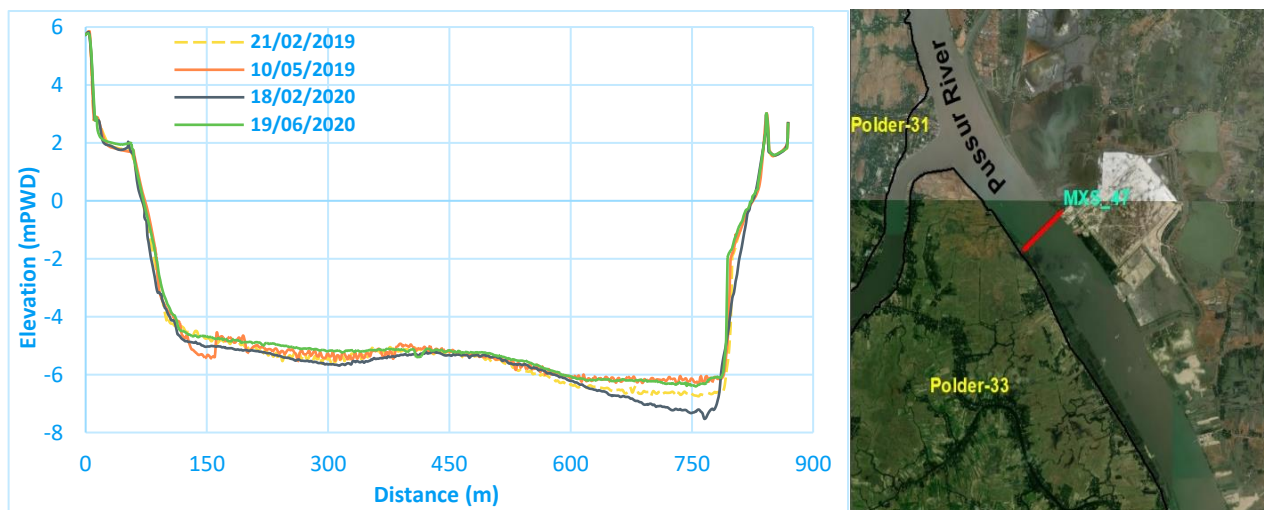
Figure 3-10: Superimposed monitoring section-47 of Pussur River with location

Monitoring section-47 in Pussur River has been surveyed four times during the period from 21 February 2019 to 19 June 2020. Figure 3-10 shows the superimposed section with location. Findings from the analysis of monitoring section-47 of Pussur River are summarized in Table 3-10. The cross-sectional analysis of the river portion shows that the top widths at bankfull stage as compared to the width in February 2019 are reduced on all the occasions of surveys in May 2019, February 2020 and June 2020 due to sedimentation by 2.68 m, 0.28 m and 2.47 m respectively. The overall monitoring survey in 16 months demonstrates an average reduction in top width by 1.81 m indicating tendency in bank siltation. With respect to the section in February 2019, the overall section of the river shows reduction in area due to sedimentation in May 2019 and June 2020 by 124 m² and 187 m² respectively. However, the section experiences enlargement due to erosion in February 2020 by 113 m². The

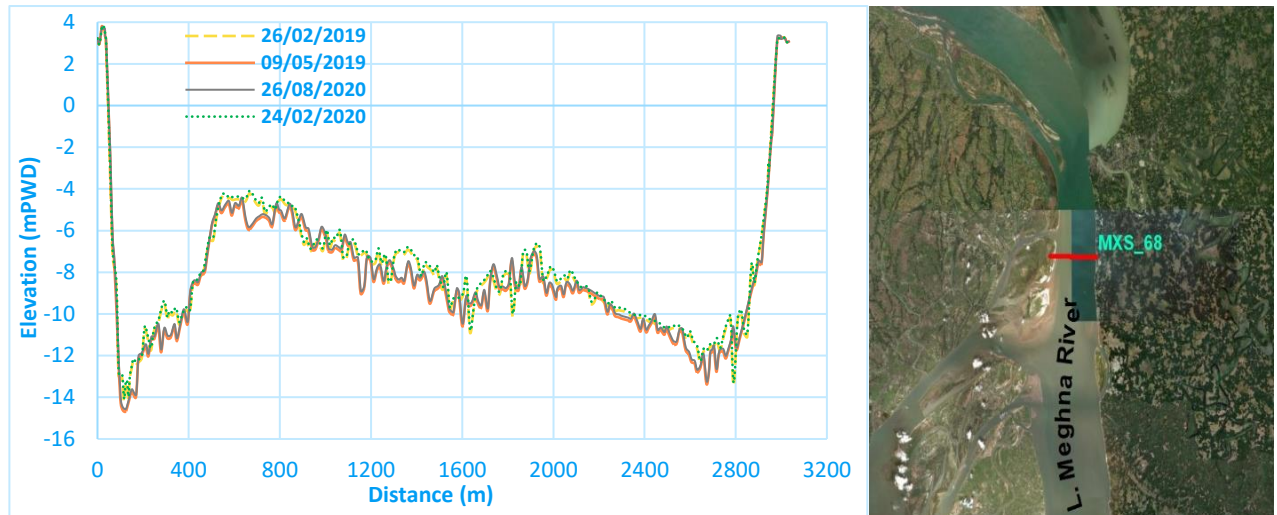
Figure 3-13: Superimposed monitoring section-68 of Lower Meghna River with location

The monitoring section-68 has been surveyed four times during the period from 26 February 2019 to 26 August 2020. Figure 3-13 shows the superimposed section with location. Findings from the analysis of Lower Meghna River monitoring section-68 are summarized in Table 3-13. The cross-sectional analysis of the river portion shows that the changes in top widths at bankfull stage as compared to the width in February 2019 are not that significant. In May 2019, the top width is slightly increased due to bank erosion by 0.04 m; later in February 2020 and August 2020 sedimentation caused the top width to reduce by 0.69 m and 1.57 m respectively as compared with the initial survey in February 2019. The overall monitoring survey in 18 months demonstrates an average reduction in top width by 0.74 m which is not that significant compared to the top width; although it is indicating the tendency in bank siltation. With respect to the survey in February 2019, the overall section of the river shows enlargement in area due to erosion in May 2019 and August 2020 by 1116 m² and 734 m² respectively. However, the section experiences reduction in area due to sedimentation in February 2020 by 379 m². The section during the monitoring period undergoes an average enlargement in the cross-sectional area by 490.37 m² indicating the development of erosion. Lower Meghna is a very dynamic river and tidal in nature and erosion/ deposition is mainly governed by the extent of tidal flow as well as the freshwater flow from the upstream during monsoon. Findings from the monitoring surveys show that the thalweg levels as compared to February 2019 is increased in May 2019 and August 2020 by 0.47 m and 0.34 m respectively; however, in February 2020 the level is reduced by 0.13 m. The average of the thalweg level in 18 months monitoring period is increased by 0.23 m as compared with the thalweg level in February 2019. Thalwegs at the section with respect to the thalweg in February 2019 are found to be shifted to the right on all events of survey during May 2019, February 2020 and August 2020 by 8 m, 0.7 m and 9 m respectively. This frequent shifting of the thalweg indicates the dynamic nature of the river. The overall monitoring survey demonstrates an average shifting of the thalweg by 5.67 m to the right of the thalweg in February 2019. Figure 3-13 shows changes in flood plain elevations with respect to the flood plain in February 2019. No significant changes in elevations are observed. The maximum increase in elevations of the left flood plain by 0.05 m due to sedimentation are occurred in February 2020 and August 2020. On the average in 18 months monitoring survey period, the left and right flood plain at the section experience increase in elevations by 0.03 m and 0.01 m respectively.

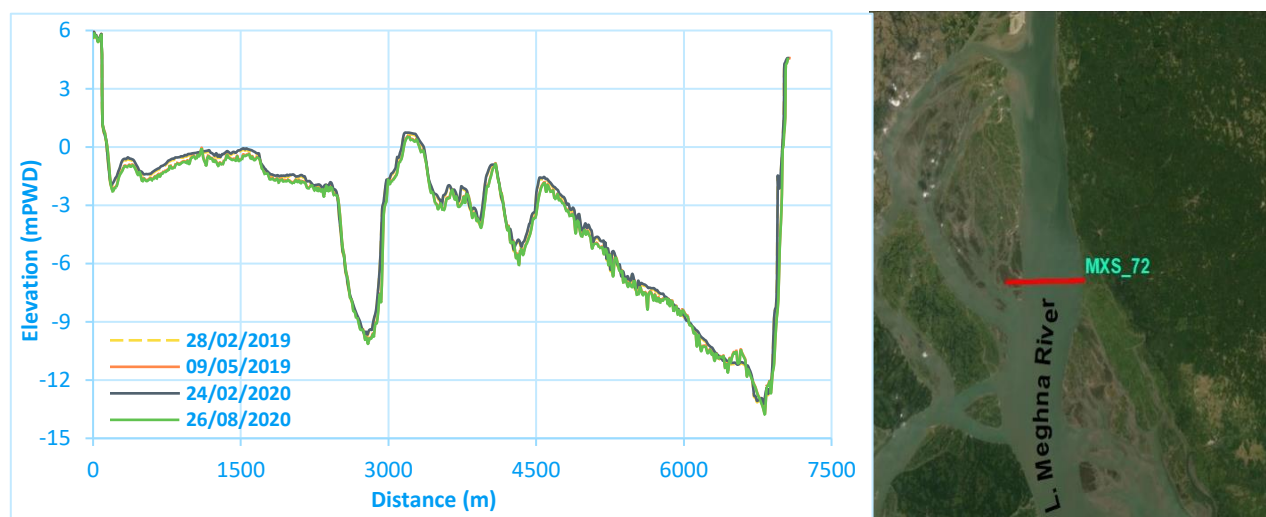
Figure 3-14: Superimposed monitoring section-72 of Lower Meghna River with location

The monitoring section-72 in Lower Meghna River has been surveyed four times during the period from 28 February 2019 to 26 August 2020. Figure 3-14 summarizes the superimposed section with location. Findings of the analysis from monitoring section-72 of Lower Meghna River are summarized in Table 3-14. The cross-sectional analysis of the river portion shows that the top widths at bankfull stage as compared to the width in February 2019 are increased in May 2019 and August 2020 due to bank erosion by 14.47 m and 14.76 m. In February 2020 sedimentation caused the top width to reduce

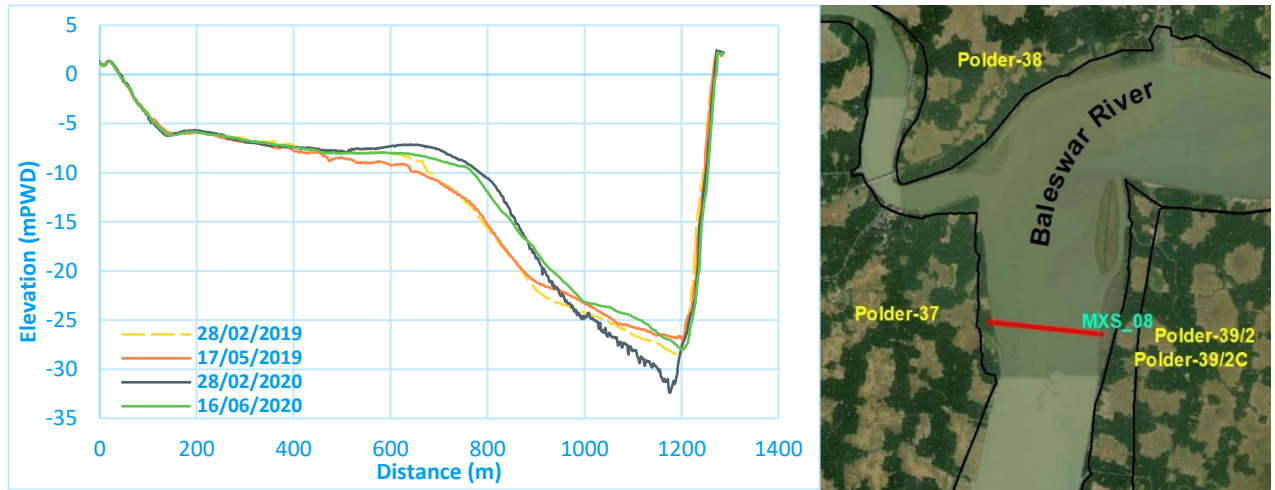
Figure 3-21: Superimposed monitoring section-08 of Baleswar River with location

Cross sections surveys in the monitoring section-08 of Baleswar River were carried out on four occasions during the period from 28 February 2019 to 16 June 2020. Figure 3-21 shows the superimposed section with location. Findings from the analysis of monitoring section-08 of Baleswar River are summarized in Table 3-21. As compared with the survey in February 2019, the top widths at bank full stage on all occasions of the surveys in May 2019, February 2020 and June 2020 are enlarged due to bank erosions by 0.95 m, 0.92 m and 6.82 m respectively. The overall monitoring survey in 16 months demonstrates an average increase in top width by 2.9 m indicating the tendency in bank erosion. The table shows that the sectional area of the river in May 2019 compared to the area in February 2019 is enlarged by 44 m² due to erosion. However, the section experienced reduction in areas due to sedimentation in February 2020 and June 2020 by 587 m² and 947 m² respectively. The section during the monitoring period undergoes an average reduction in the cross-sectional area by 496.66 m² indicating the development of siltation. Baleswar River is a tidal in nature and the erosion and sedimentation processes in the river is mostly influenced by the magnitude of tidal flow as well as by the upstream freshwater flow during monsoon. Findings from the monitoring surveys show that the thalweg level as compared to 28 February 2019 is decreased in 17 May 2019 and 16 June 2020 by 1.74 m and 0.64 m respectively. However, the thalweg has been found to be increased by 3.73 m in February 2020. The average of the thalweg level in 16 months monitoring period has been increased by 0.45 m. Thalwegs at the section in May 2019 and June 2020 are found to be shifted to the right from the thalweg in February 2019 by 8.69 m and 8.34 m respectively. However, the maximum shifting of the thalweg was occurred in February 2020 by 15.84 m to the left. The overall monitoring survey demonstrates an average shifting of the thalweg by only 0.4 m to the right of the thalweg in 28 February 2019. Considering the dynamic behaviour of the river the extent of thalweg shifting as obtained from the monitoring surveys are minor. Sedimentation on the left flood plain according to the monitoring survey has not been found significant. The maximum change of 0.08 m in elevation of the left flood plain has occurred in February 2019 due to sedimentation. On the average in 16 months monitoring survey period, the left flood plain at the section experiences increase in elevation by 0.04 m. Monitoring survey has not been carried out on the right flood plain due to the existence of Sundarban forest.

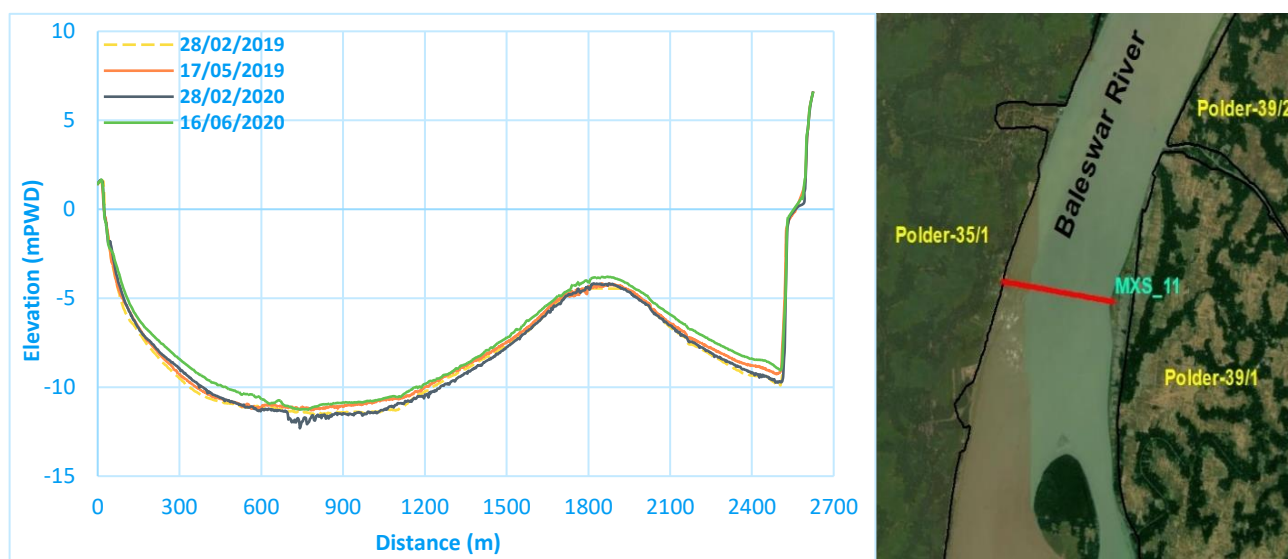
Figure 3-22: Superimposed monitoring section-11 of Baleswar River with location

Cross sections surveys for the monitoring section-11 in Baleswar River were carried out on four occasions during the period from 28 February 2019 to 16 June 2020. Figure 3-22 shows the superimposed section with location. Findings of the analysis from monitoring section-11 of Baleswar River are summarized in Table 3-22. As compared with the survey in February 2019, the top widths at bank full stage on all occasions of the surveys in May 2019, February 2020 and June 2020 are reduced due to river bank sedimentations by 16.28 m, 4.5 m and 20 m respectively. The overall monitoring survey in 16 months demonstrates an average reduction in top width by 13.6 m indicating bank siltation. The table shows that the sectional areas of the river compared to the area in February 2019 are reduced on all events of monitoring survey in May 2019, February 2020 and June 2020 by
