Coastal Embankment Improvement Project, Phase-1
(CEIP-1)

Mid Term Evaluation Report

February 2022

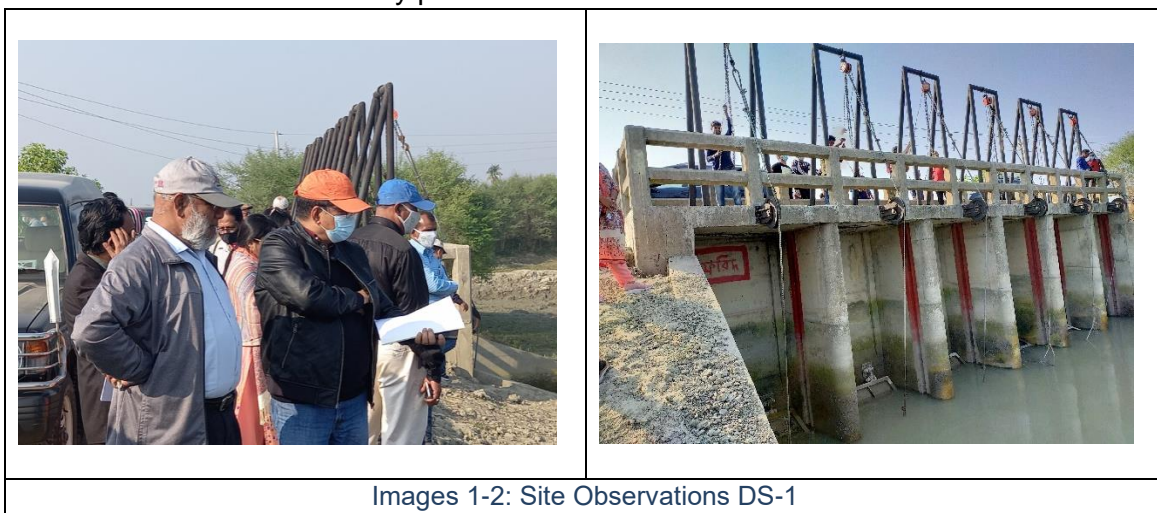
The teams visited the Drainage Sluice (DS-1) and found functioning. This is the biggest DS in Polder 35/3 and even in Package W-01. This is six-vent sluice. Old and broken sluices are carefully dismantled from upstream. All gates of sluice were found functioning.

Then the committee members also monitored the embankment construction works adjacent of DS-1. The countryside slope of the embankment is not maintained at the ratio specified of 1:3 in some places of embankment. The committee also visited the afforestation activities and had a discussion with the representatives of DOF, Social Forest Division, Bagerhat. The committee observed over density of **Babla tress** and recommended to follow the right composition during future plantation. DOF representative responded that in saline area babla tree grows well and many planted trees died due to salinity problem.

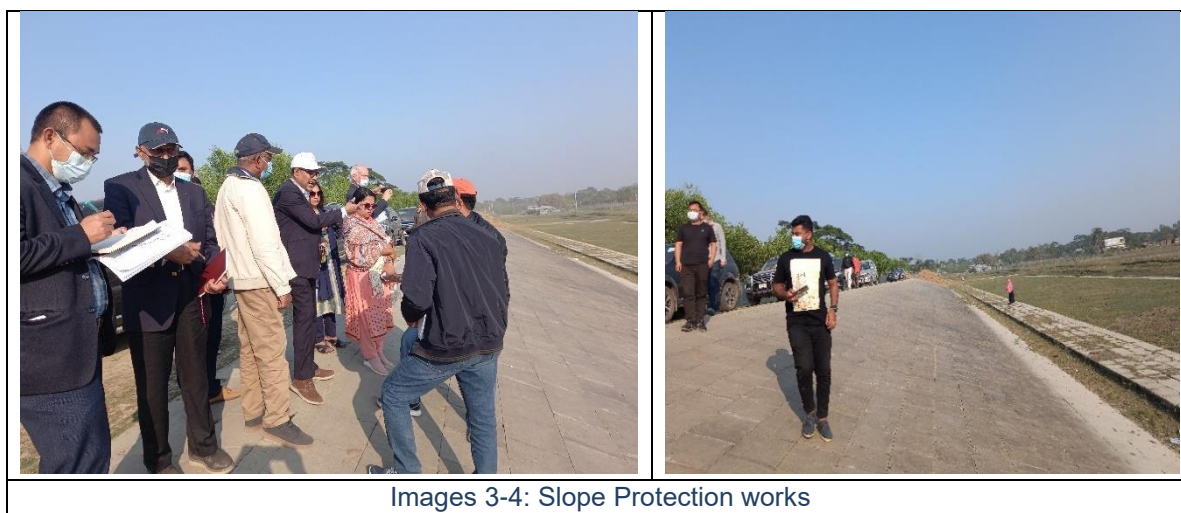
The team visited 700 m slope protection (**ch. Km 38+580 to 39+280 km**) works in this area. Slope protection works successfully protected the embankment and gradual siltation is being formed. The Environmental Specialists informed the team that they pay great attention to the Environment and try to create secured working environment. They also fulfill the requirements of Department of Environment (DoE) and receive renewal on Environment Clearance Certificate on regular basis. The Social team informed that about 293 numbers of PAP have been compensated as well as rehabilitated in Polder 35/3 through CEIP-1. The team wanted to know about the CC block testing provisions of CEIP-1. The CSE of DDCS&PMS consultant responded that most of the tests are being conducted in the self-laboratory established in BWDB campus of Noor Nagar, Khulna under CEIP-1.

- I. The slope protection works found in good condition. The team expressed satisfactions for the CEIP-1 works in this site.
- II. The team advised to the DDCS&PMS Consultant to perform some CC block test as well as materials tests (sand, sands stone, cement etc.) from Khulna University of Engineering and Technology (KUET).

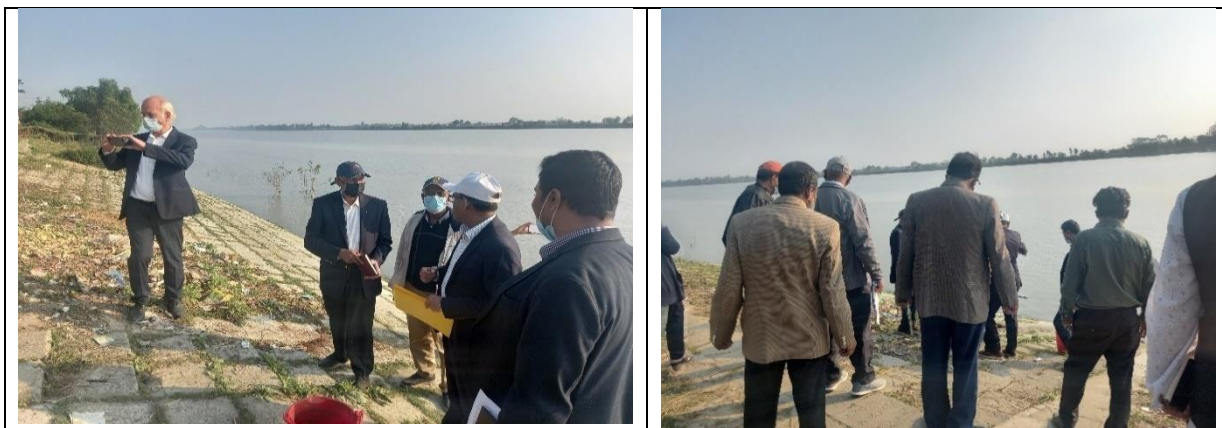
Images 5-6: River bank protection (RBP) works

The team visited 150 m River Bank Protection (**Ch. Km 36+220 to 36+370 km**) works in this area. The team expressed satisfaction for slope protection works which also facilitated stair for easy movement of villagers in this Bazar area. The local people also thanked the Govt. for this good work. In recent past, there was probability for severe erosion in this area, but due to implementation the River Bank Protection works, this area is now secured and the weekly Bazar (Hat) is sitting regularly.

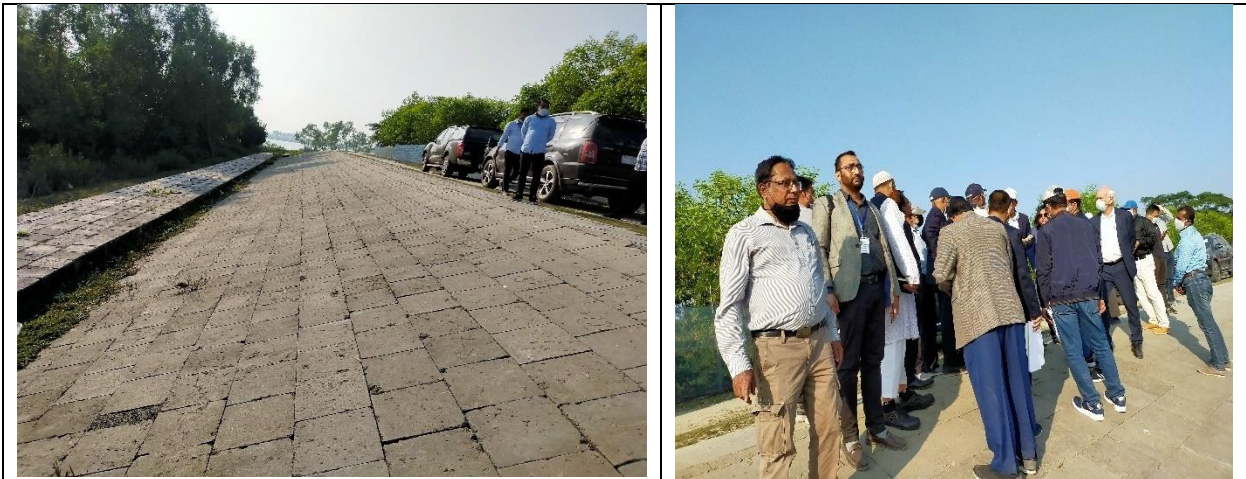
Images 9-10: Slope protection works

- I. Afforestation work in embankment to be completed immediately.
- II. Slope protection works is found in good condition and has facilitated siltation in Country side.

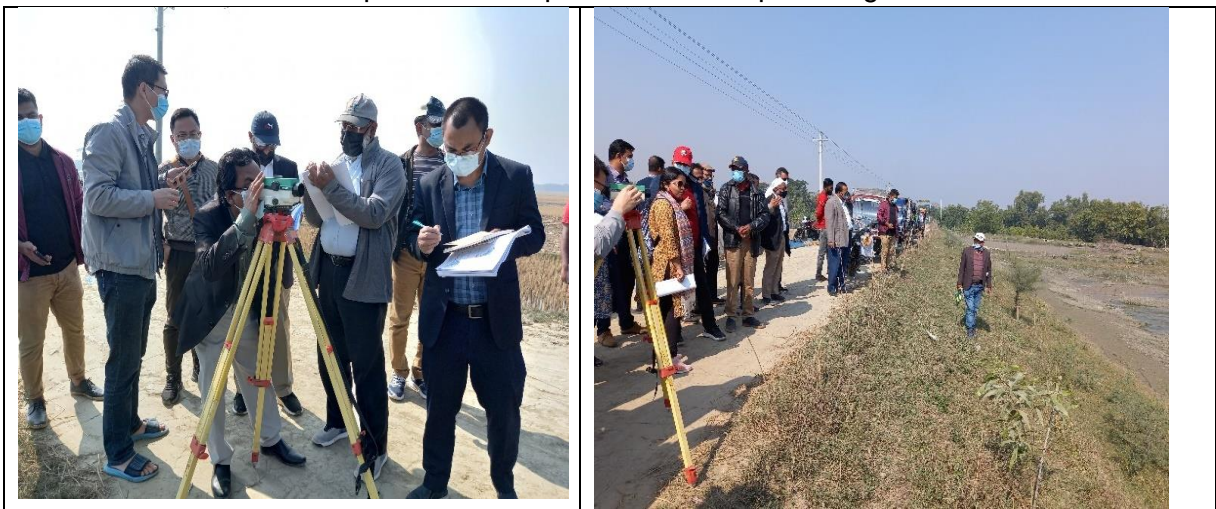
Images 11-12: Measurement of embankment works

The teams moved for checking the embankment works. The team selected the site in Banishanta (just after Laudobe Bazar) and measured the embankment top level and side slope. The team found that the embankment top and side slope was done as per design.

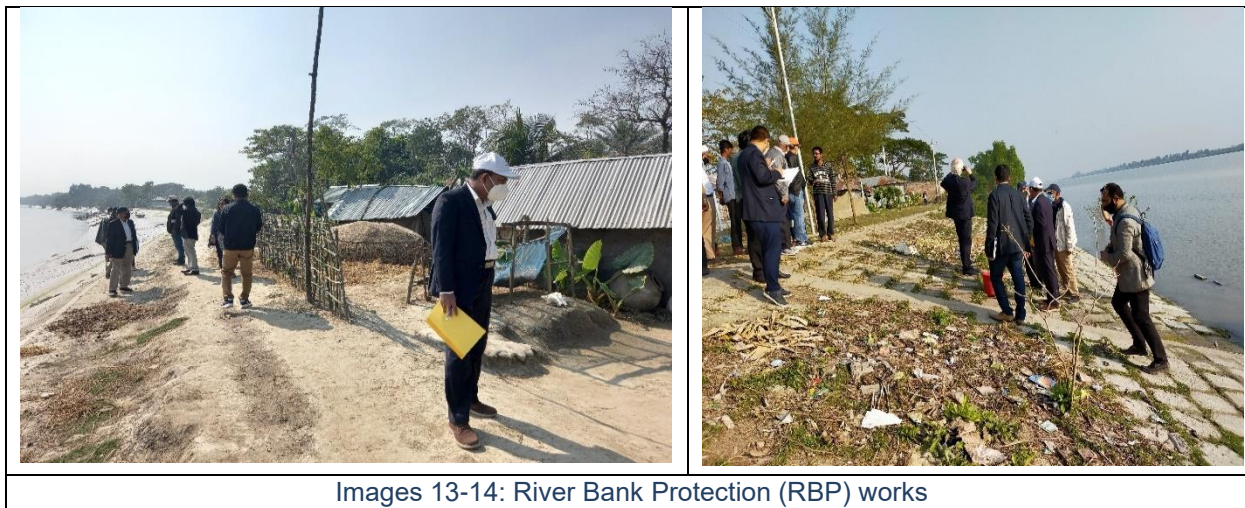
Images 13-14: River Bank Protection (RBP) works

- I. The local community requested for more CC block works.
- II. The team observed that the RBP work is in good condition.

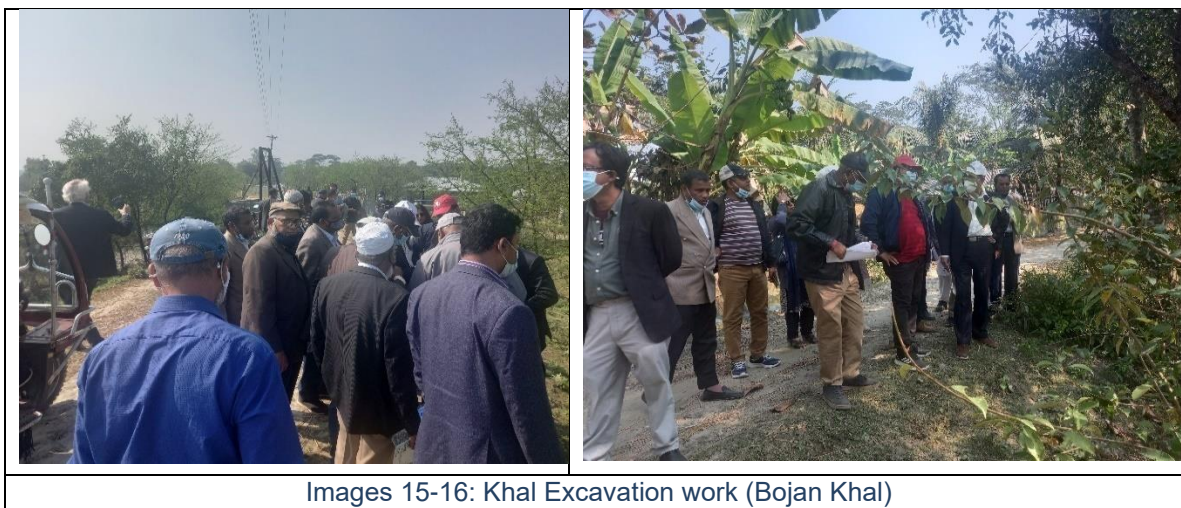
Images 15-16: Khal Excavation work (Bojan Khal)

- I. The convener advised the DDCS&PMS consultants to check the top of the khal, bed width while taking **Post work measurements** before final payment.
- II. The completed channel re-excavation work should be checked as per approved design before final payment.

- 5) Team recommended embankment construction/ re-sectioning work will be re-checked before final payment as well as drainage channel re-excavation work.

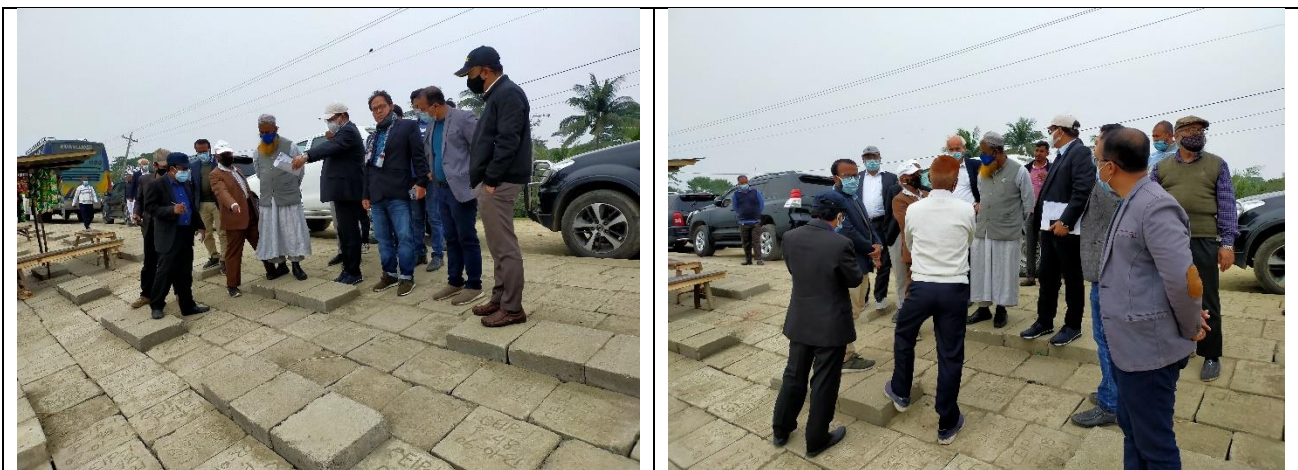
Images 17-18: Slope protection works

- I. Slope protection works successfully has protected the embankment and gradual siltation is being formed.
- II. The slope protection works found in good condition.

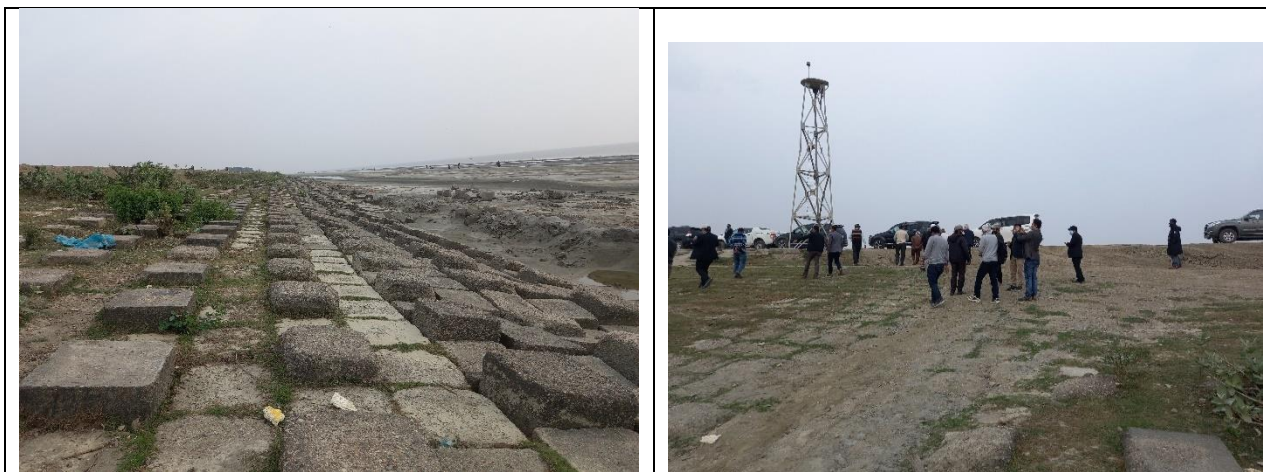
Images 19-20: Slope protection repair works

The teams visited 2285 m slope protection repair works (Ch. Km 32+015 to 34+300 km = 2,285m) (c/s slope 1:5) in this area. They physically visited at Ch. 34+ 300. The work was on going and workers had taken proper safety measures. Previous Slope protection works was done by WAMIP Project. Some block of existing slope protection works is found in good condition and that will be reused. The Project Director informed that CEIP-1 committee count the blocks as and

when required. Old and new blocks will be used in this repair work. The Consultant briefed the construction procedure to the Mid-term Team.

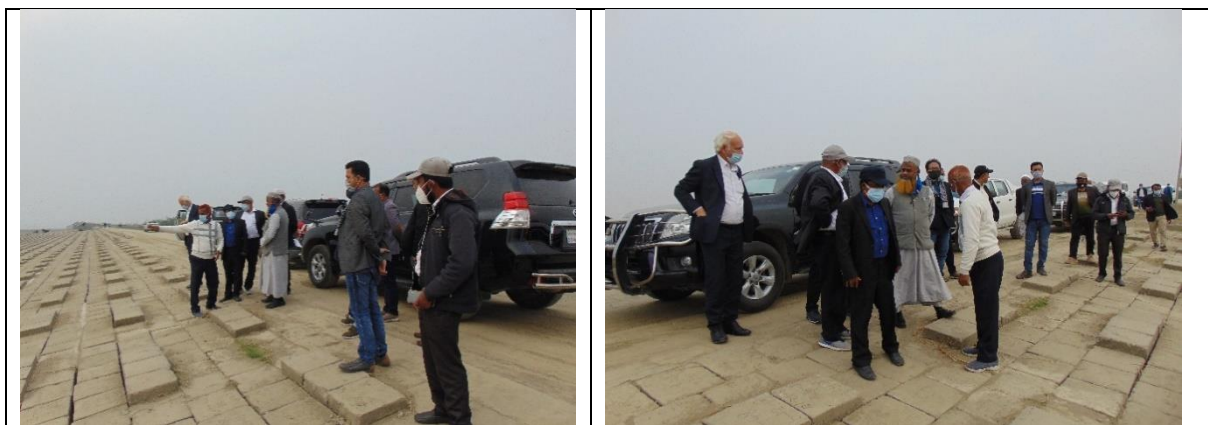
Images 21-22: Slope Protection Works at Km 34+300 to Km 34+878

- I. The slope protection works found in good condition.
- II. The team expressed their satisfaction regarding the slope and quality of the work

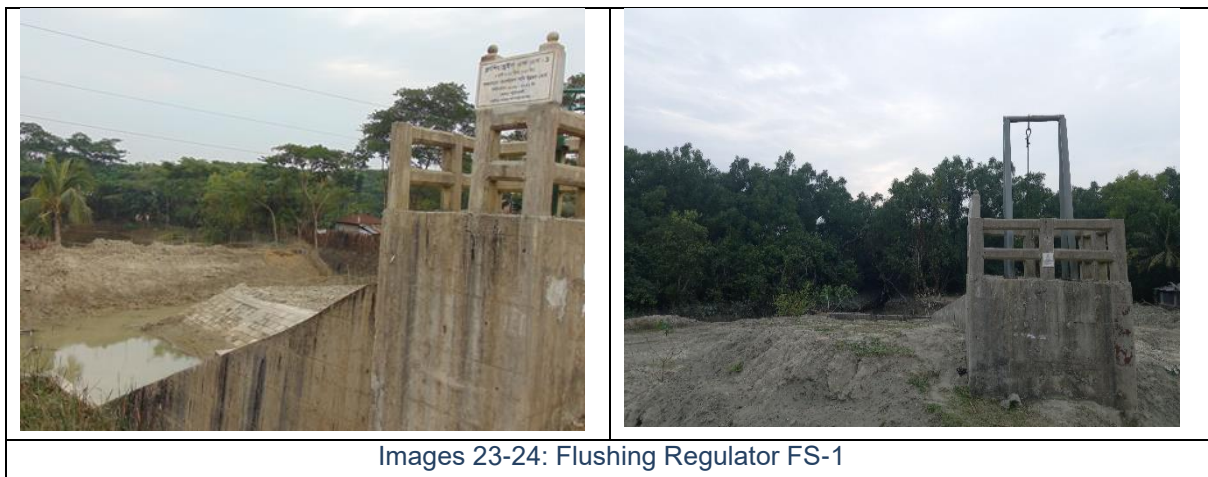
Images 23-24: Flushing Regulator FS-1

The teams visited the Flushing Sluice (FS-1) and found functioning. This is newly constructed sluice connected with adjacent khal. This is one-vent sluices.

- i. Old and broken sluices are carefully dismantled from upstream
- ii. Gate of sluice was functioning
- iii. All types of sluice works such as structural works, loose apron and connecting khal excavations are completed.
- iv. Then the committee members also monitored the embankment construction works adjacent of FS-1 and instruct to maintain the slope as well as crest level of embankments.

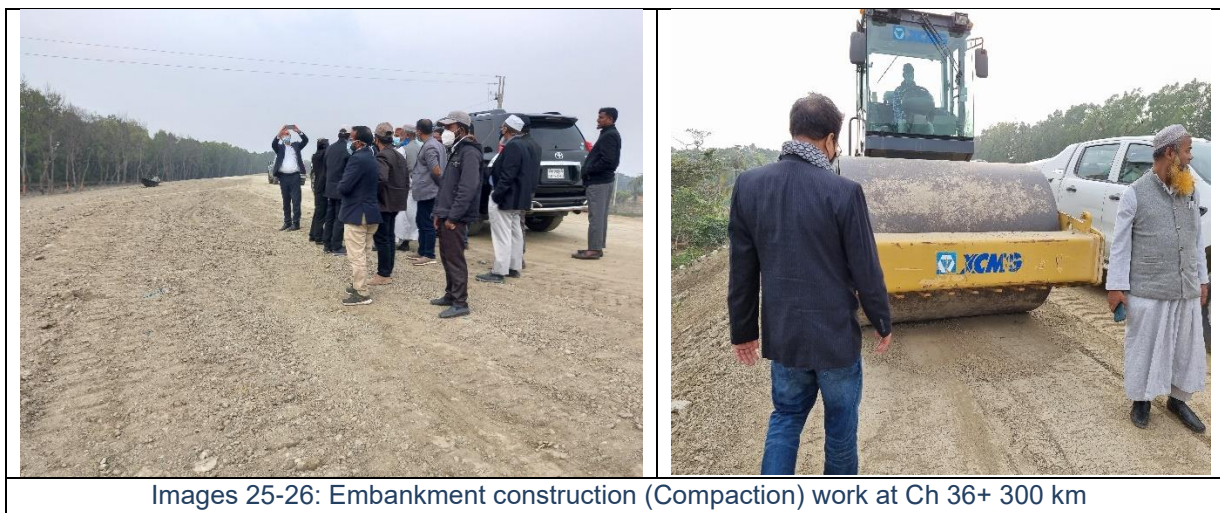
Images 25-26: Embankment construction (Compaction) work at Ch 36+ 300 km

The teams moved for checking the ongoing embankment construction works at chainage 36+300 km. The team found that embankment is being compacted with Bulldozer. Project director informed the committee that for ensuring 95% compaction of embankment Bulldozer, sheep foot roller and chain excavator is frequently used in our project.

- i. Committee found river side slope as per design, but countryside slope not yet developed as per design. Consultant assured that it will be done as per drawing as work is now ongoing.

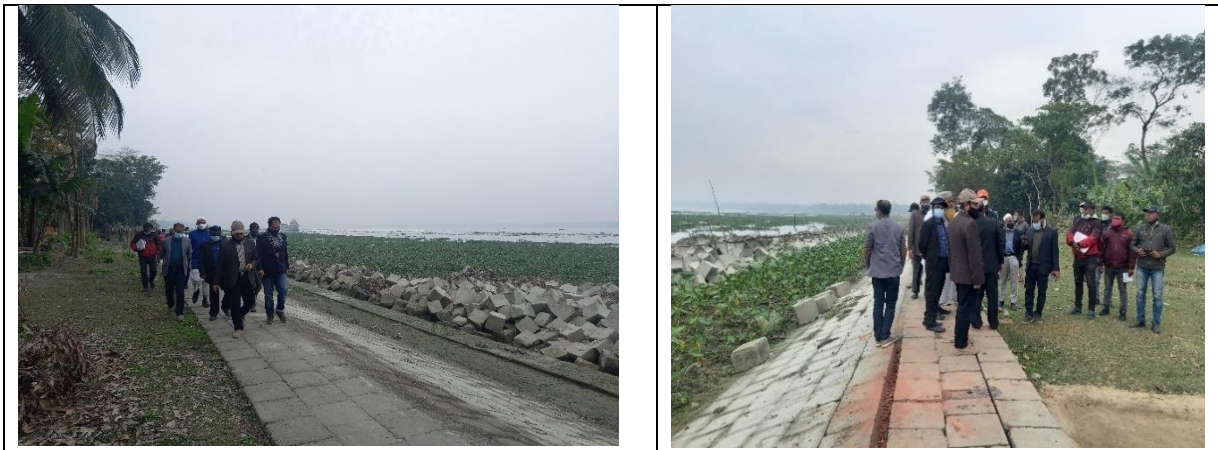
Images 27-28: River Bank Protection Work

- i. Bank protection works successfully has protected the river
- ii. The Bank protection works found in good condition.

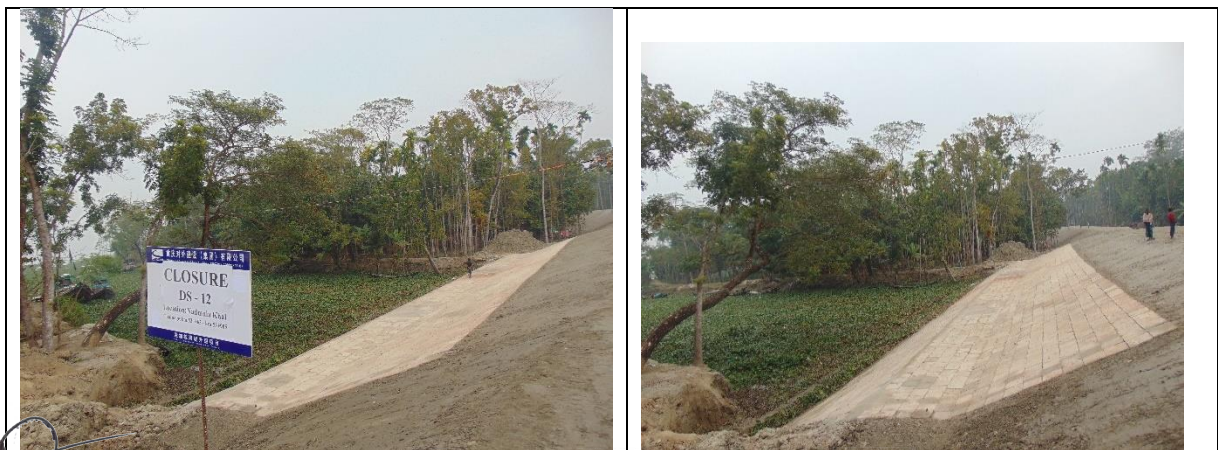
Images 29-30: Closure Construction works

- I. The closure has successfully closed the river
- II. Works found in stable condition.

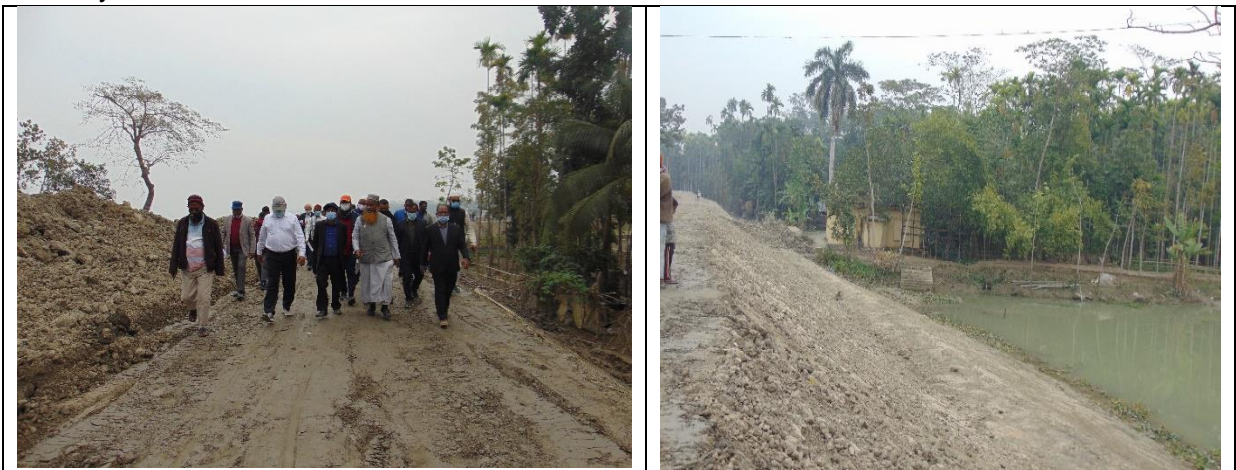
Images 33-34: Embankment construction work

The committee visited embankment construction work at adjacent area. Workers had adequate safety measures at site. Bull dozer was compacting the earth. The committee asked how testing of soil and confirmation of compaction is done. Consultant informed that compaction is done layer by layer and test is done at every layer as per specification and test is conducted in CEIP-1 laboratory.
