Coastal Embankment Improvement Project, Phase-I (CEIP-I)

**Long Term Monitoring, Research and Analysis of  
Bangladesh Coastal Zone (Sustainable Polders Adapted to  
Coastal Dynamics)**

**Report  
on  
Selection of Polders for Conceptual Design as Pilot  
Program (Revised)**

March 2021

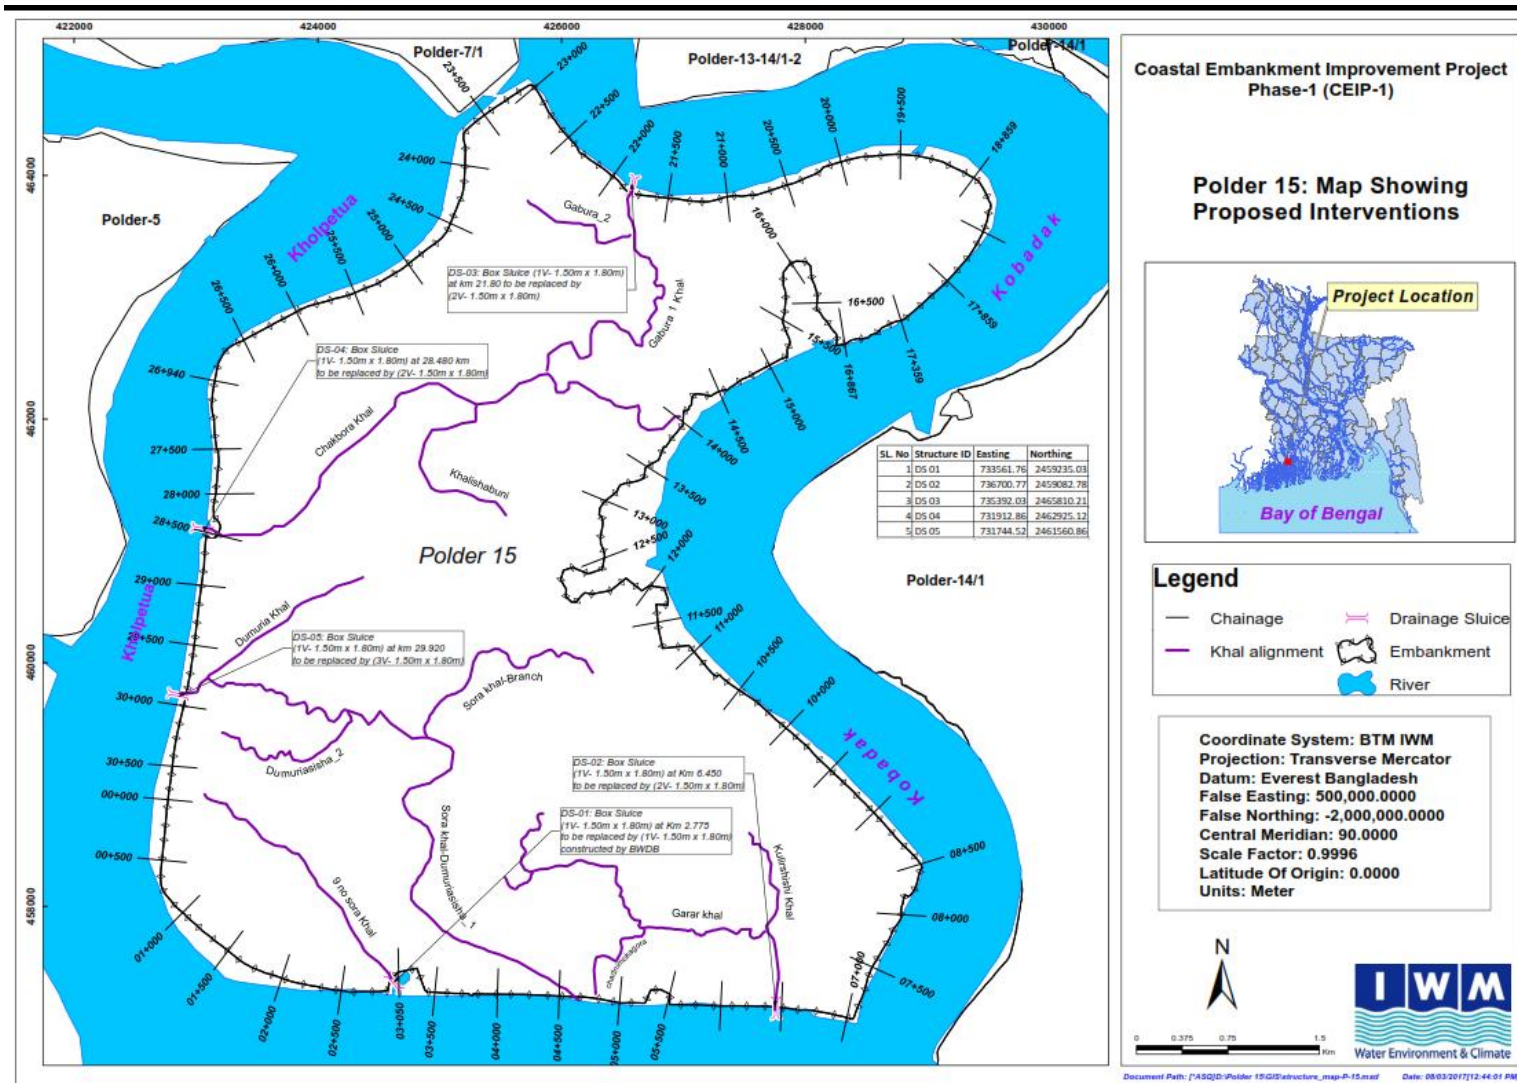
Figure 3: Detailed map of Polder 15 under CEIP-1 project

The existing embankment of Polder 15 ( from km 8.60 to 8.80 ) has been protected by Slope Protection works by CC blocks about 50 m length has already been damaged due to wave action. The embankment is prone to river erosion as well as wave action. Bank protection work is essential to protect the embankment, crops and local community. Recent bathymetric survey suggests that the existing Bank of the river is about 70-80 meters away from the toe of the existing embankment. On the other hand, the cross-section indicates that the slope of the bed of the river is not very stiff and the location of the same is far away from the existing embankment. Mangrove afforestation is required.

In 2020, Polder 15 was affected severely by cyclone Amphan. A breach on the embankment had occurred and caused severe flooding in Polder 15.

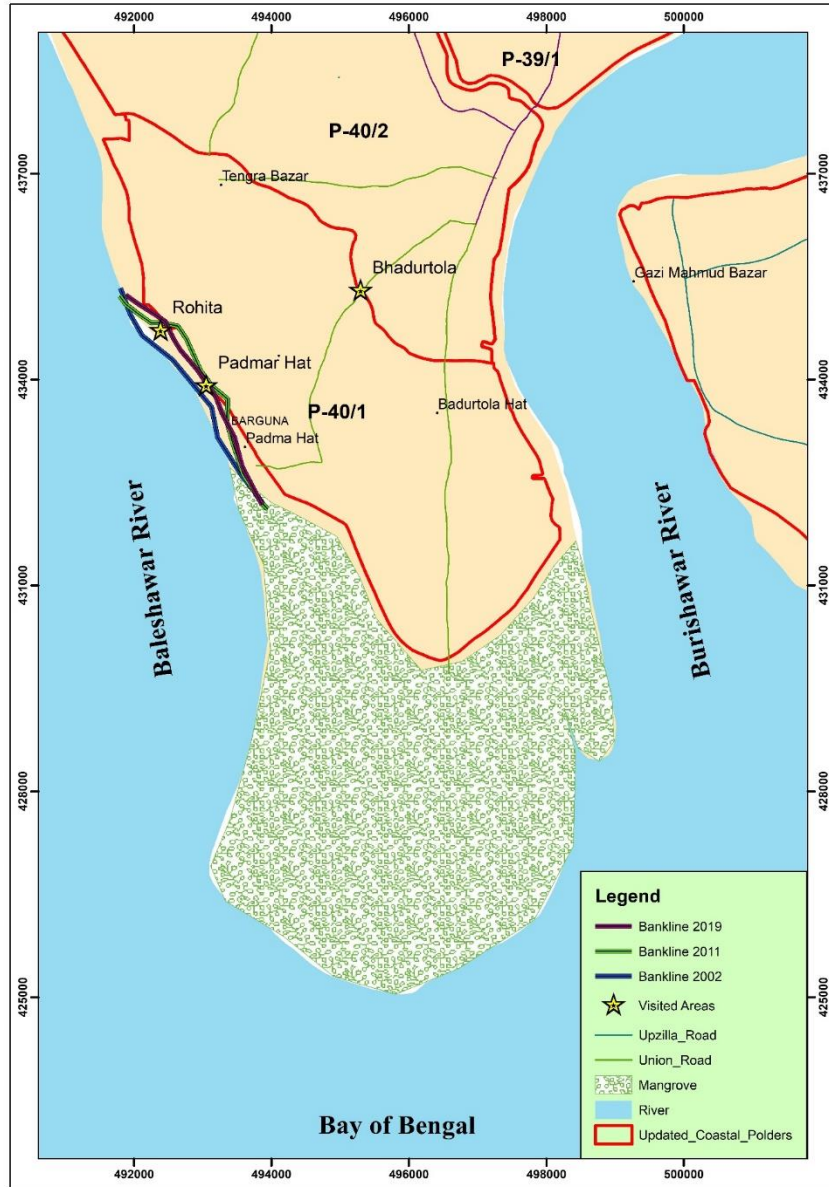
Figure 5: Location map of field visit at Polder 40/1

The polder was severely damaged during the Cyclone SIDR in 2007. The team visited the most vulnerable part of this polder at Padma Hat and Rohita area along the left bank of Baleswar river. Local people informed the team about the damage in the polder during Cyclone SIDR and recent condition around these areas. The retired embankment was built at Rohita area after the cyclone which was totally damaged during SIDR and this embankment is now again vulnerable to erosion. So, the BWDB official informed that the structure has repaired recently, and the team also observed the recent repair work (Figure 5). In Padma Hat area, a long stretch of the existing embankment is vulnerable to erosion and emergency protective works by geo-bag was made by BWDB (Figure 6). Planned protective measures considering, river flow, cyclonic storm surge, climate change and mangrove afforestation is required

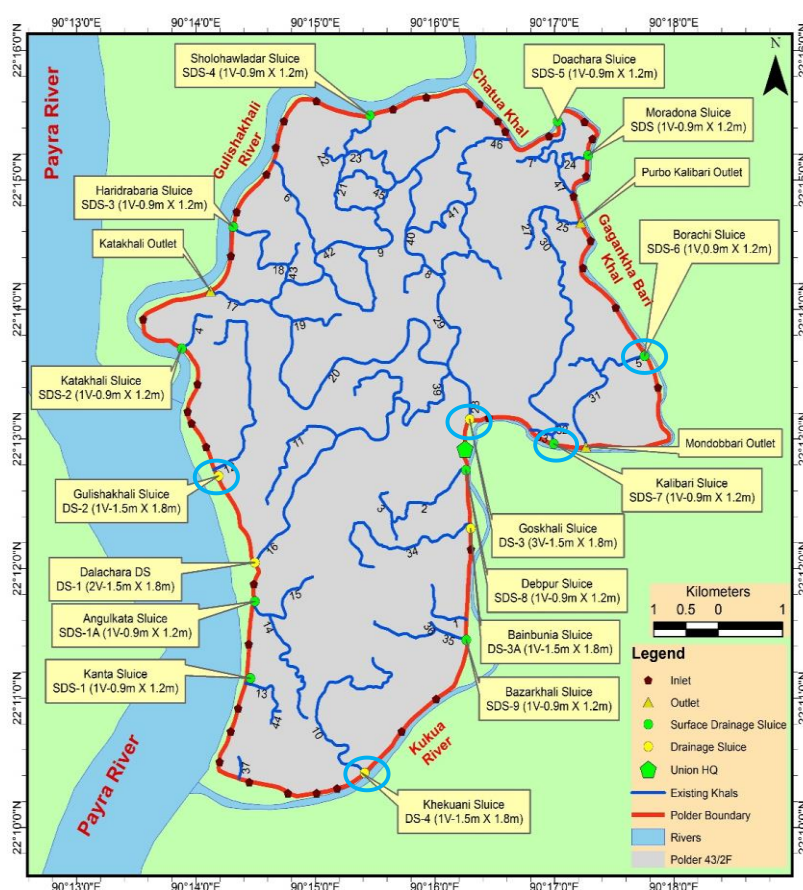
Figure 7: Map showing the khals and sluices of Polder 43/2f

Polder 43/2f is located in Gulishakhali union of Amtali upazila, Barguna district. The polder is surrounded by Gulishakhali and Payra rivers in the west and the Kukuua River (in the east) (Figure 7). The polder covers an area of 4,130 ha, with a Net Cultivable Area (NCA) of 2,590 ha (63%). The polder area is bounded by a 33 km embankment that protects the area against tidal and storm surges as well as salinity intrusion. The embankment beside the Payra River at Angulkata, Gulishakhali, Dalachara and Naiapara is vulnerable to erosion and tends to be eroded whenever a moderate flood occurs. Besides, there are 16 drainage sluices, 4 drainage outlets and a number of flushing inlets within the area. The existing water control structures are not functioning up to the desired level due to damages in the wheels and shafts. There are also severe mismanagement issues regarding the water control structures. Around 37 km (40% of the total length) of water courses inside the polder are affected by drainage congestion problems. Drainage congestion at some places leads to water management issues, which affect the agriculture sector within the polder. Figure 7 shows the existing regulators, khals and peripheral river network

Few years back, IWM carried out a research project in this polder and collected topography data, khal and structure information. IWM found that this polder is experiencing some severe problems. Therefore, there is an opportunity to introduce some engineering innovations in this polder for the better water management. There are huge potentials to increase the cropping intensity and economic activities of local communities since river water salinity remain below 1ppt all over the year and road communication is very good. The existing problems inside the polder are presented in the Figure 8.

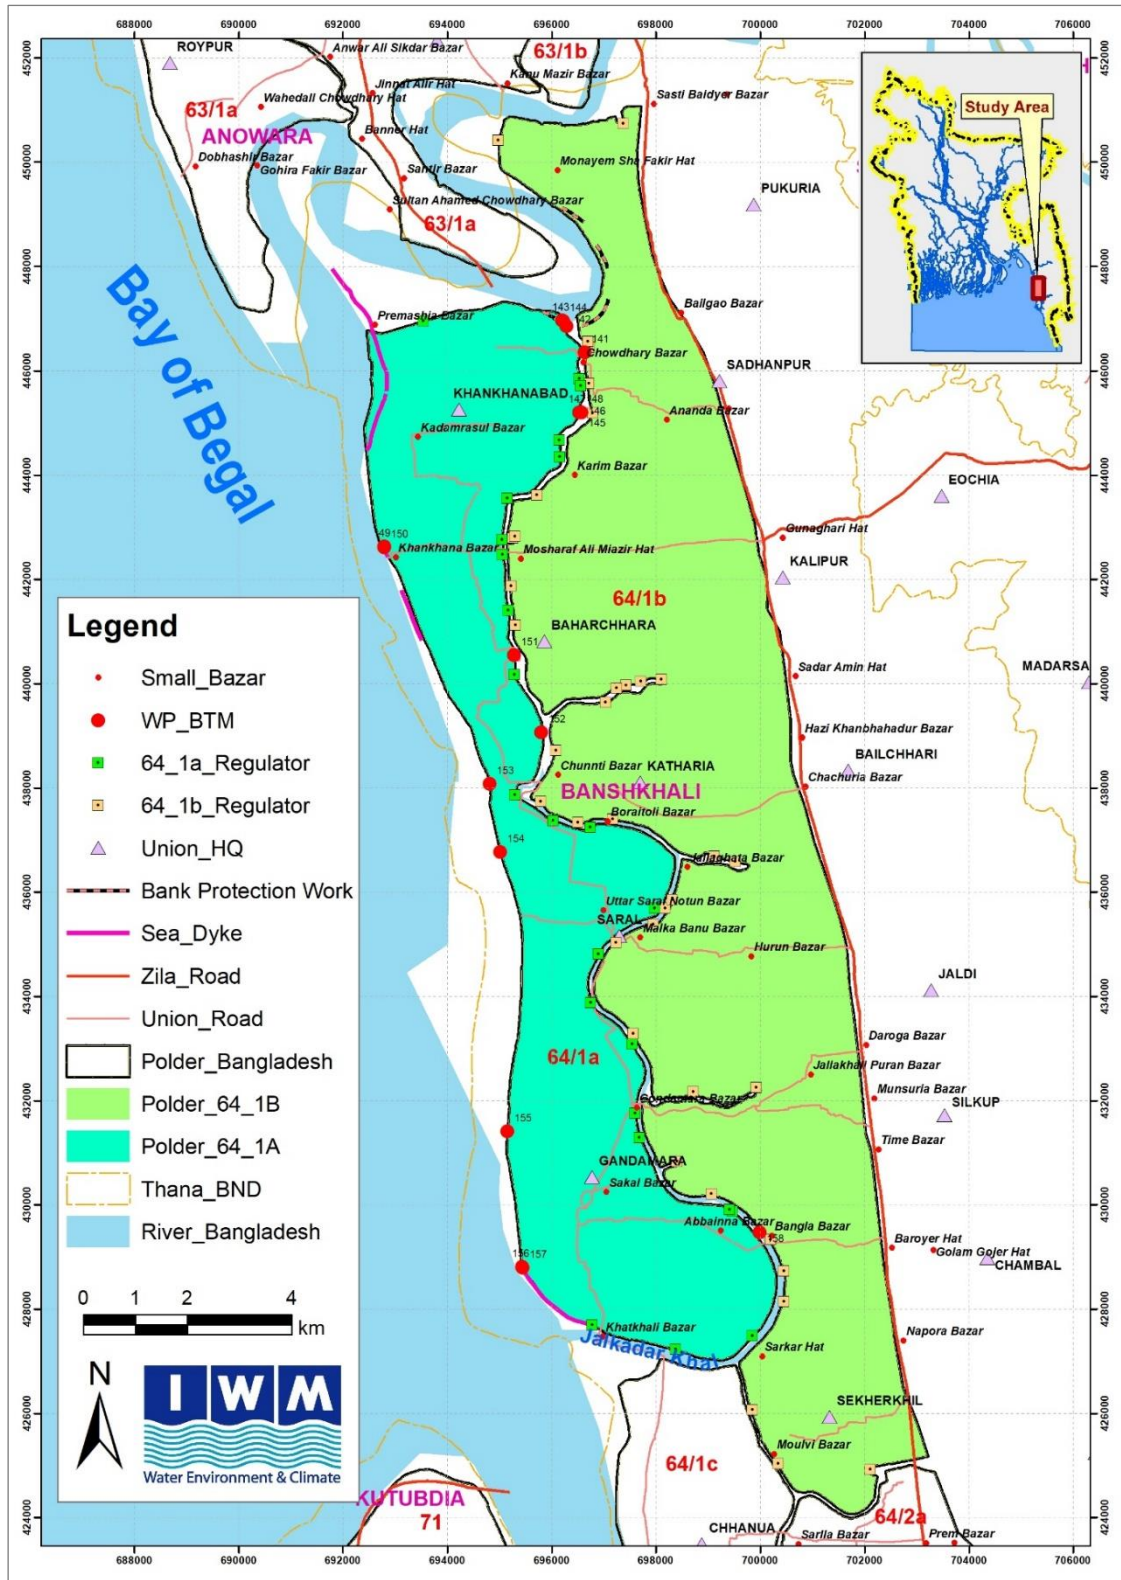
Figure 11: Map Showing Field Visit Observation of Polder 64/1A and Polder 64/1B

- At first, visit was made at Jalkadar Khal and the breach of embankment and eroded area by the Sangu River (Photograph-10, Photograph-11 & Photograph-12). The team visited bank protection at Eshorbabur Hat (390m). The erosion threat area is already protected by the construction of revetment from Sangu Bridge to outfall of the River. The total length of the revetment work (Photograph-12) is 3300 m. The overall condition of the revetment is good. The bank protection work has been constructed in two phases of 2100 m (near Polder 64/1b) and 1200m (near 64/1a).

- The team discussed with local community. Water logging problems was not observed during the visit. However, it was reported that the polder facing water logging problems for 2–3 days during Flash Flood According to local people. Jalkadar khal needs to re-excavate from Sangu confluence to outfall. The team observed that Jalkadar Khal is wider and deeper in the South (Photograph-21). Only the upper part of the Khal is narrow and silted up which needs to re-excavate (Photograph-16). The polder is exposed to Bay of Bengal and vulnerable to cyclonic storm surge There is need of excavation internal khal system.

- The embankment at the sea side of the polder is kancha and damaged in the salt farming areas. The team observed the damaged embankment at sea side near Haliapara in Polder 64/1a. The embankment is damaged due to movement of Salt carrying tractors (Photograph-18). The part of the embankment of Polder 64/1a needs to be repaired and maintenance.

- Team observed the area under afforestation reduced bank erosion and accelerate land reclamation outside the embankment of Polder 64/1a ( Photograph-17 ).
- The team visited kataria Sluice at West Bagmara and observed heavy deposition at the upstream of the structure ( Photograph-16 ). Re-excavation of Khal is required for smooth functioning of the regulator. According to local people the low land area of Polder 64/1A facing water logging problem due to silted up of drainage khals. There are some encroachment of khals. in Polder 64/1a.

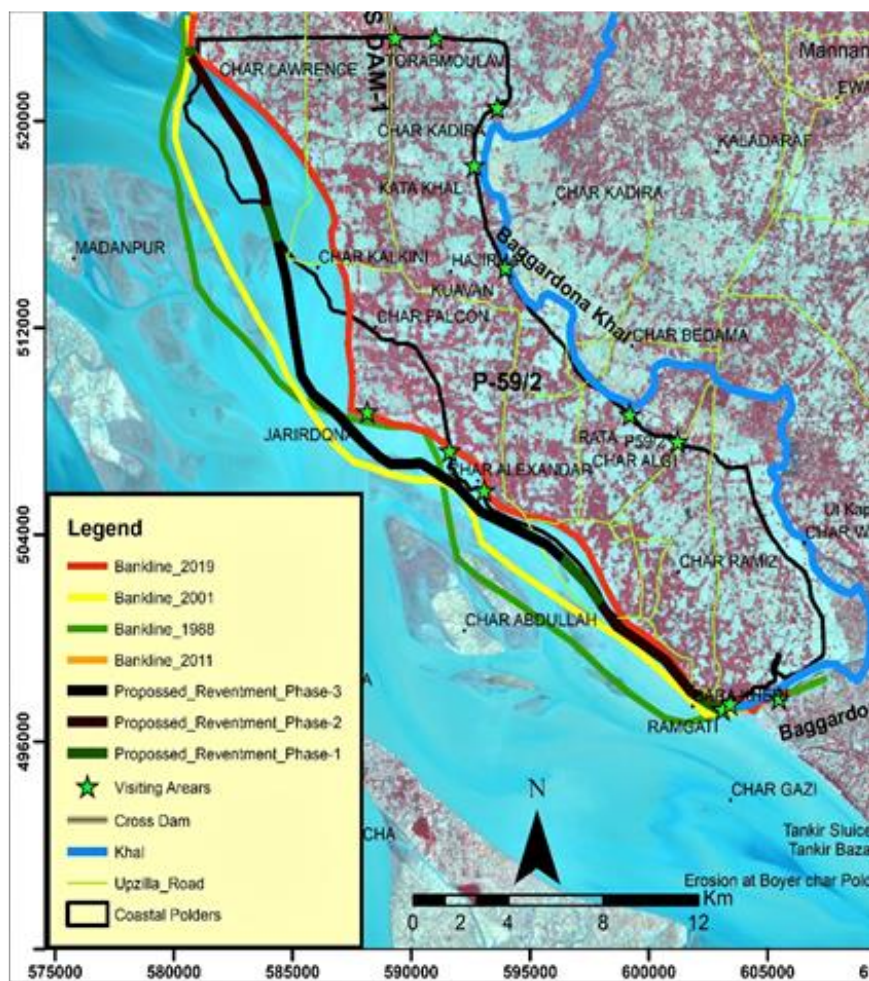
Figure 12: Map of Ramgati west coast showing bank lines of different years

A protection work has been carried during (2016 –17) and (2017 – 18) in the severe eroded areas. Part of the protection works of 600m at the tail end of Ramgati and 3000m at Kamal Nagar has been implemented and the performance is satisfactory except areas at terminal points. A detail reconnaissance survey will provide the status of present revetment and the need of bank protection at all areas of Ramgati. Figure 12 shows the historical bank erosion and Figure 13 shows the existing bank protection work at Lower Meghna.

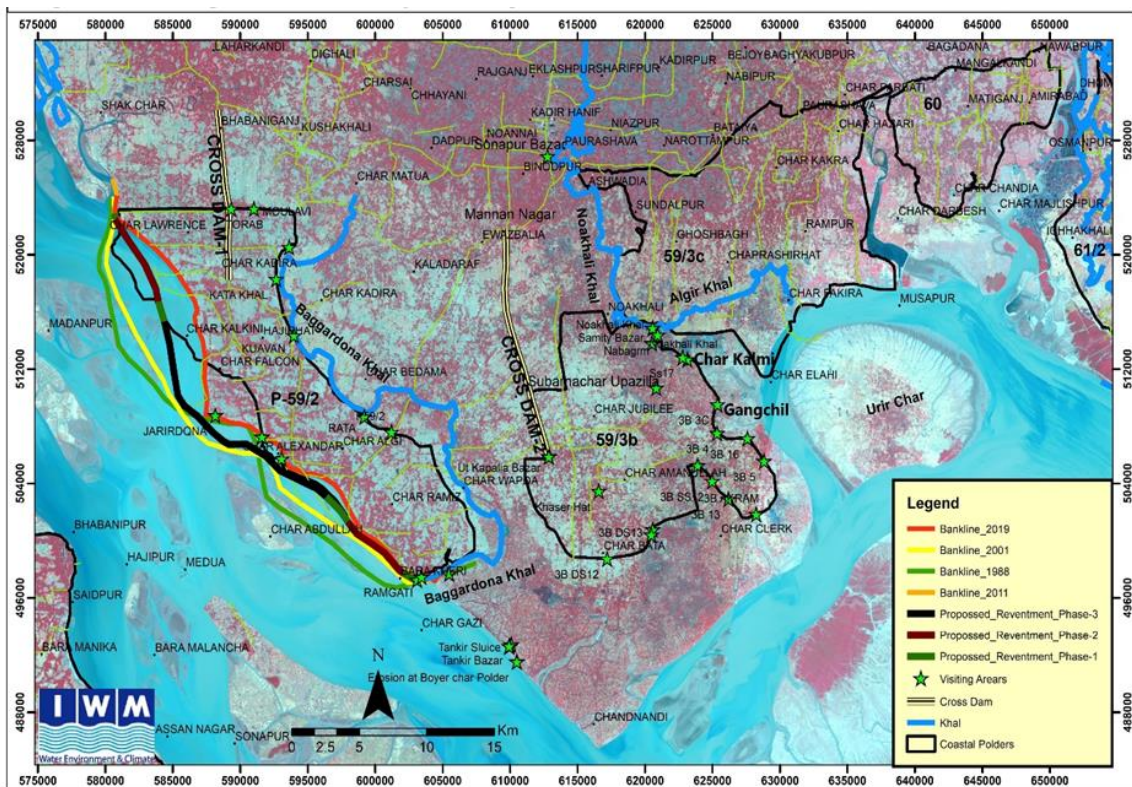
Figure 14: Polder-59/3B with surrounding khals and rivers

Polder 59/3B has become an upland polder meaning it has lost connection with peripheral rivers. The rainfall runoff is often hindered causing water logging and there is no arrangement to make use of either rain water or water of the peripheral rivers (Noakhali khal, Baggerdona channel). Once the Noakhali Khal is rejuvenated (next year), the regulators at east will be functional for drainage as well as for intake of water for appropriate water management. Potentials are there for use of surface water from Baggerdona river also. Location of Polder-59/3B is shown in Figure 14.

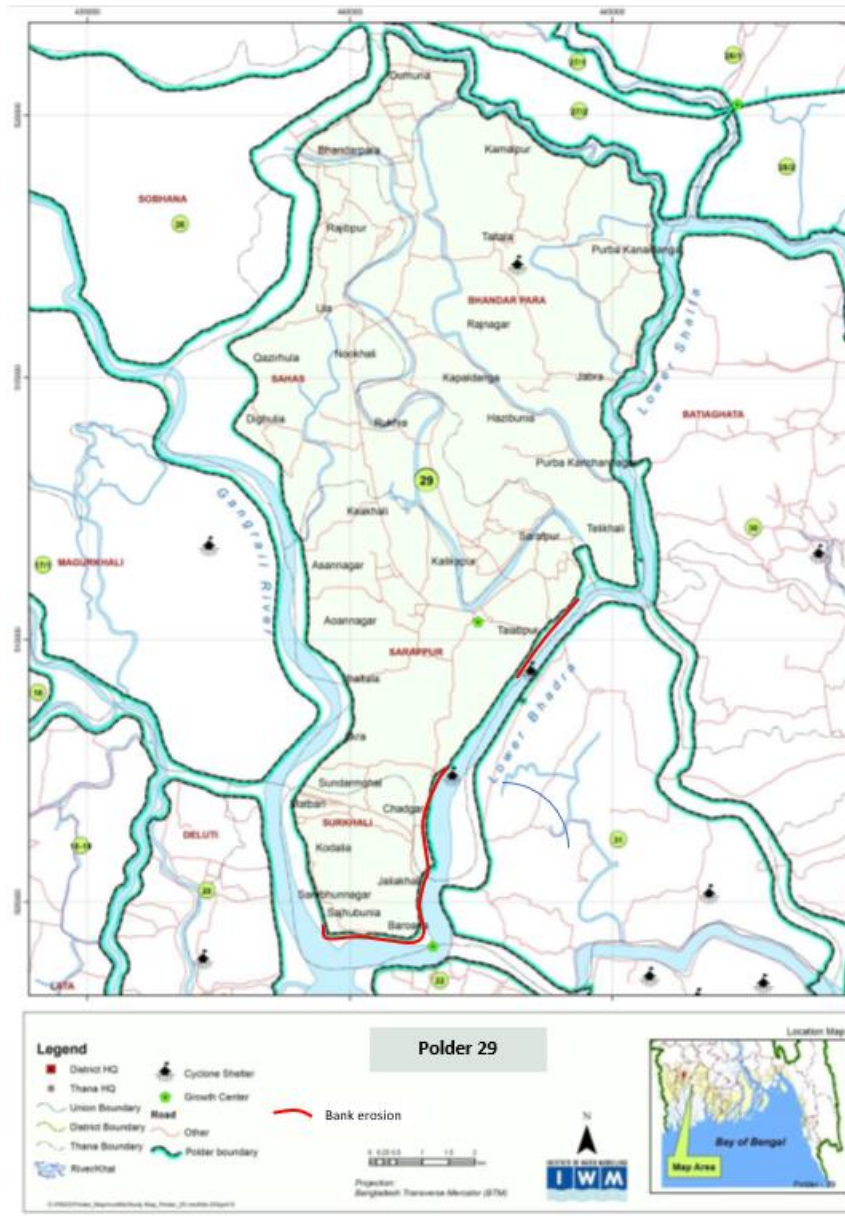
Figure 15: Detailed map of Polder 29 under Blue Gold Program

The major problem at present in the Polder as observed was erosion at the Bhadra River along right bank at Chandghar and Baroaria. According to Rashedul Islam of BWDB, 3 km (ch. 25.3 km to ch. 28.3 km) along right bank of Bhadra river at Baroaria is under threat of erosion and a portion of it has suddenly been eroded on the night of April 19, 2019. The reason behind it as reported is the development of a bar at the middle of Bhadra river which made the flow area constricted on the side channels. As a result, the near bank velocity along the right bank of Bhadra river at Baroaria is increased and caused bank erosion. However, BWDB has taken it up on an emergency basis through protective work by Geobag placement. Precautionary protective work by Geobag is also been done under Blue Gold program at Chandghor and other places, but they are not enough. A permanent solution to the problems is the demand of the local inhabitants.

Erosion problem in the peripheral river of Polder 29 is presented in the Figure 15 and some problems photographs are shown in the Figure 16.

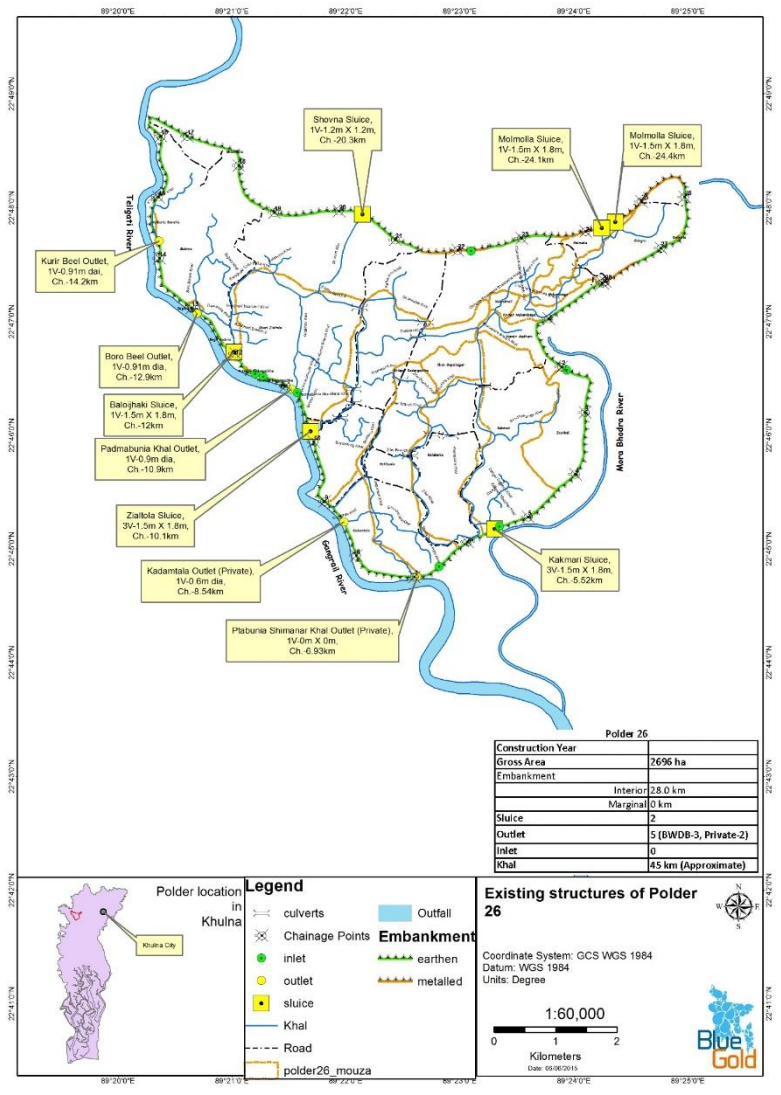
Figure 17: Detailed map of Polder 26 under Blue Gold Program

The existing condition of the peripheral embankment is good in most of the portion and only around 5% of it is paved. Blue Gold Program in this polder was initiated in January 2013 and their interventions for rehabilitation like re-sectioning of the existing embankment, repairing of 2 drainage sluices, construction of 2 new 2-vent sluices, construction of 2 new outlets and re-excavation of 9 inside drainage khals have made the polder free from the existed water logging and drainage problems. According to Mr. Hasnat (concerned Sub-Assistant Engineer, BWDB), no outstanding issue at present exists in Polder 26. However, he stated that siltation in Teligati river from Khornia Bridge towards south is being in progress which would be creating drainage problem for the polder soon. Figure 17 shows the detailed features of Polder 26.

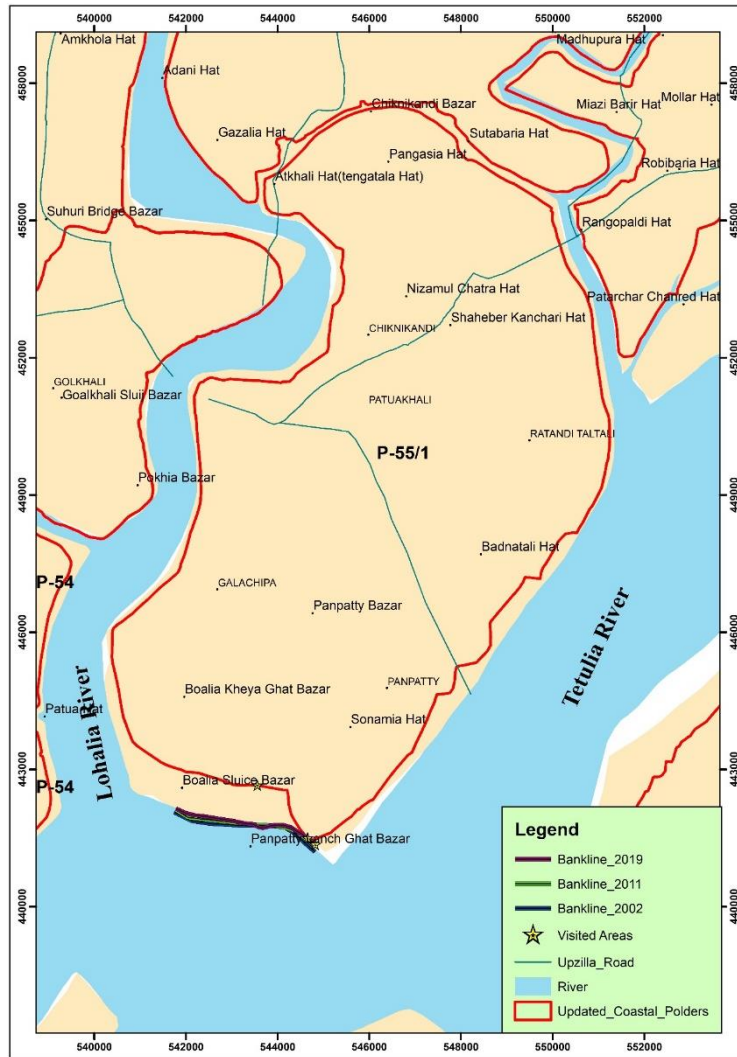
Figure 19: Location map of field visit at Polder 55/1

The Team met Mr. Md. Hasanuzzaman, Executive Engineer, BWDB at his office at Patuakhali and Assistant Engineer Mr. Md. Miraz Gazi. They informed about the existing condition of this polder. The main problem of this polder is river bank erosion and the polder presently do not have waterlogging and drainage problems.

The team visited the most vulnerable part of this polder at Panpatty Bazar and Panpatty launch Ghat area along the bank of the confluence of Lohalia and Tetulia river. Local people informed that this area was mostly affected during the Cyclone SIDR, 2007 and still it is vulnerable to erosion. Some emergency protection work by sand geo-bag was observed and some new erosion area also found in this area ( see the Photographs ). Local people were also informed the team that there is some more erosion vulnerable area along the right bank of Tetulia river. Prior to visit Panpatty Bazar, the team also visited Boalia Sluice and the structure looks good in condition ( Figure 20 ).
