November, 2023

# POLDER 33

FIELD VISIT REPORT

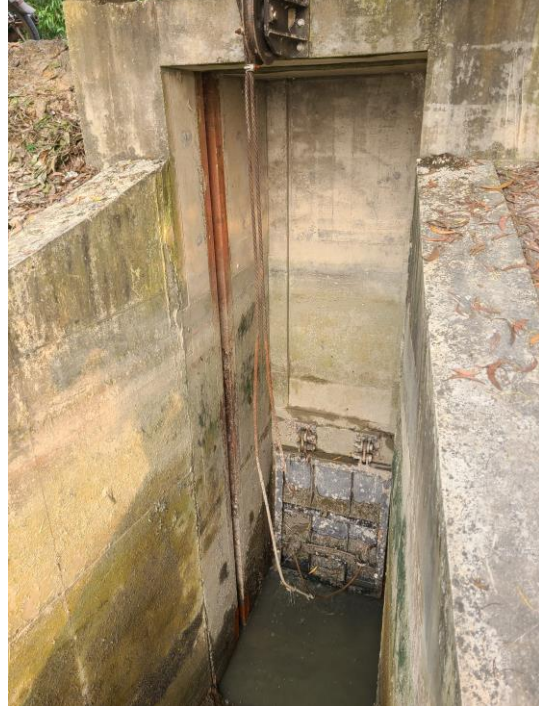
Date	Polder Name	Chainage (Km)	ID of Structure
22.11.2023	Polder 33	18.66	FS-6

**Observation:** Structure is in good condition. Both gates are closed and operable. Vertical lift gate hoist and chain pulley copper is available. Leakage could not be measured because of low level of water. Medium rust in stem, nuts bolts and chain pulley block.

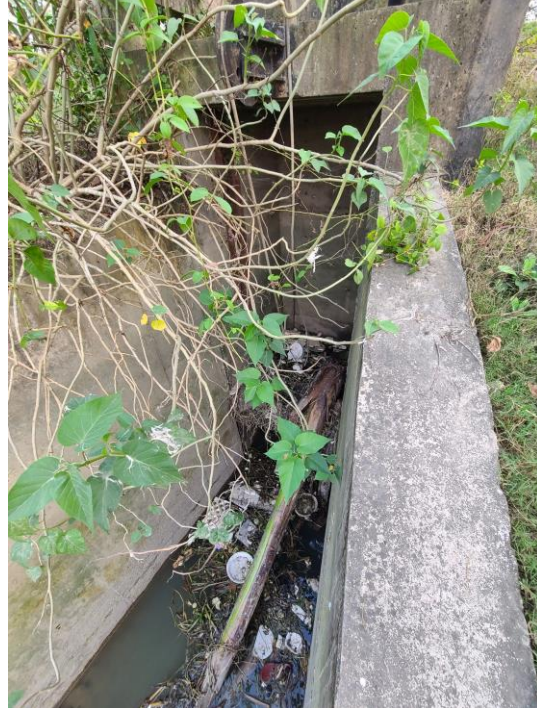
Date	Polder Name	Chainage (Km)	ID of Structure
22.11.2023	Polder 33	27.93	FS-9

**Observation:** Both gates are closed. Vertical lift gate hoist and chain pulley block is available. But vertical lift gate is not operable because the stem rod is bend and vertical gate is not open fully. Flap gate could not closed properly because vent is block by debris. Leakage could not measured because of low level water. Medium rust in stem rod, nuts & bolts, steel rope and chain pulley Block.
