# Polder 35/1

Field Visit Report

tareq islam  
[COMPANY NAME]

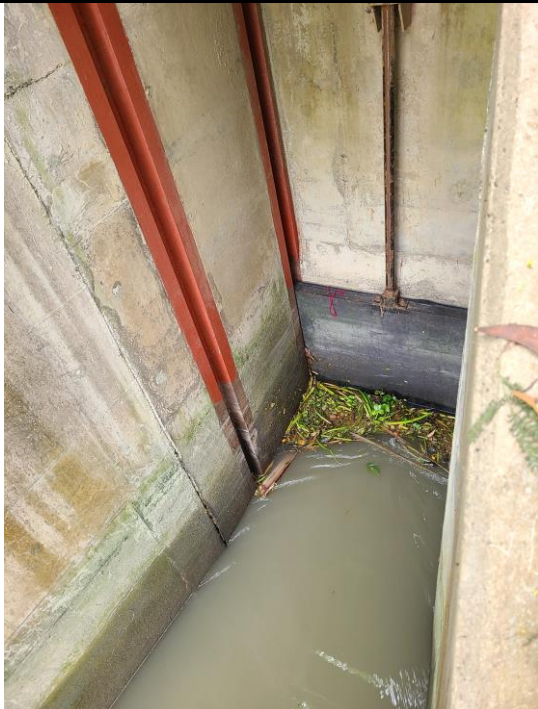
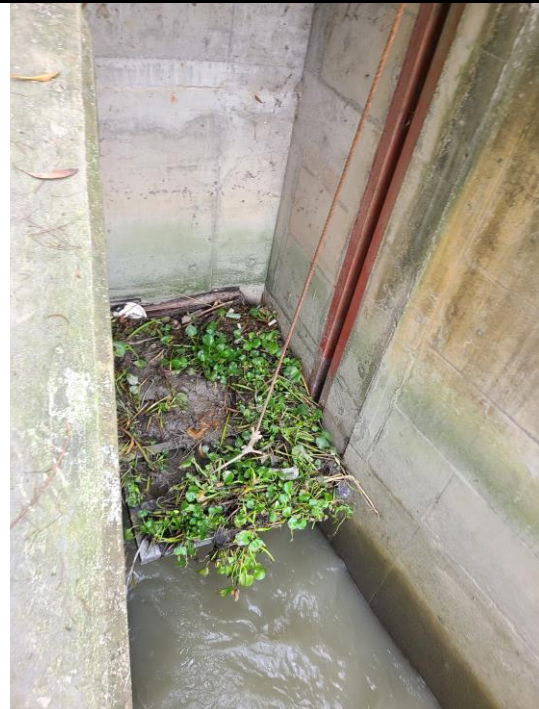
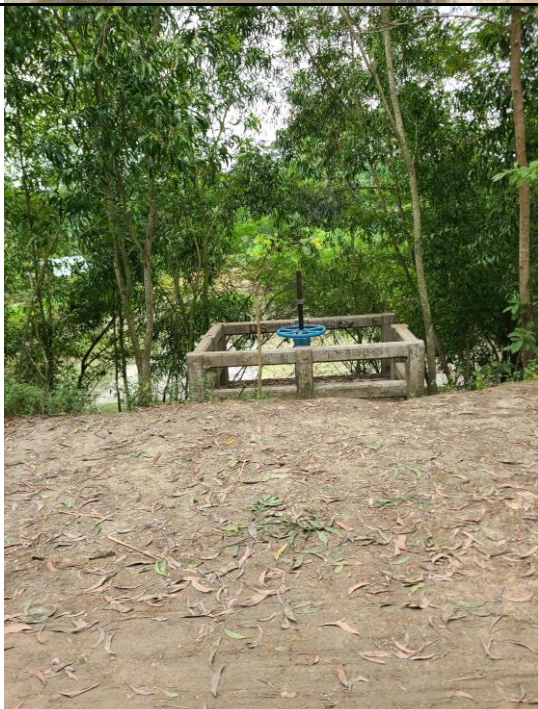
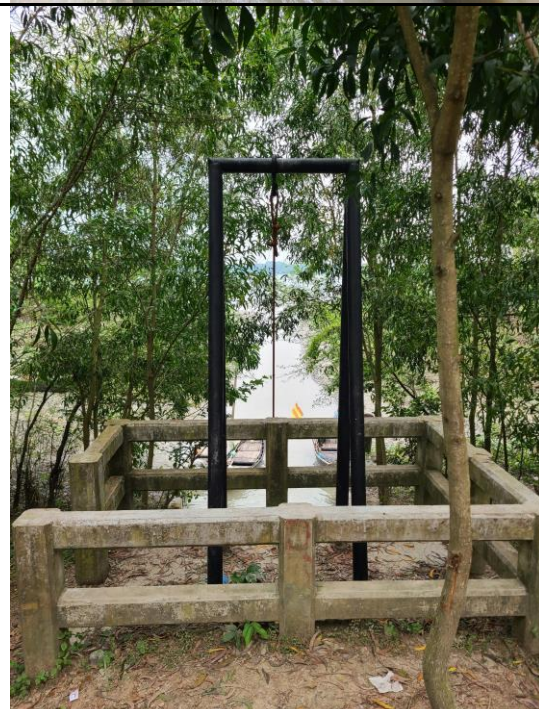
Date	Polder Name	Chainage (Km)	ID of Structure
21.11.2023	Polder 35/1	0	DS-1

**Observation:** Vertical lift gate is partly open and it is operable. Flap gate is opened and it is not operable because chain pulley block is missing. A steel rope is used for keeping the flap gate open. Nut and bolts and steel rope are rusted.

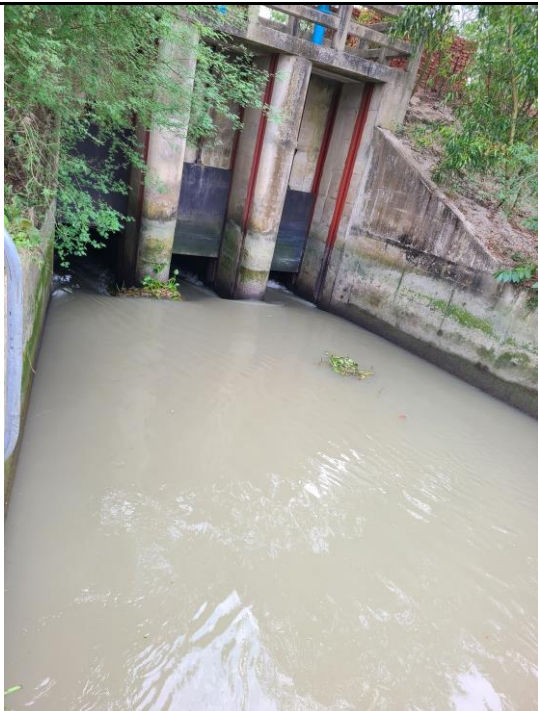
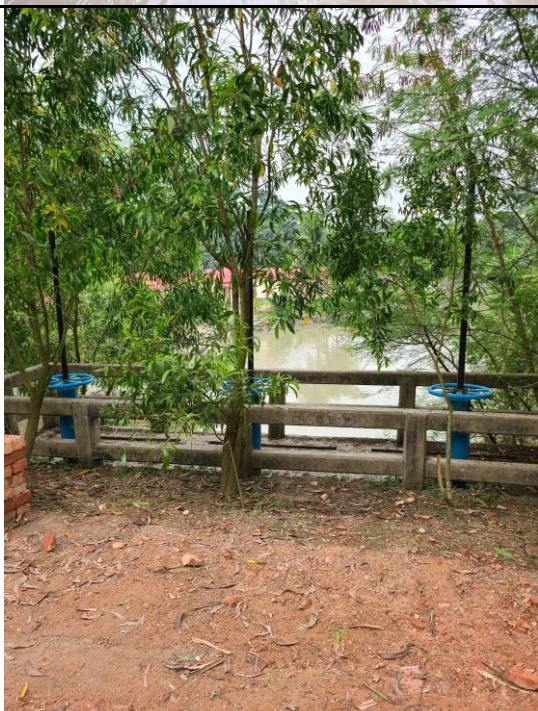
Date	Polder Name	Chainage (Km)	ID of Structure
21.11.2023	Polder 35/1	3.332	DS-2

**Observation:** All Vertical lift gate are open and operable. Two flap gate is open and debries on the flap gate. Another flap gate is closed but not properly closed. All flap gate are not operable because chain pulley block missing. Steel rope used for keeping the flap gate open. There is rust on nuts, bolts and settel rope.

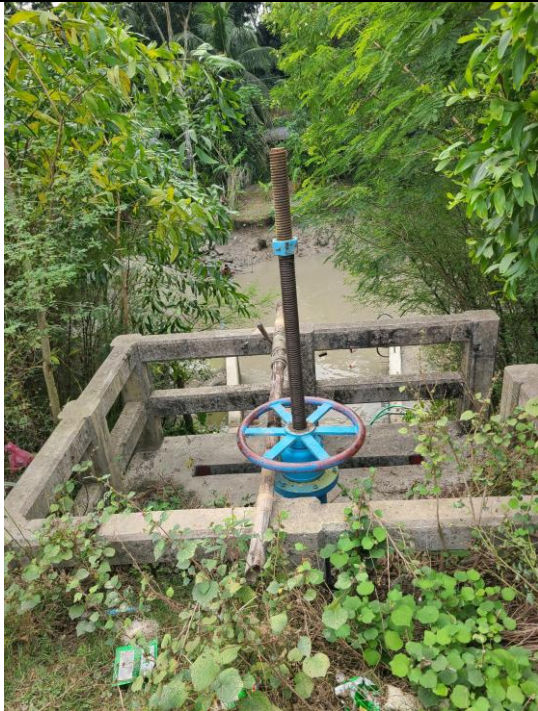
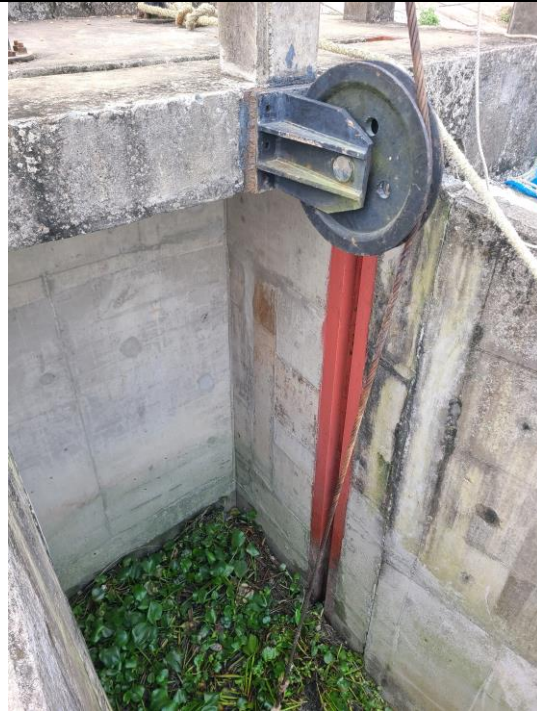
Date	Polder Name	Chainage (Km)	ID of Structure
21.11.2023	Polder 35/1	14.39	DS-5

**Observation:** In this structure vertical lift gate is open and operable. We could not take picture due to heavy bush beside the wing wall of the structure. River side flap gate is open and not operable because chain pulley block is not available. There are lots of debries on the flap gate. A steel rope is use for keeping the flap gste open.

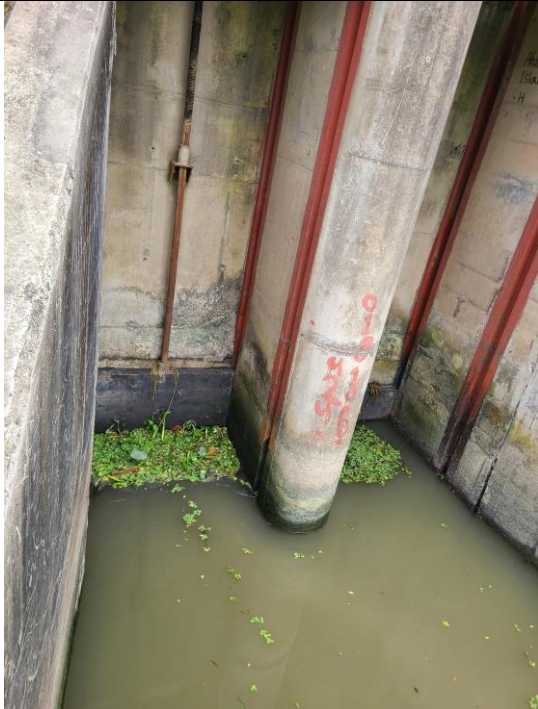
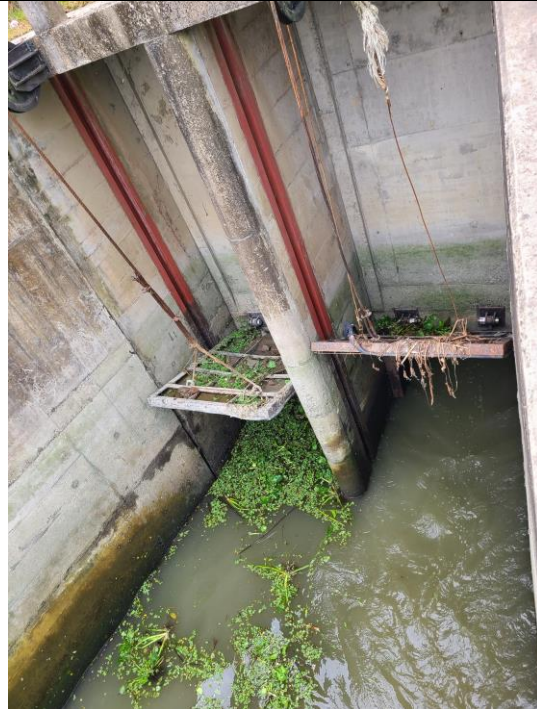
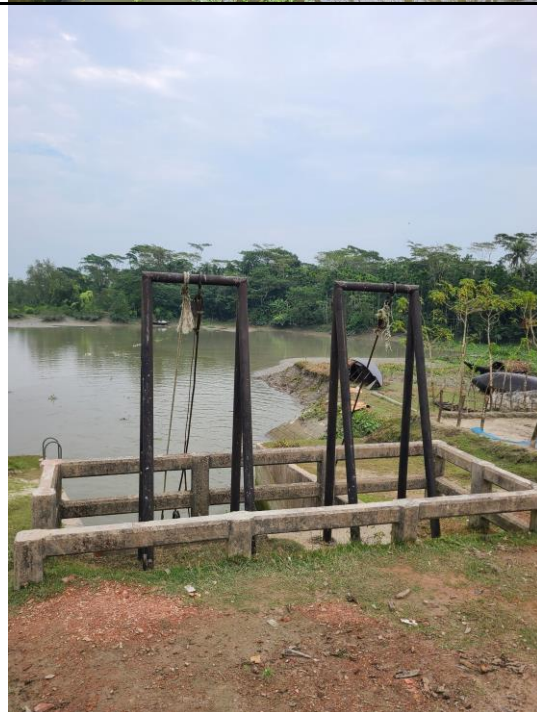
Date	Polder Name	Chainage (Km)	ID of Structure
21.11.2023	Polder 35/1	19.973	DS-6

**Observation:** In this structure vertical lift gate is partly open and operable. There are Water hyacinth on the country side lift gate. River side flap gate is open and not operable because chain pulley block is not available. There is lots of debris on flap gate. A steel rope is used for keeping the flap gates open. Steel rope, flap gates, nuts and bolts are rusted.

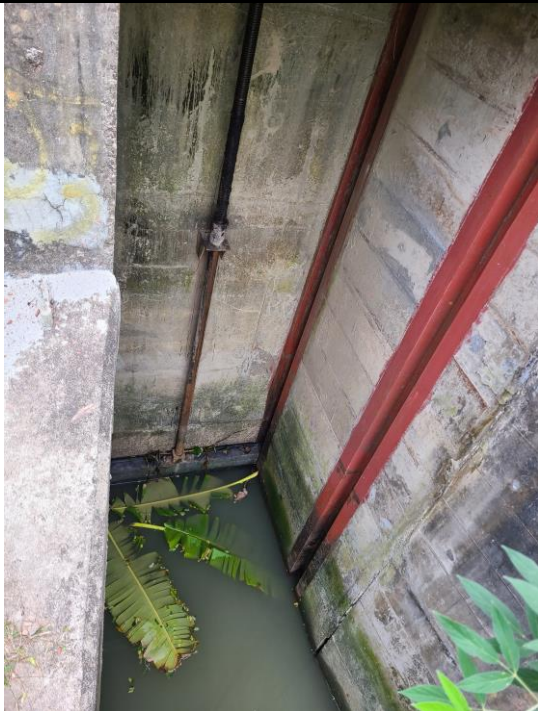
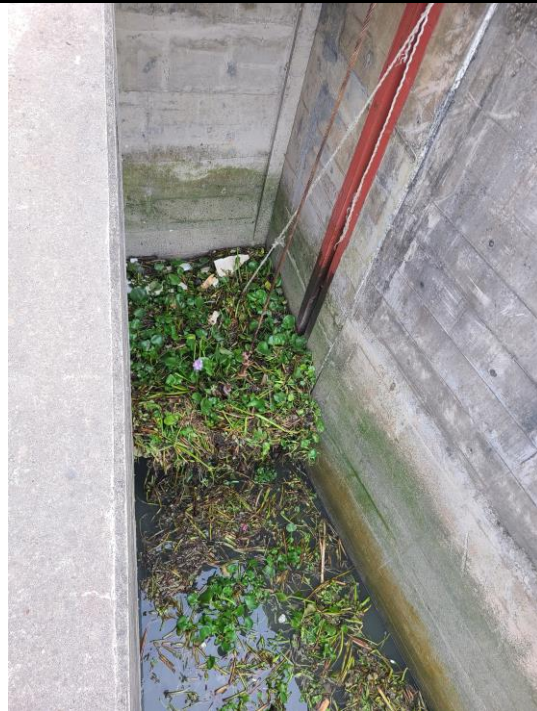
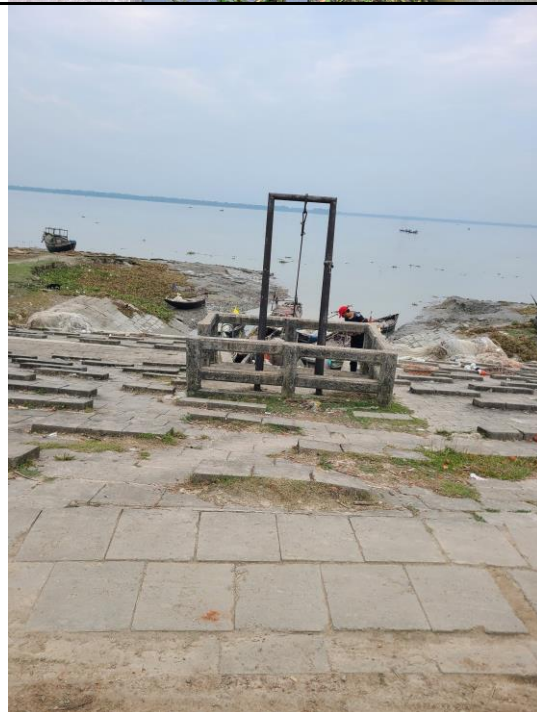
Date	Polder Name	Chainage (Km)	ID of Structure
21.11.2023	Polder 35/1	23.537	DS-7

**Observation:** In this structure vertical lift gate is closed and operable. River side flap gate is open and not operable because chain pulley block is not available. There are lots of debris and Water hyacinth on the flap gate. A steel rope is use for keeping the flap gates open. Steel rope, flap gates, nuts and bolts are rusted.

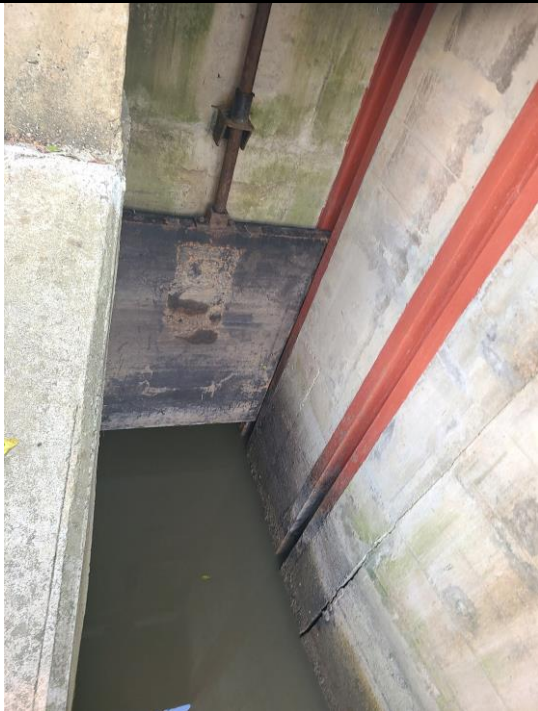
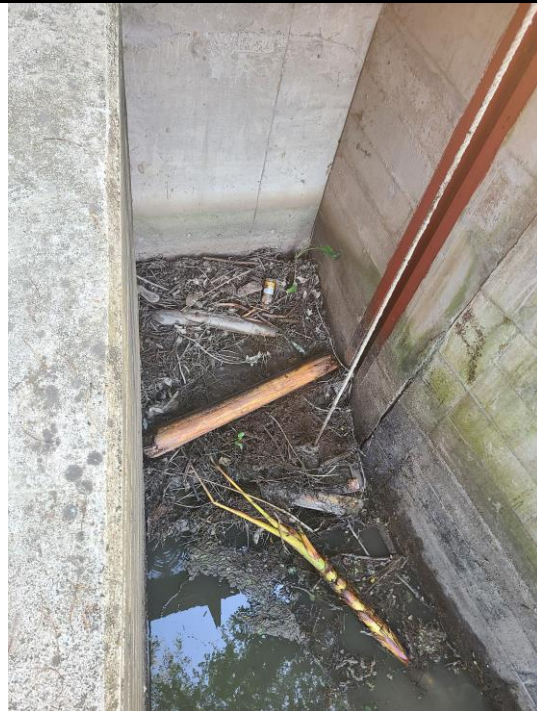
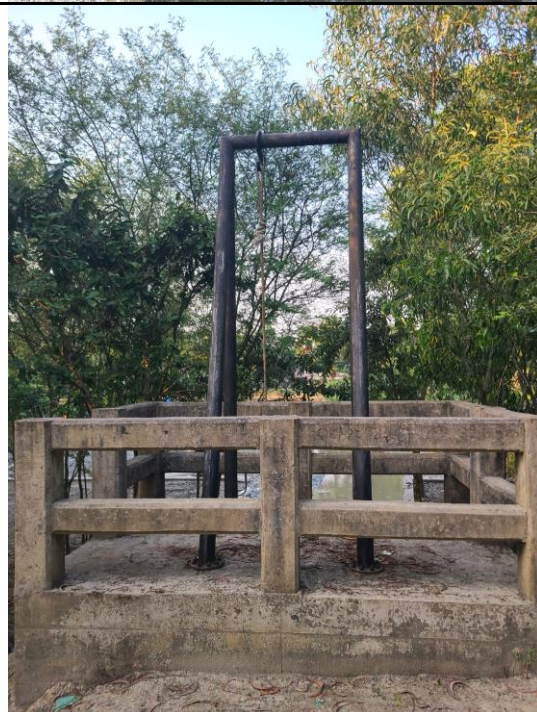
Date	Polder Name	Chainage (Km)	ID of Structure
23.11.2023	Polder 35/1	50.253	DS-17

**Observation:** Lift gate is open and operable and flap gate is open but not operable, because chain pulley block is missing. There are debris on the flap gate. Local People have tied the flap gate with steel rope at the hook. Lower portion of stem rod and lift gate are seen severely rusted, Nuts and bolts are rusted.

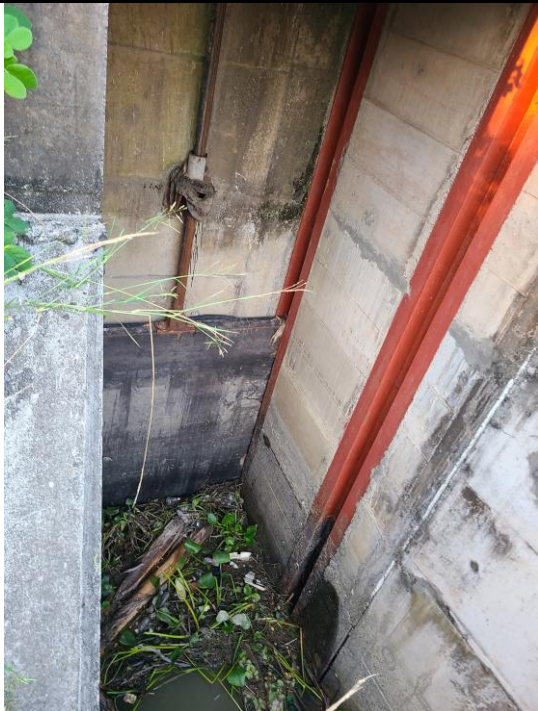
Date	Polder Name	Chainage (Km)	ID of Structure
23.11.2023	Polder 35/1	53.94	DS-13

**Observation:** Lift gate is open and operable and flap gate is also open but not operable, because chain pulley block is missing. There are debris in the both gates. Local People have tied the flap gate with steel rope at the hook. The lower portion of stem rod and lift gate are seen severely rusted. Nuts and bolts are rusted.

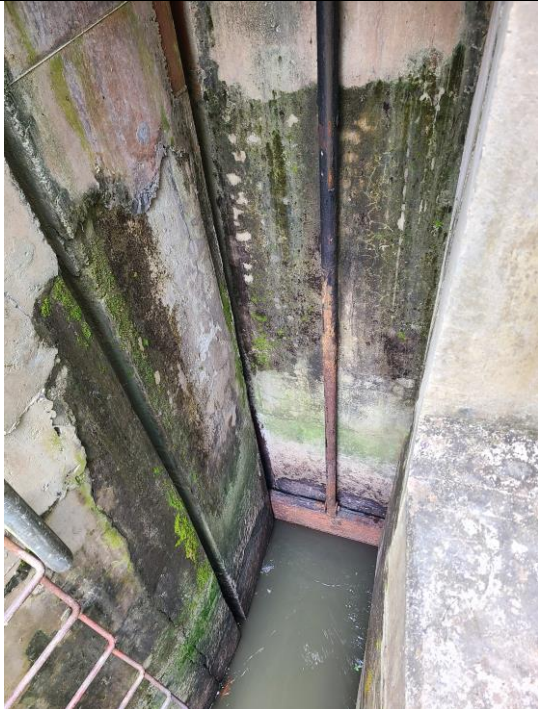
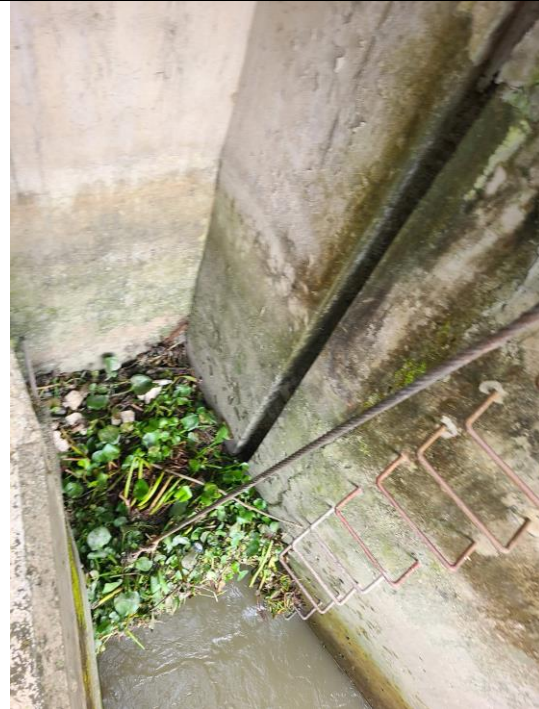
Date	Polder Name	Chainage (Km)	ID of Structure
21.11.2023	Polder 35/1	59.745	DS-15

**Observation:** Both gates are open but flap gate is not operable, because the chain pulley block is missing. There are debris and water hyacinth on the flap gate. Local People have tied the flap gate with steel rope at the railing. Lower portion of stem rod and lift gate are seen severely rusted. Nuts and bolts are rusted.

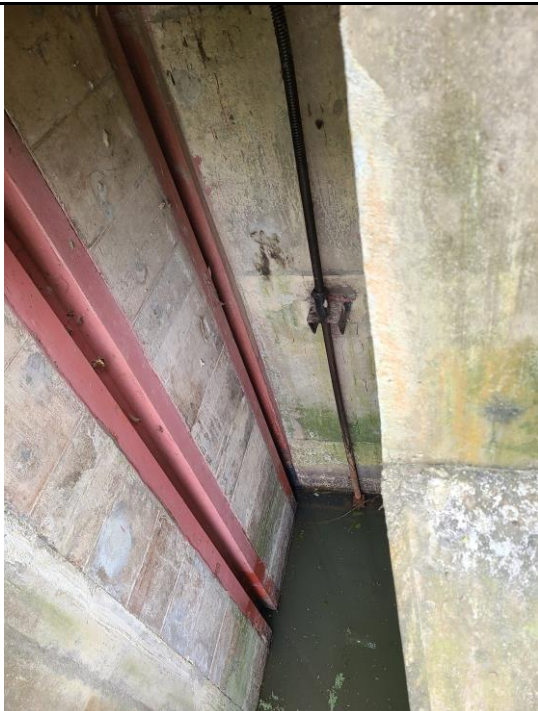
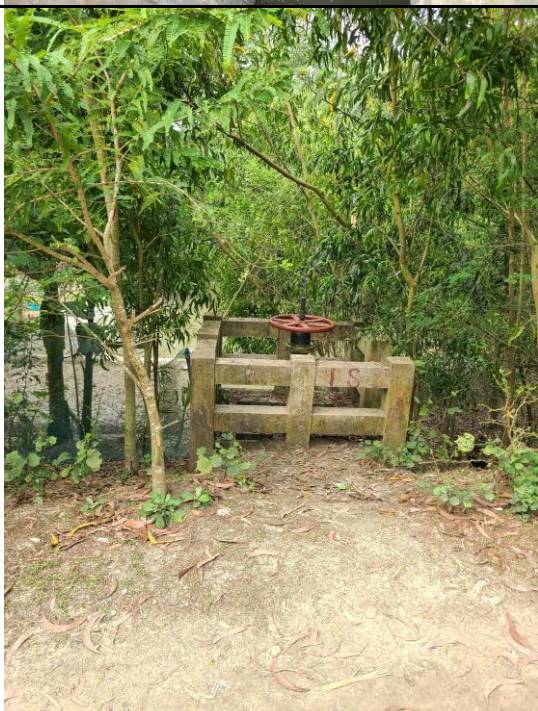
Date	Polder Name	Chainage (Km)	ID of Structure
21.11.2023	Polder 35/1	5.743	FS-2

**Observation:** Vertical lift gate is in good condition. The vertical lift gate is operable. Flap gate is open and flap gate is not operable because chain pulley block is missing. There are debries and water hyacinth on the flap gate. There is rust on the steel surface, stem rod and nuts and bolts.

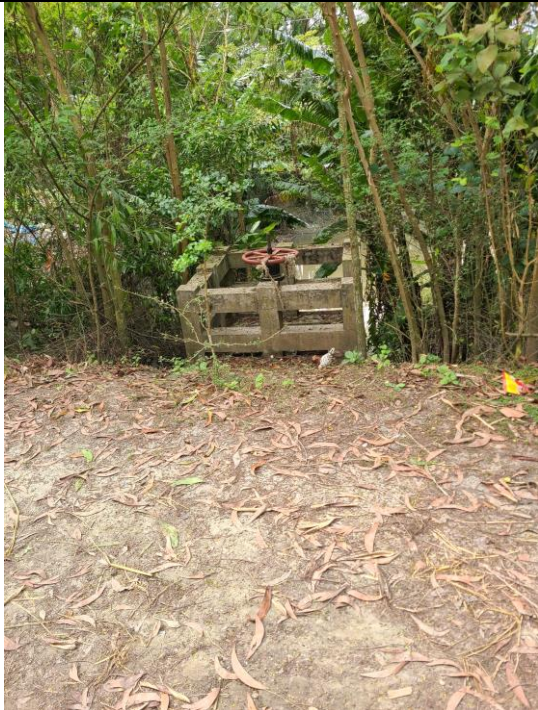
Date	Polder Name	Chainage (Km)	ID of Structure
21.11.2023	Polder 35/1	9.44	FS-4

**Observation:** Vertical lift gate is in good condition. The vertical lift gate is operable but we could not take lift gate photo for bush beside the wing wall of the sluice. Flap gate is closed and flap gate is not operable because Chain pulley block is missing . There are debries and water hyacinth on the flap gate. There is rust on the steel surface, stem rod and nuts and bolts.

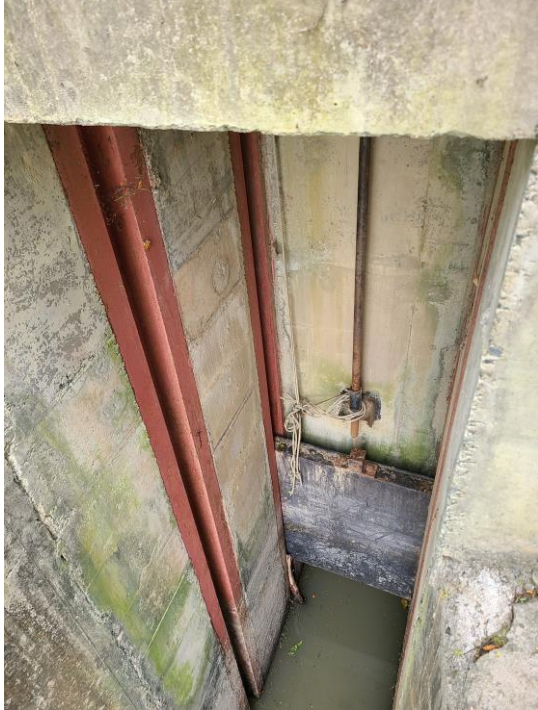
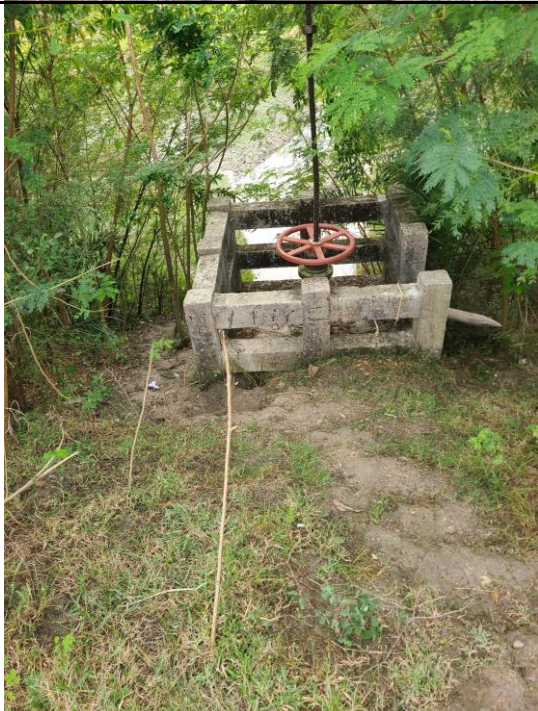
Date	Polder Name	Chainage (Km)	ID of Structure
21.11.2023	Polder 35/1	16.744	FS-5

**Observation:** Vertical lift gate is in good condition. The vertical lift gate is operable . Flap gate is closed and flap gate is not operable because Chain pulley block is missing from flap gate. There is debris and water hyacinth on the flap gate. There is rust on the steel surface, stem rod and nuts and bolts.

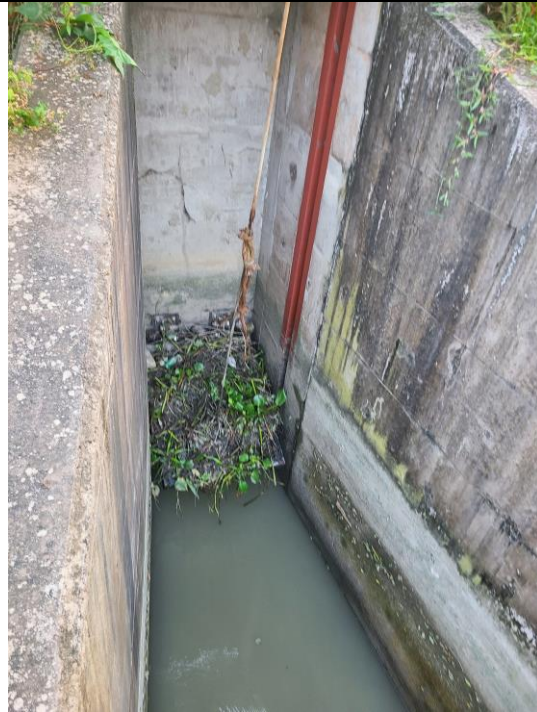
Date	Polder Name	Chainage (Km)	ID of Structure
23.11.2023	Polder 35/1	55	FS-18

**Observation:** Vertical lift gate is in good condition and closed. The vertical lift gate is operable . Flap gate is open and flap gate is not operable because Chain pulley block is missing. There are debris and water hyacinth. There is rust on the steel surface, stem rod and nuts and bolts.

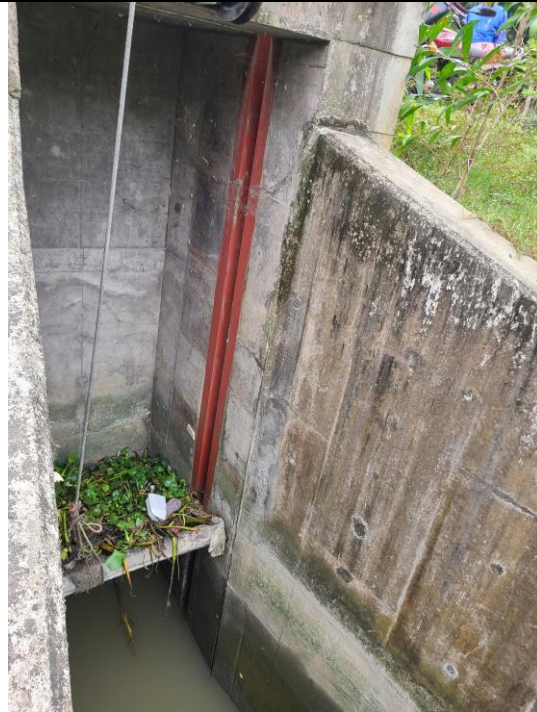
Date	Polder Name	Chainage (Km)	ID of Structure
23.11.2023	Polder 35/1	56	FS-19

**Observation:** Vertical lift gate is in good condition and open. The vertical lift gate is operable . Flap gate is open and flap gate is not operable because Chain pulley block is missing . There are debris and water hyacinth. There is rust on the steel surface, stem rod and nuts and bolts. Local People tie flap gate with a steel rope at the structure railings.
